## FACILITY NEEDS ASSESSMENT

### ESSEX ELEMENTARY SCHOOL AND MANCHESTER ESSEX MIDDLE-HIGH SCHOOL

#### Manchester Essex Regional School District

DRAFT REPORT: January 27, 2023  
H&A JN 2217.01

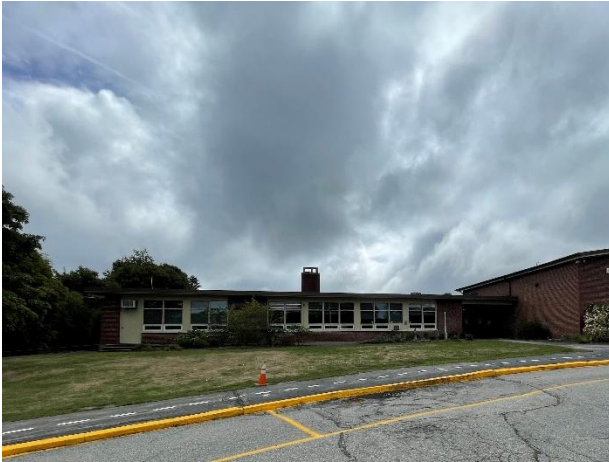
1. Bituminous driveway shows signs of cracking and freeze/thaw damage.

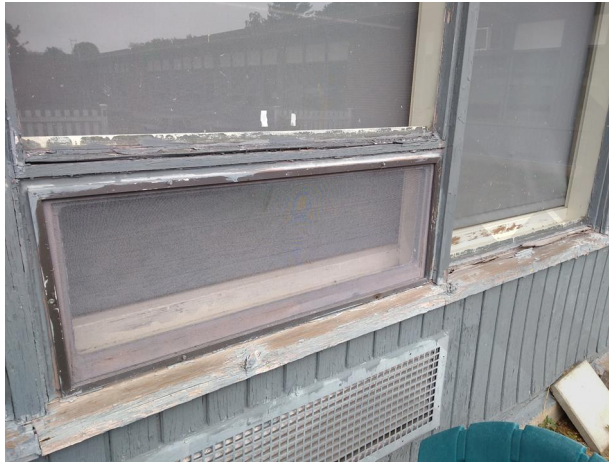
2. Original windows and trim have deteriorated.

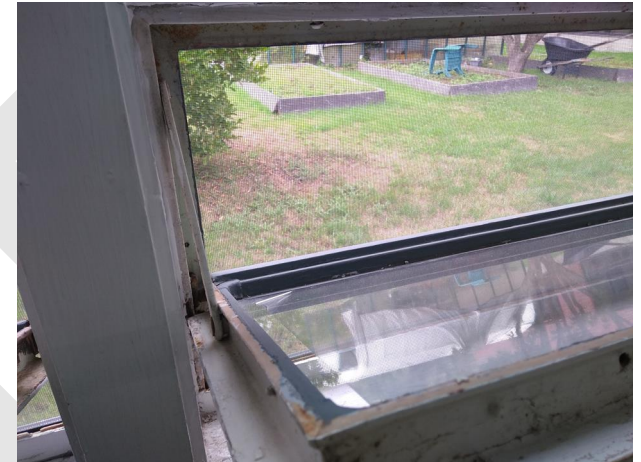
3. Operable steel hopper window has no weather strip.

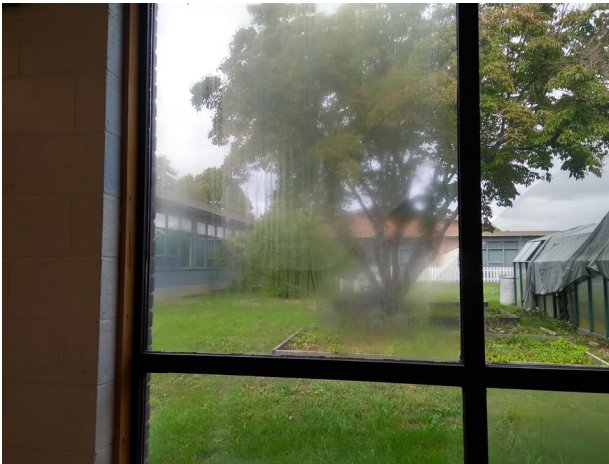
4. Thermal pane window has seal failure.

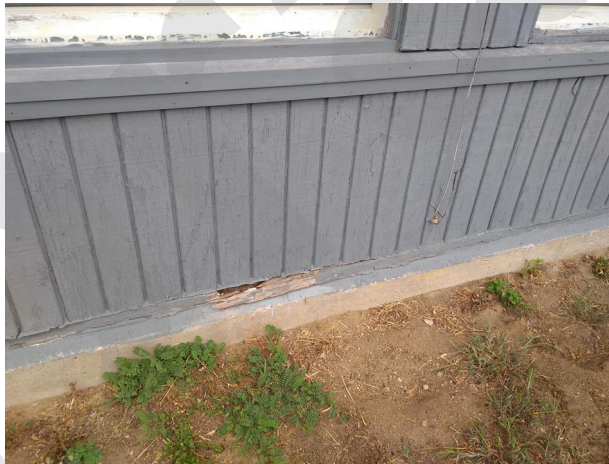
5. The wood siding is rotted and damaged.

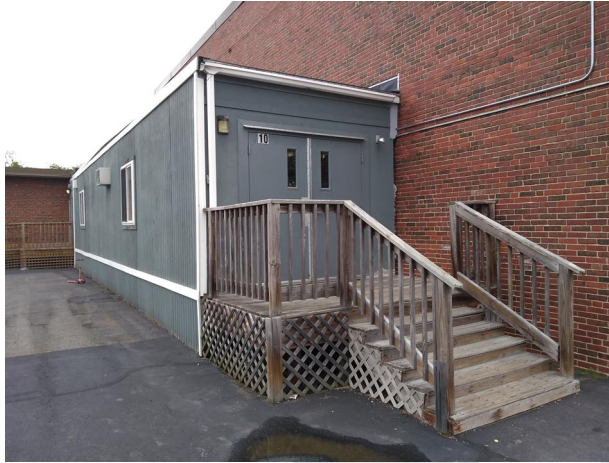
8. Modular addition has deteriorated and leaks at connection to main building.

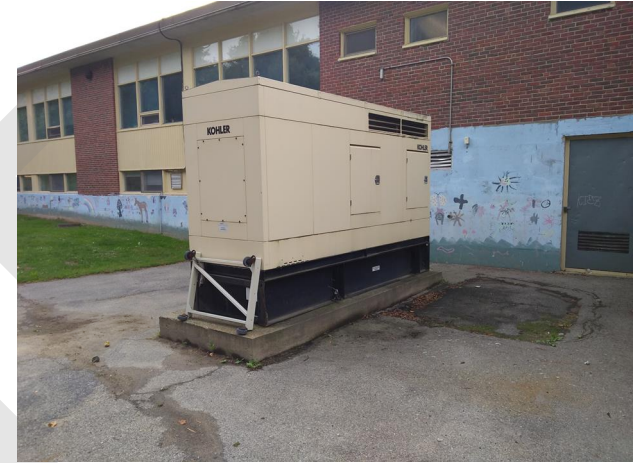
9. Confirm that generator has been maintained per manufacturer's recommendations.

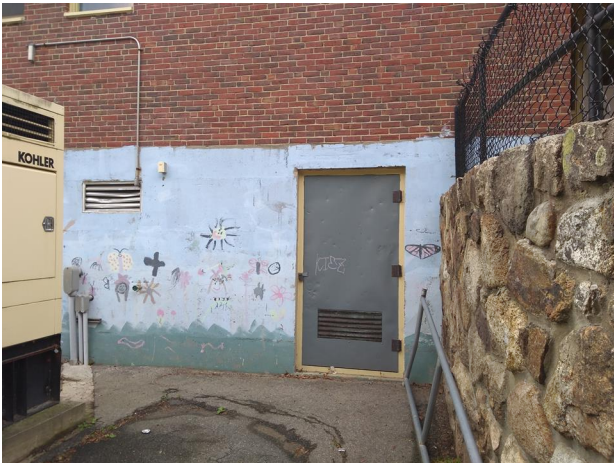
10. Bituminous pavement is damaged, original hollow metal doors require repair/replacement.

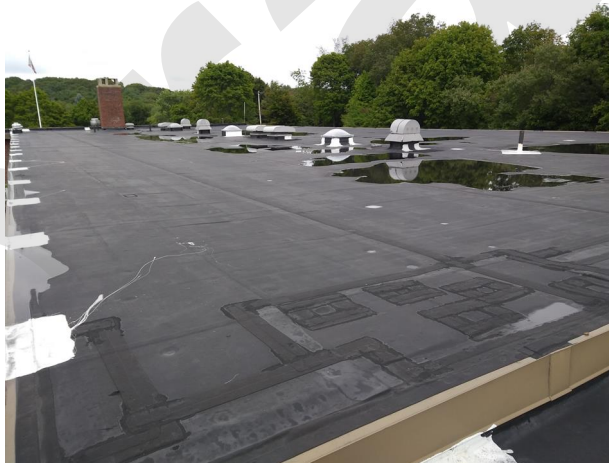
11. Rubber membrane roof has many areas of standing water and is extensively patched.

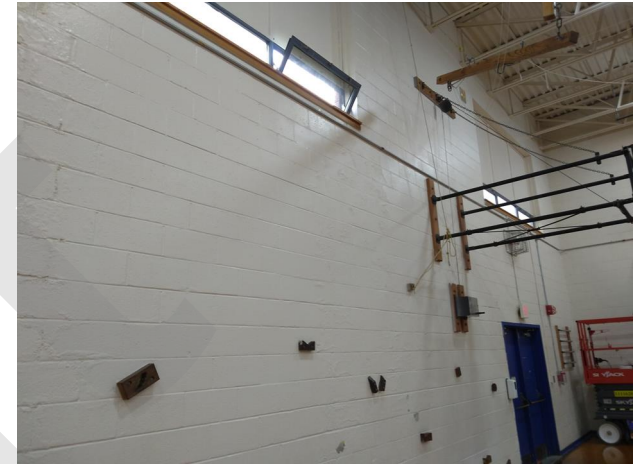
15. The brick/CMU wall of Gym shows signs of extensive water damage and is not insulated.

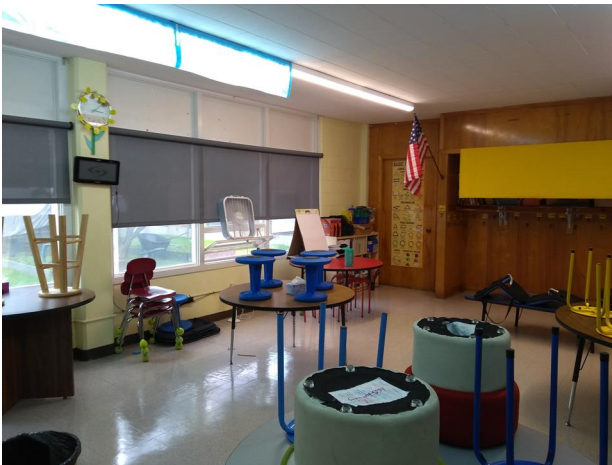
16. Classrooms have outdated spline ceiling and insufficient ventilation.

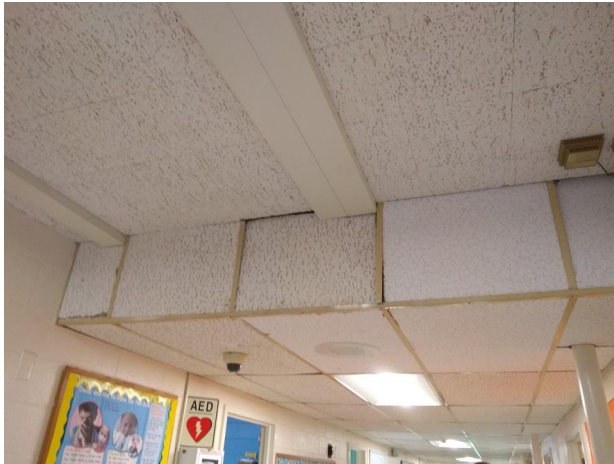
19. Existing 2x4 ceilings are discolored and tiles are mis-matched.

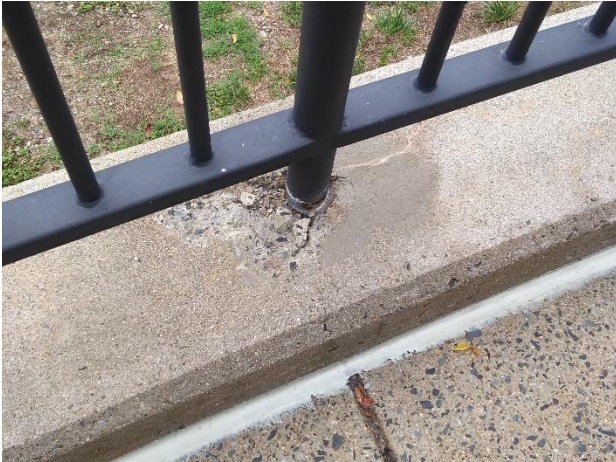
1. Concrete has spalled at some rail posts.

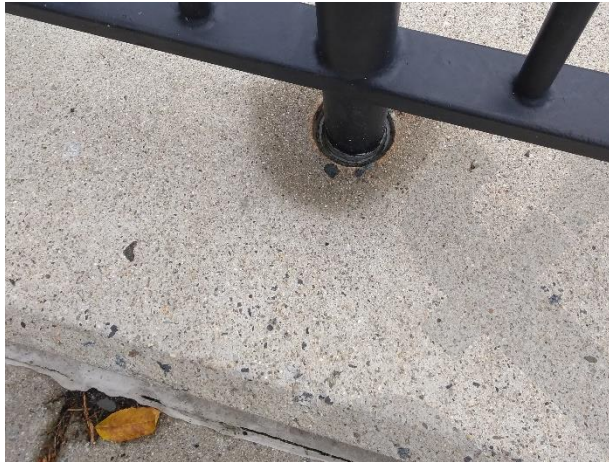
2. Rail posts do not have sealants and some sealants are failing.

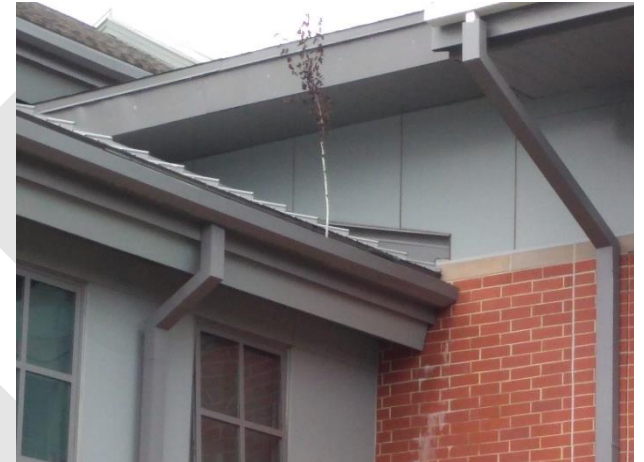
3. Some gutters are clogged with vegetation.

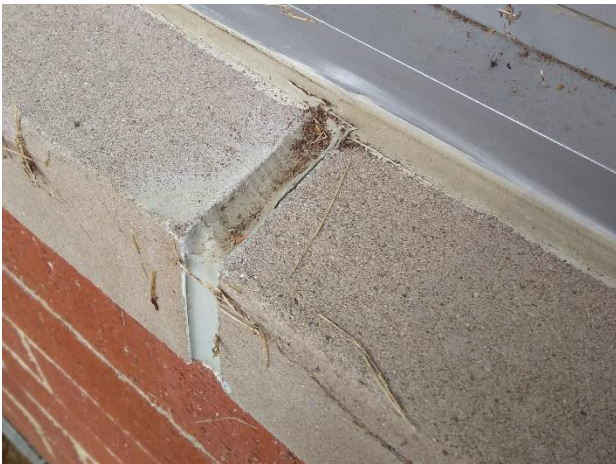
4. Some sealant shows early signs of deterioration.

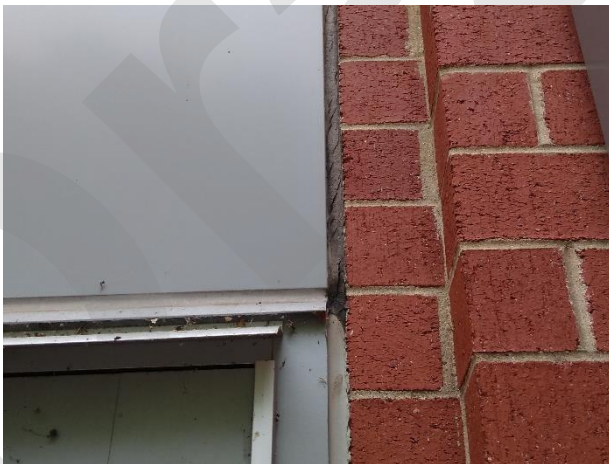
5. Sealant at metal panel is showing signs of deterioration.

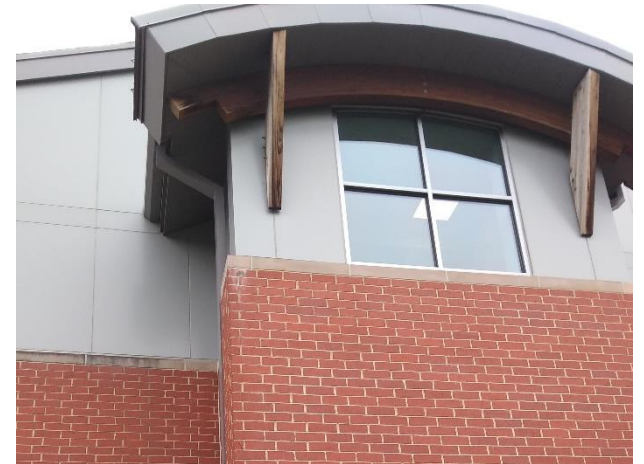
6. Discoloration is evident at wood accents, brick and precast.

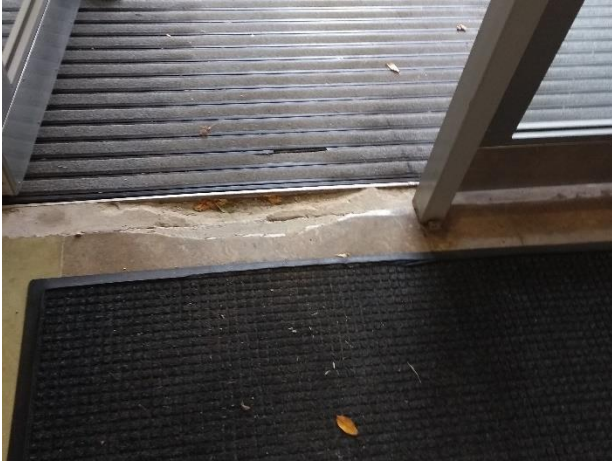
7. Threshold at entry is damaged. Walk off mat is worn.

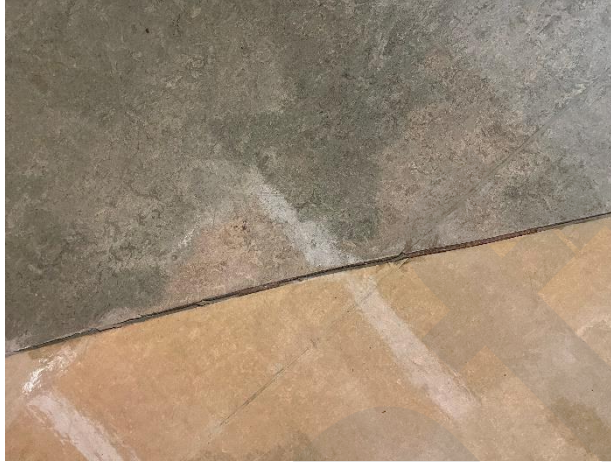
8. Some floor joints at natural linoleum are damaged.

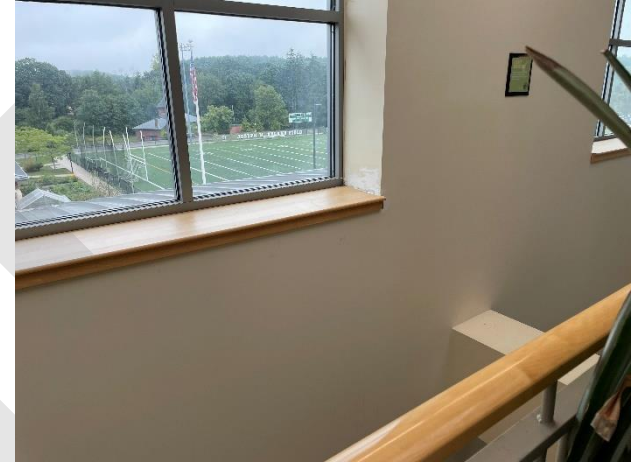
9. Several windows show signs of water damage.

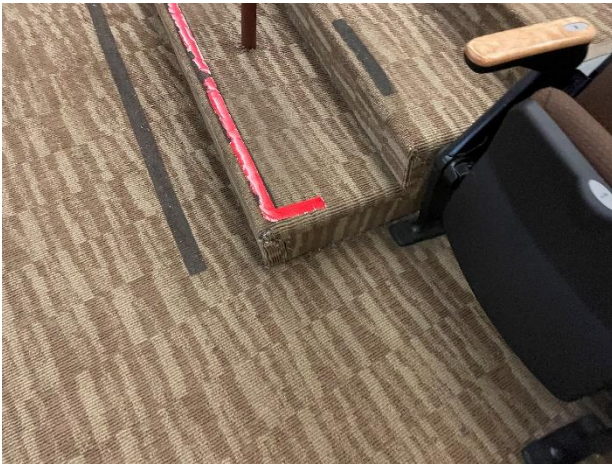
10. Original carpet at Auditorium is showing signs of wear.

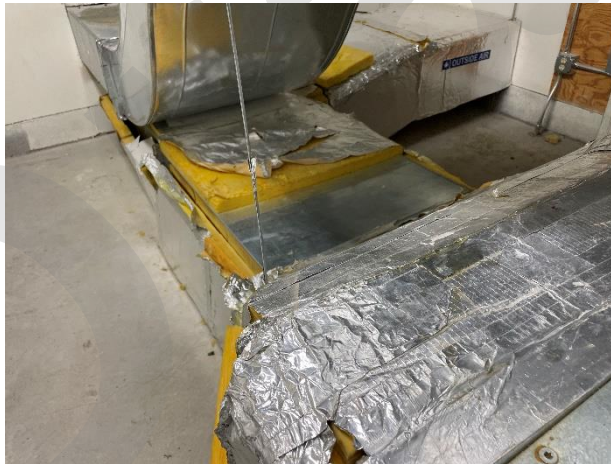
11. Some duct work has damaged or missing insulation.

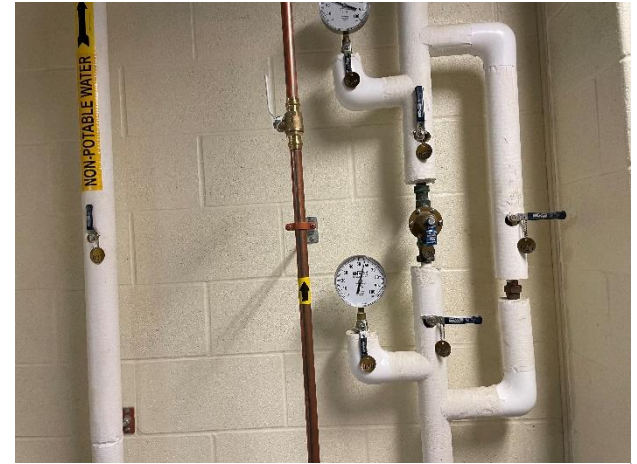
12. Plumbing valves require frequent replacement due to high mineral content in water supply.

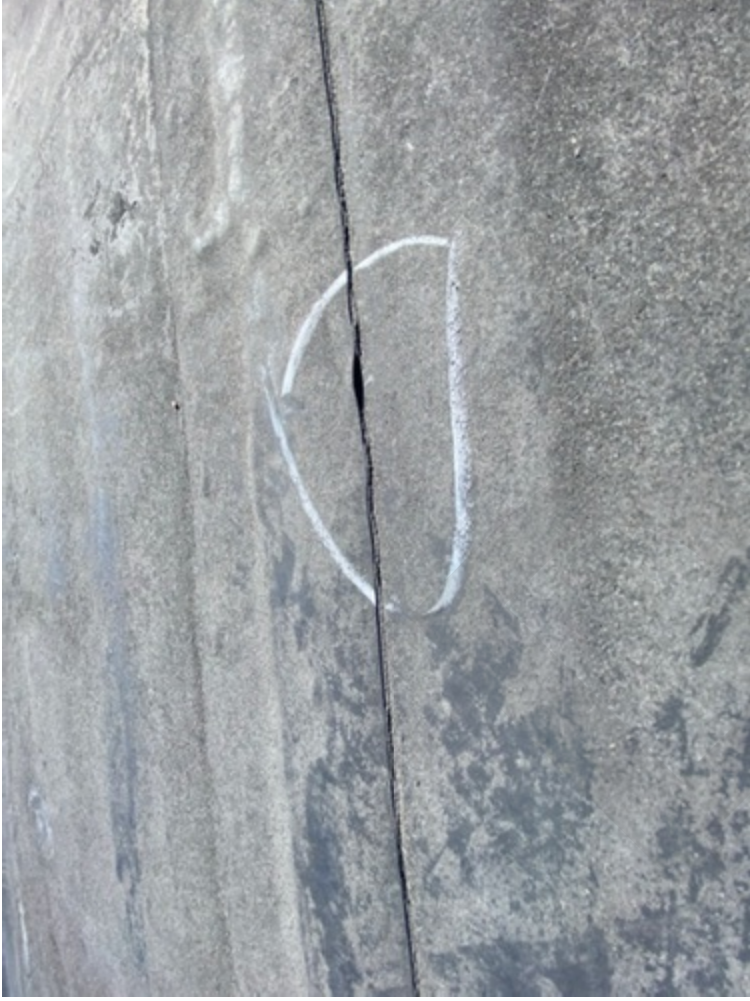
*Photo 3*

**Failed seam in ponding area.**

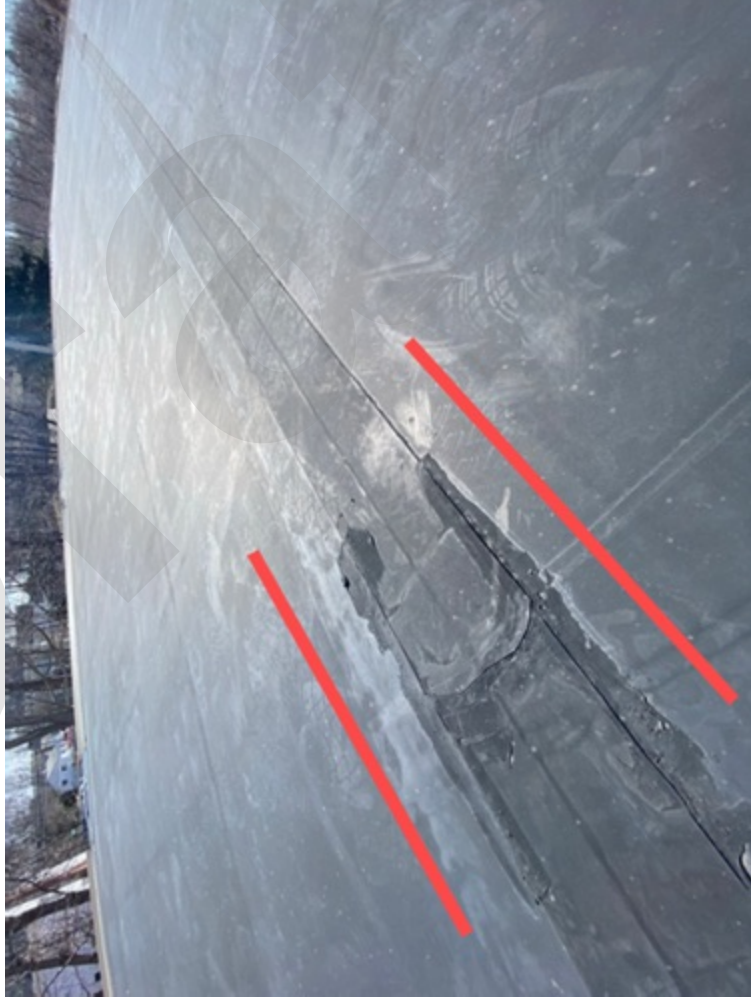
*Photo 4*

**Deteriorating coverstrip repair over seam.**

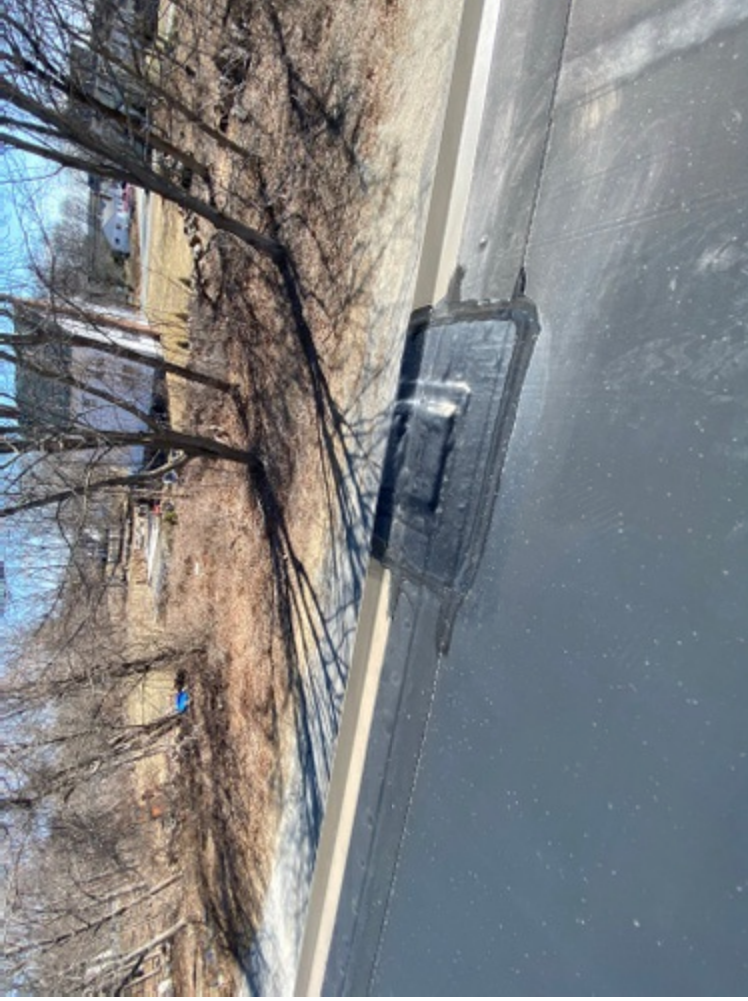
*Photo 5*

**Previously repaired open condition at lap in edge metal.**

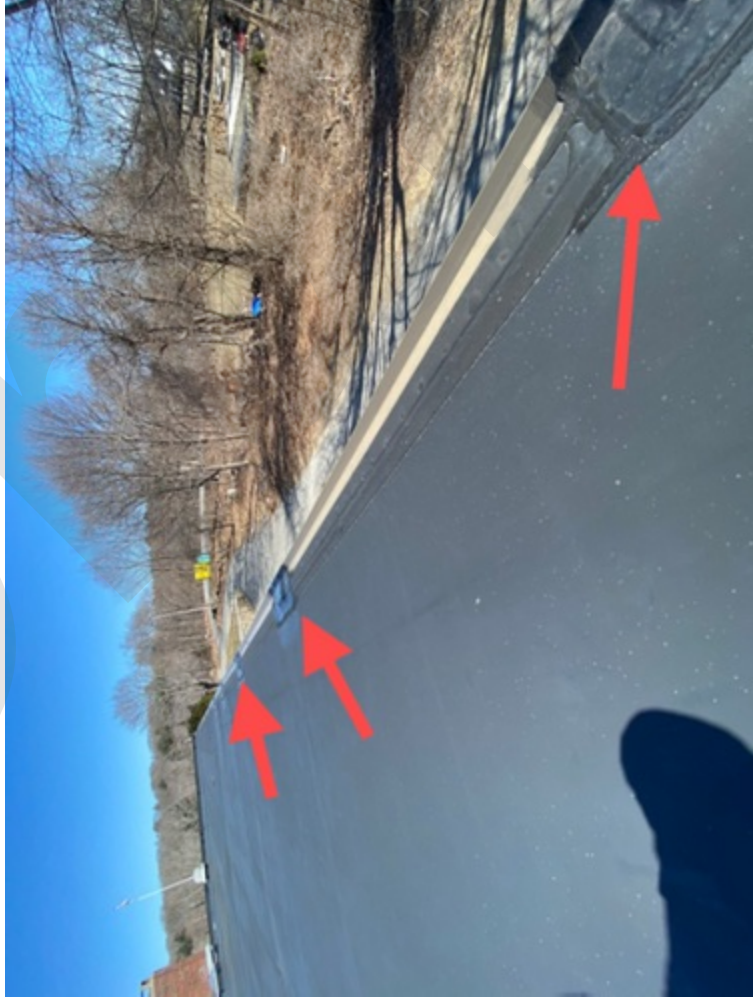
*Photo 6*

**Previously repaired laps in edge metal.**

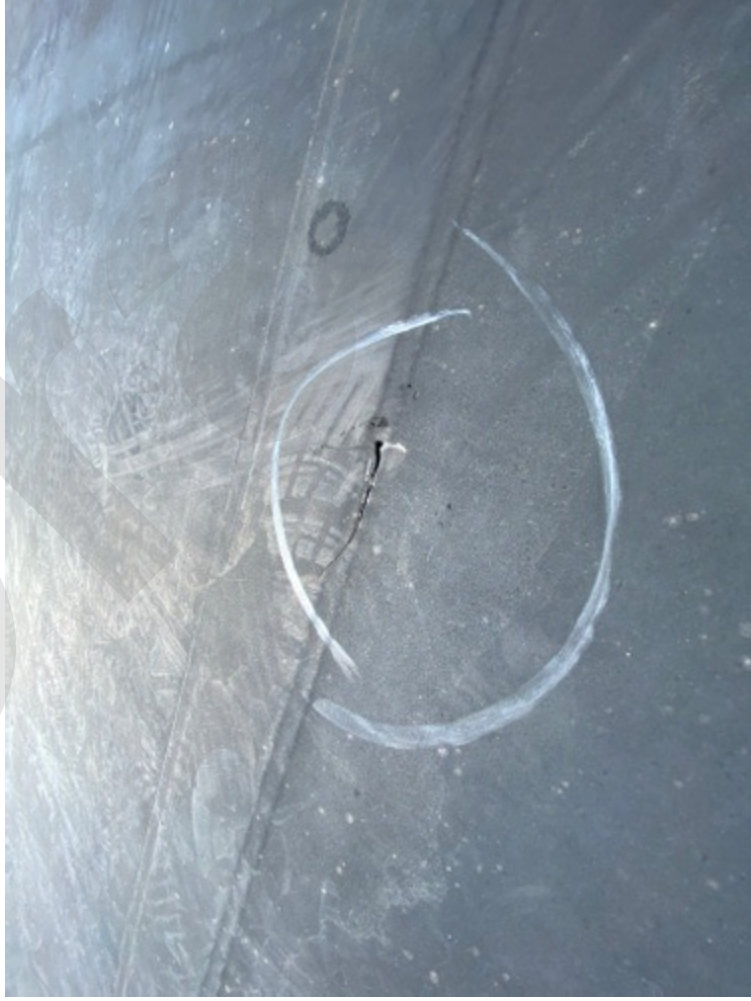
*Photo 8*

**Penetration in membrane.**  
This is a source of water infiltration to the roofing assembly.

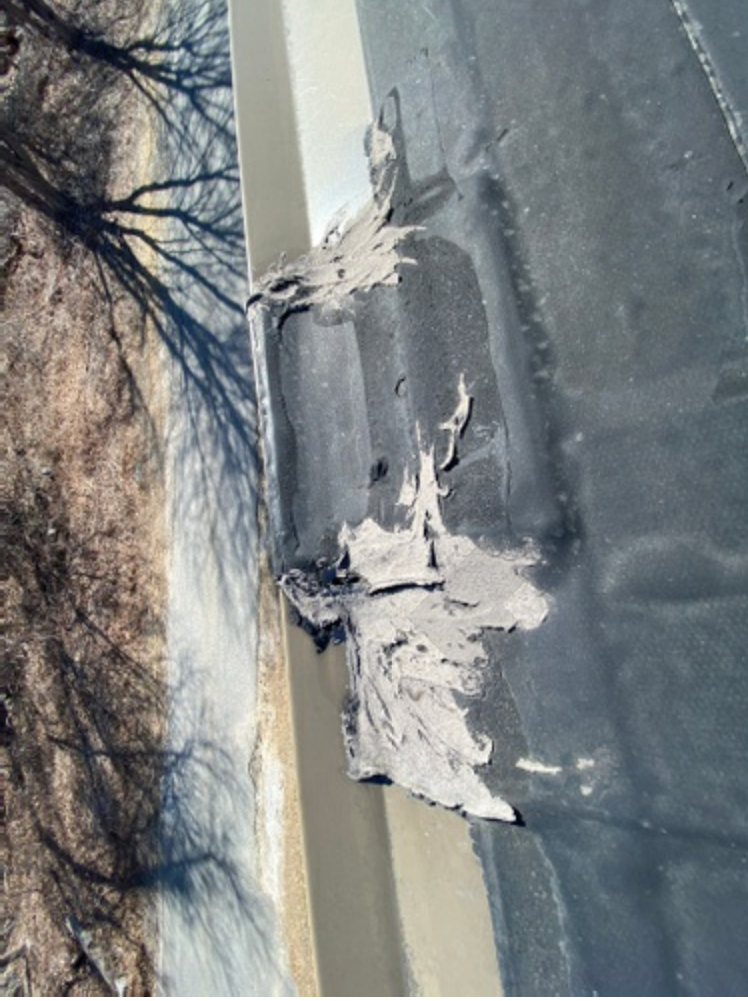
*Photo 9*

**Failed patch over lap in edge metal.**  
This failed condition was observed in approximately 30 locations.

- Troubleshoot & repair **20 failed patches and flashing conditions** on all roof sections.
- Troubleshoot & repair **30 failed patches over edge metal laps** on all roof sections.
- For penetrations and failed coverstrip/flashing:
  - Clean roof surface with high grade cleaner
  - Apply peel and stick Uni-Bond 6" tape to penetration or seam
  - Apply White Knight Plus WC to Uni-Bond tape and extend coating 4" past all seams of tape. Ensure felt backing of tape is fully saturated.
- Apply GreenLock Structural Adh at termination bars.
- All debris will be cleared up and removed.

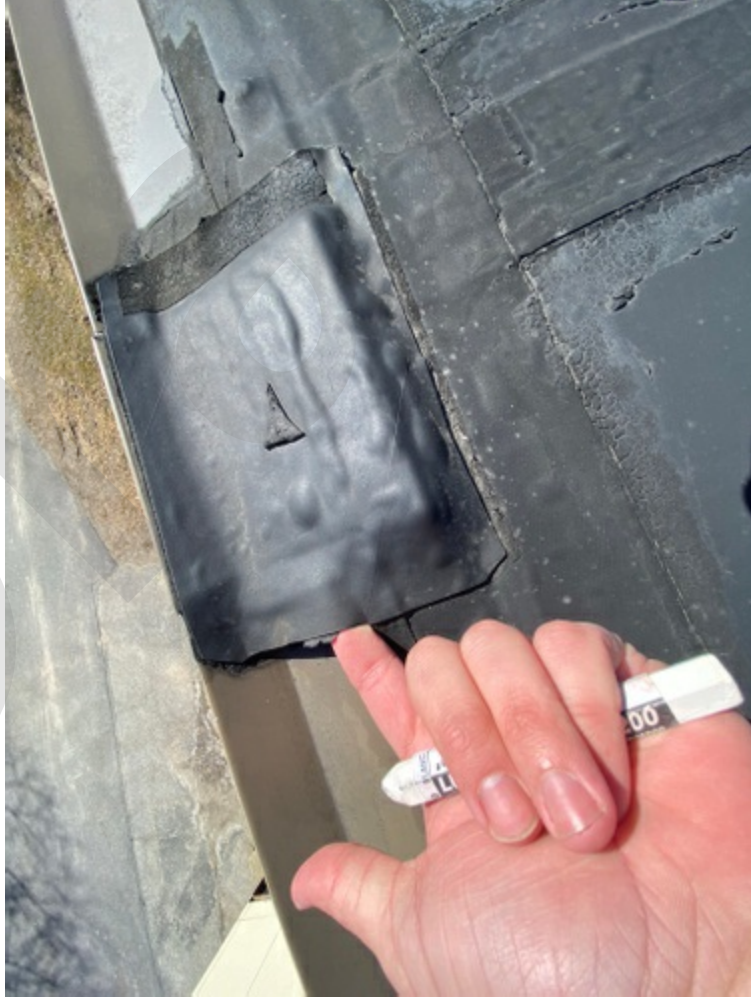
*Photo 10*

**Failed patch over lap in edge metal.**  
This failed condition was observed in approximately 30 locations.

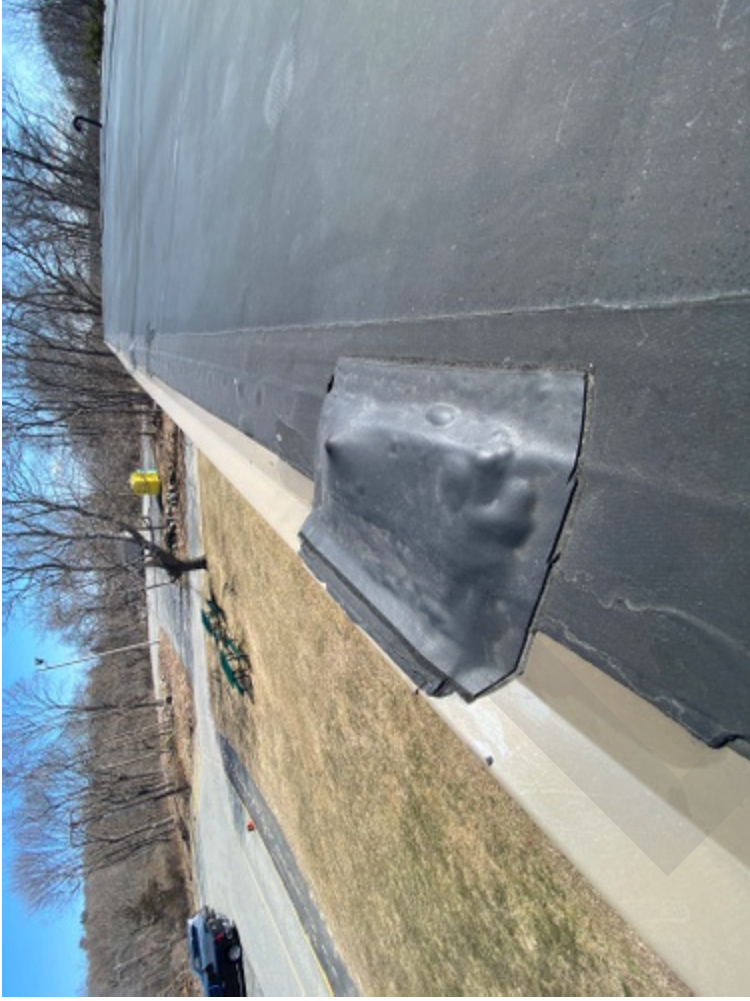
*Photo 11*

**Failed patch over lap in edge metal.**  
This failed condition was observed in approximately 30 locations.

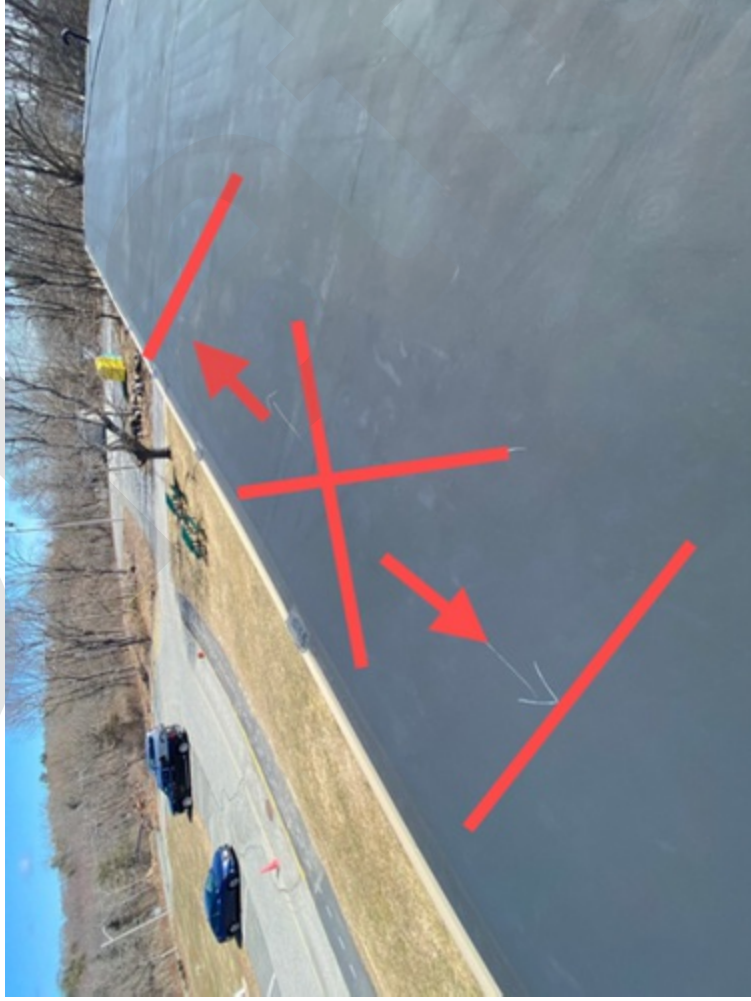
*Photo 12*

**Area of delaminated membrane from insulation.**

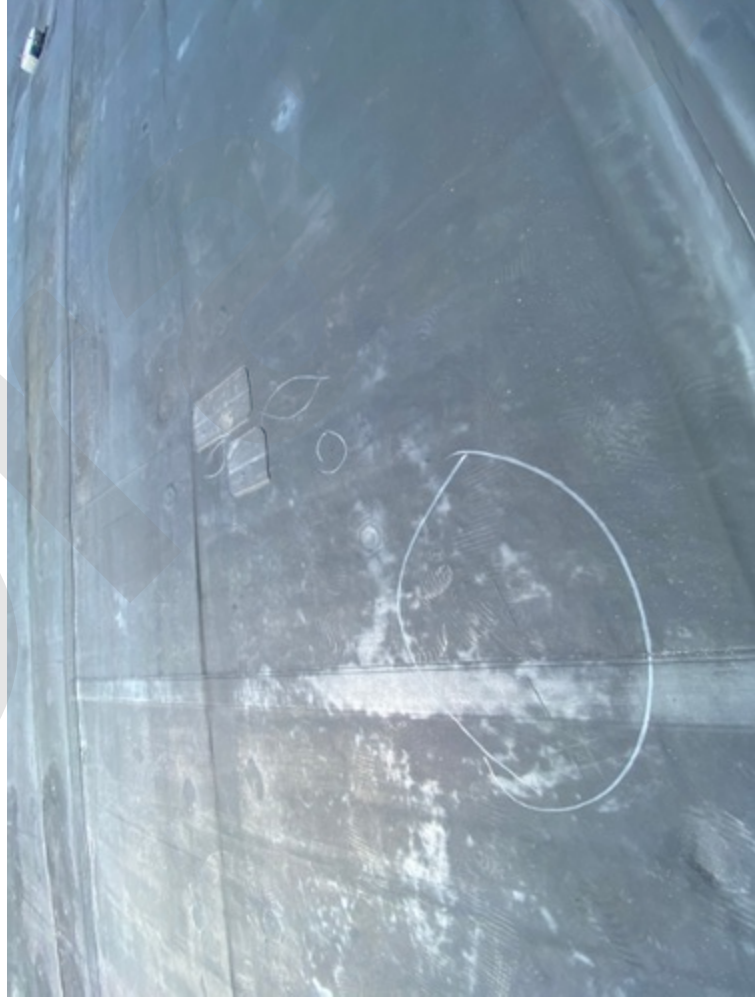
*Photo 14*

**Multiple penetrations observed in membrane.**

The following conditions are associated with water infiltration:

- Interior water damage
- Mold/Mildew
- Saturated insulation resulting in loss of dimensional stability and R Value
- Delamination of the membrane from sub-straight.
- Rust/rot of fasteners and decking

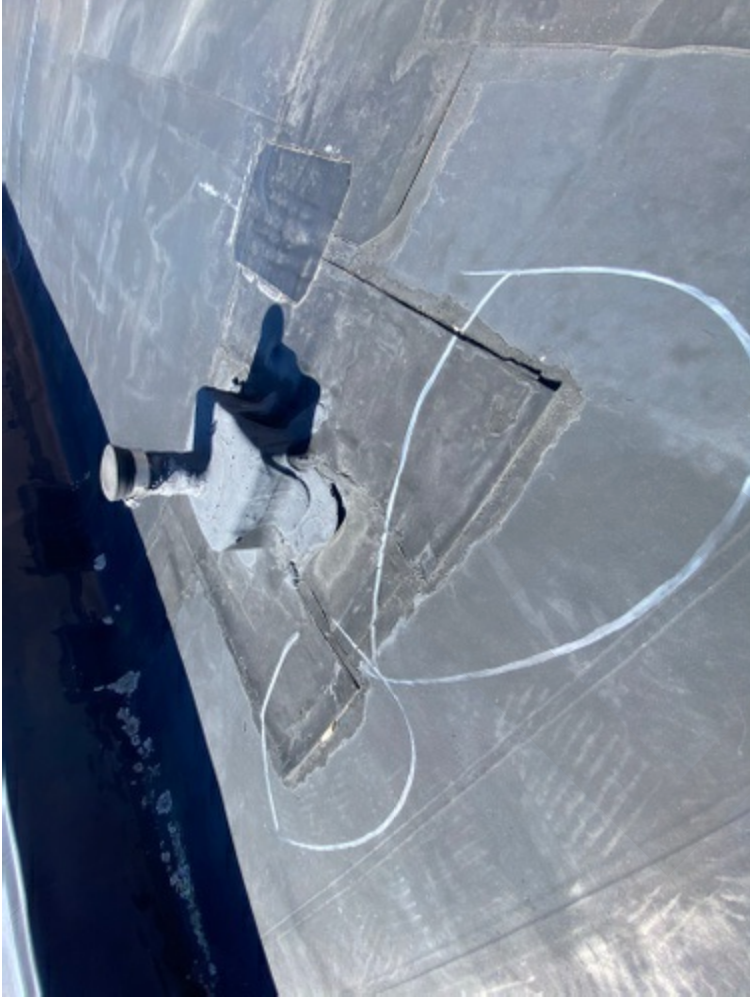
*Photo 15*

**Failed flashing around pitch pocket.**

The following conditions are associated with water infiltration:

- Interior water damage
- Mold/Mildew
- Saturated insulation
- resulting in loss of dimensional stability and R Value
- Delamination of the membrane from sub-straight.
- Rust/rot of fasteners and decking

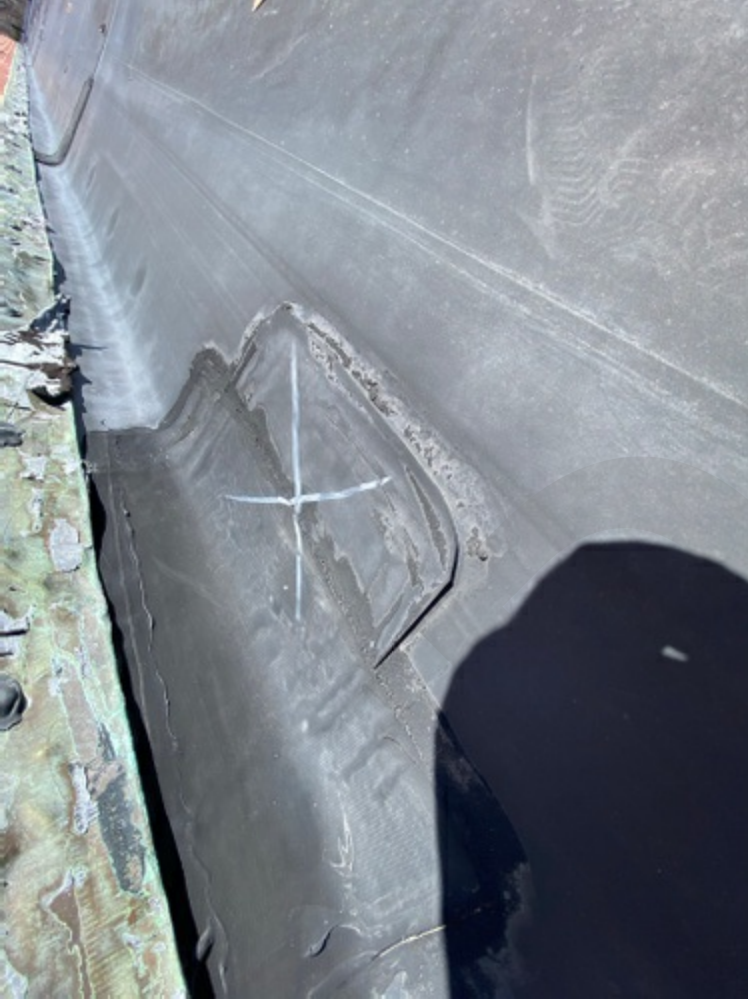
*Photo 19*

**Failed flashing.**

The following conditions are associated with water infiltration:

- Interior water damage
- Mold/Mildew
- Saturated insulation
- resulting in loss of dimensional stability and R Value
- Delamination of the membrane from sub-straight.
- Rust/rot of fasteners and decking

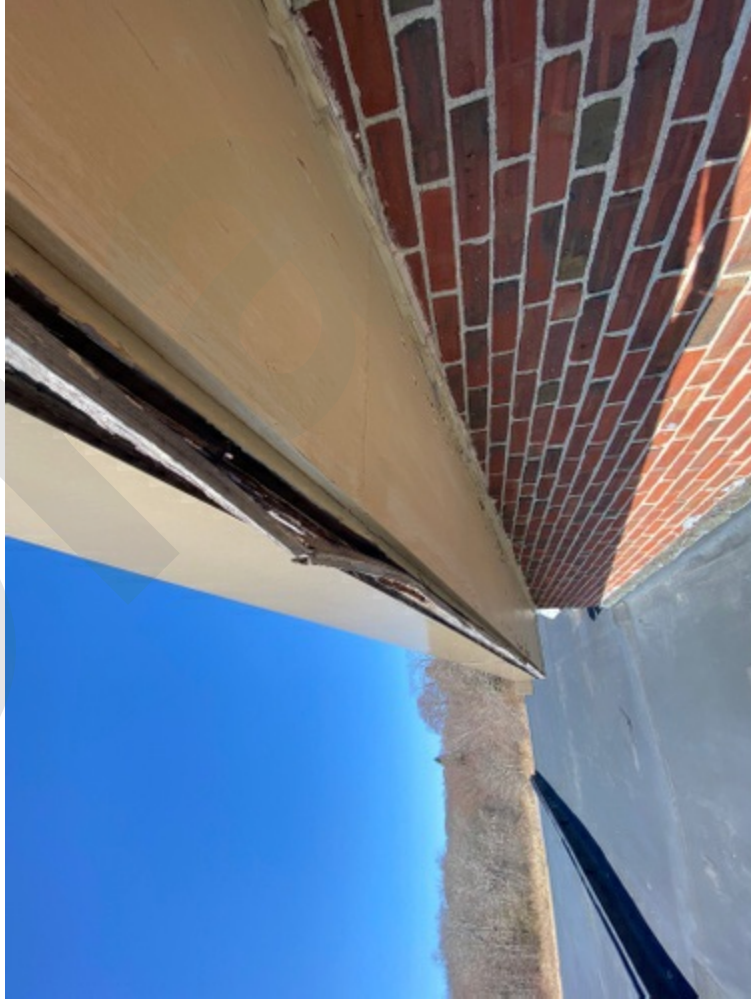
*Photo 20*

**Rotted fascia board under edge metal.**

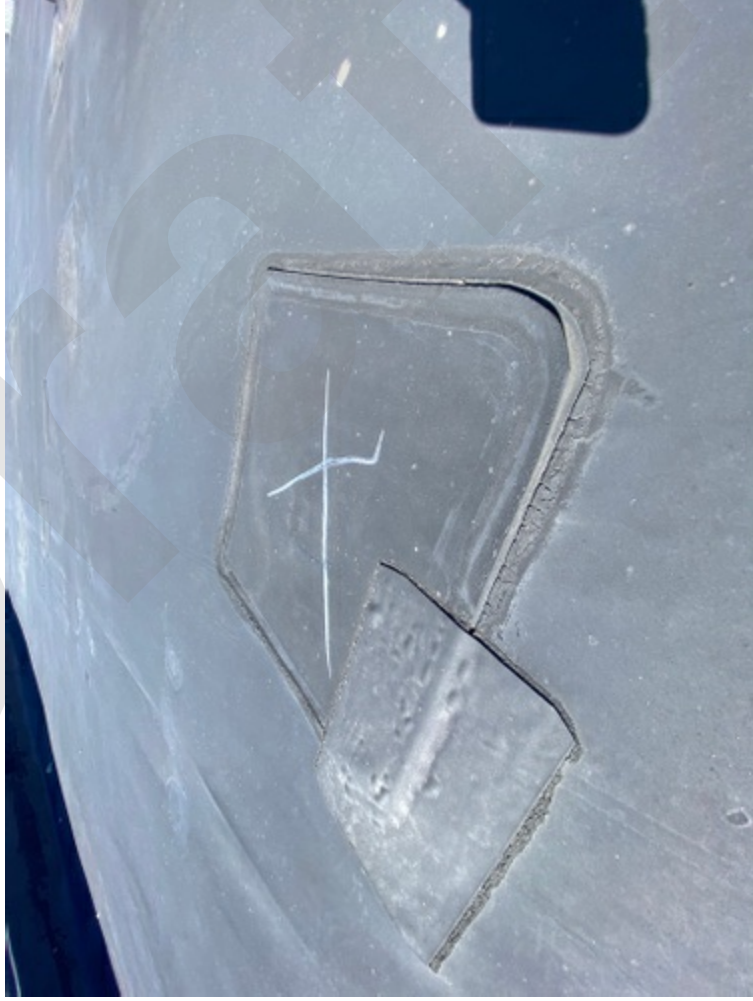
Photo 22

**Failed patch.**

The following conditions are associated with water infiltration:

- Interior water damage
- Mold/Mildew
- Saturated insulation resulting in loss of dimensional stability and R Value
- Delamination of the membrane from sub-straight.
- Rust/rot of fasteners and decking

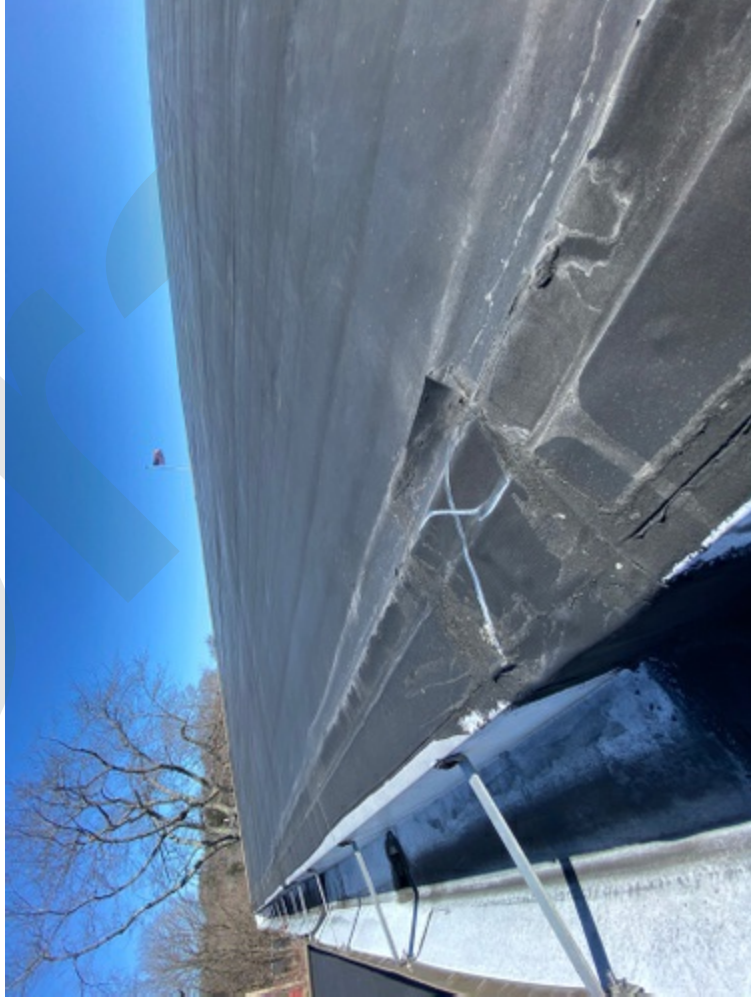
*Photo 24*

**Failed flashing above gutter.**

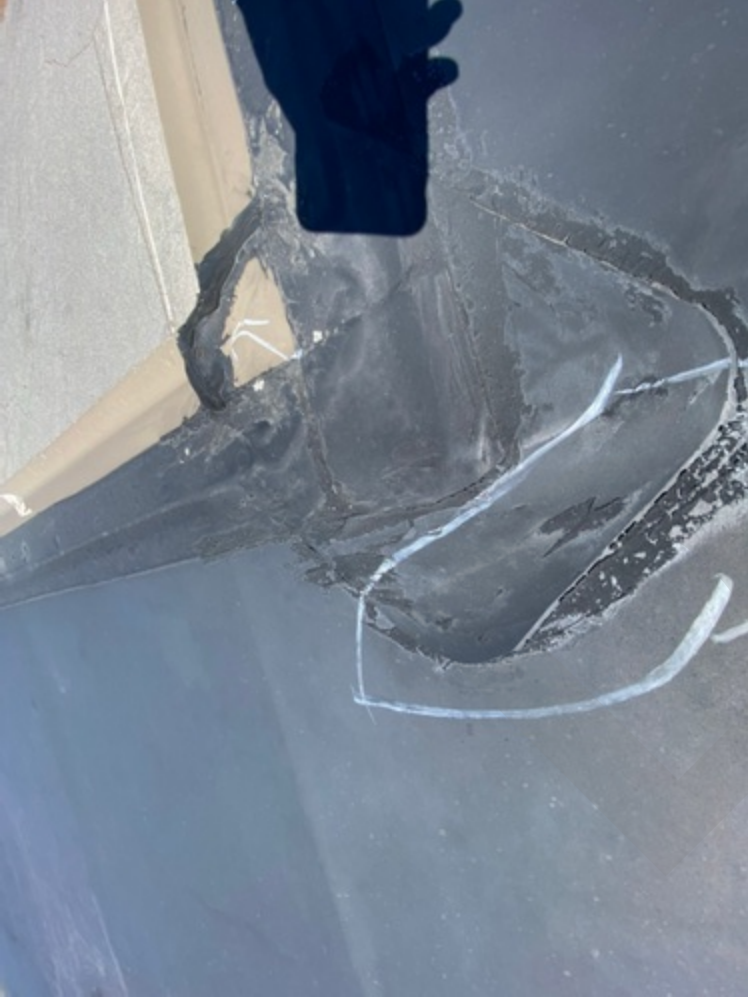
*Photo 25*

**Failed corner flashing.**

The following conditions are associated with water infiltration:

- Interior water damage
- Mold/Mildew
- Saturated insulation resulting in loss of dimensional stability and R Value
- Delamination of the membrane from sub-straight.
- Rust/rot of fasteners and decking

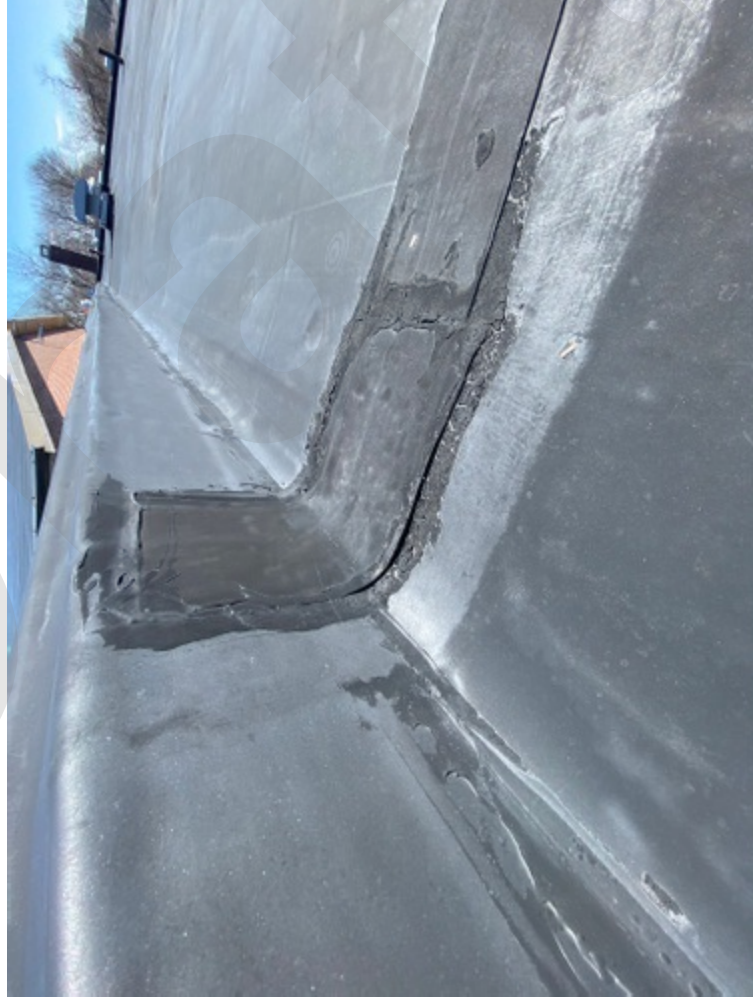
*Photo 26*

**Failed vertical flashing.**

The following conditions are associated with water infiltration:

- Interior water damage
- Mold/Mildew
- Saturated insulation resulting in loss of dimensional stability and R Value
- Delamination of the membrane from sub-straight.
- Rust/rot of fasteners and decking

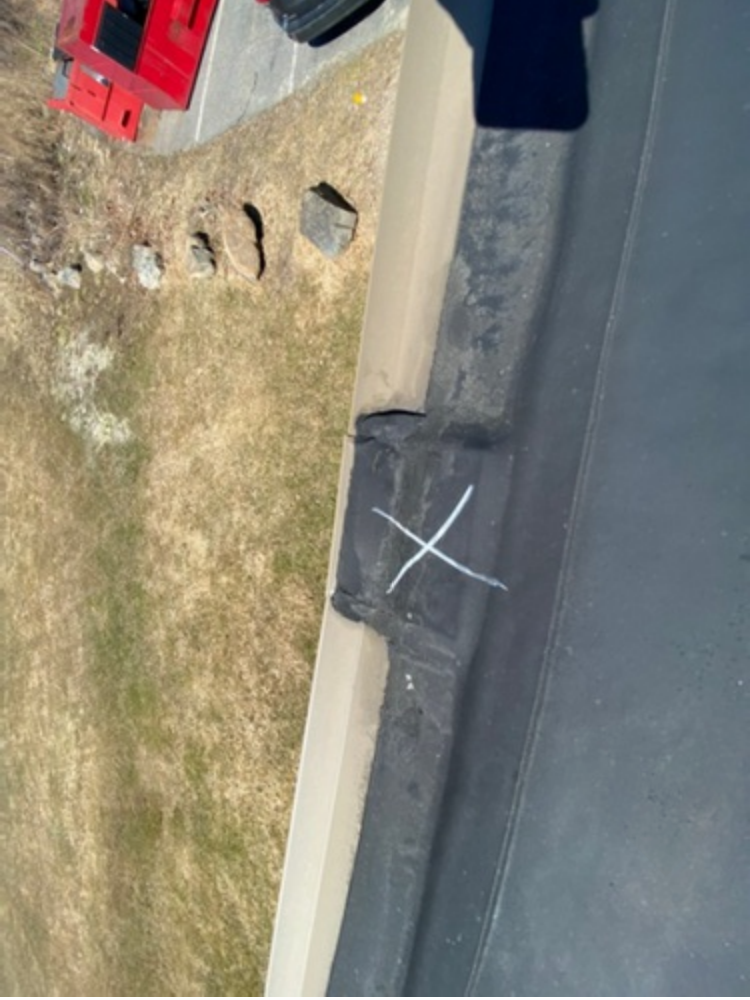
*Photo 27*

**Failed patch over lap in edge metal.**

This failed condition was observed in approximately 30 locations.

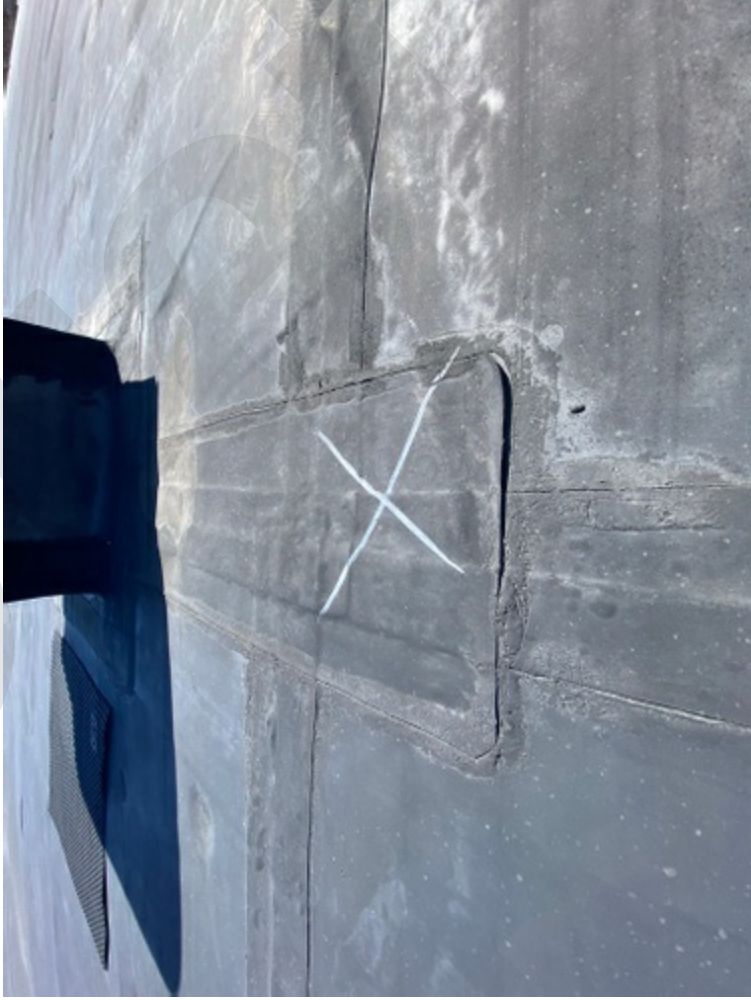
*Photo 28*

**Failed patch.**

The following conditions are associated with water infiltration:

- Interior water damage
- Mold/Mildew
- Saturated insulation resulting in loss of dimensional stability and R Value
- Delamination of the membrane from sub-straight.
- Rust/rot of fasteners and decking
