## FACILITY NEEDS ASSESSMENT

### ESSEX ELEMENTARY SCHOOL AND MANCHESTER ESSEX MIDDLE-HIGH SCHOOL

#### Manchester Essex Regional School District

DRAFT REPORT: January 27, 2023  
H&A JN 2217.01

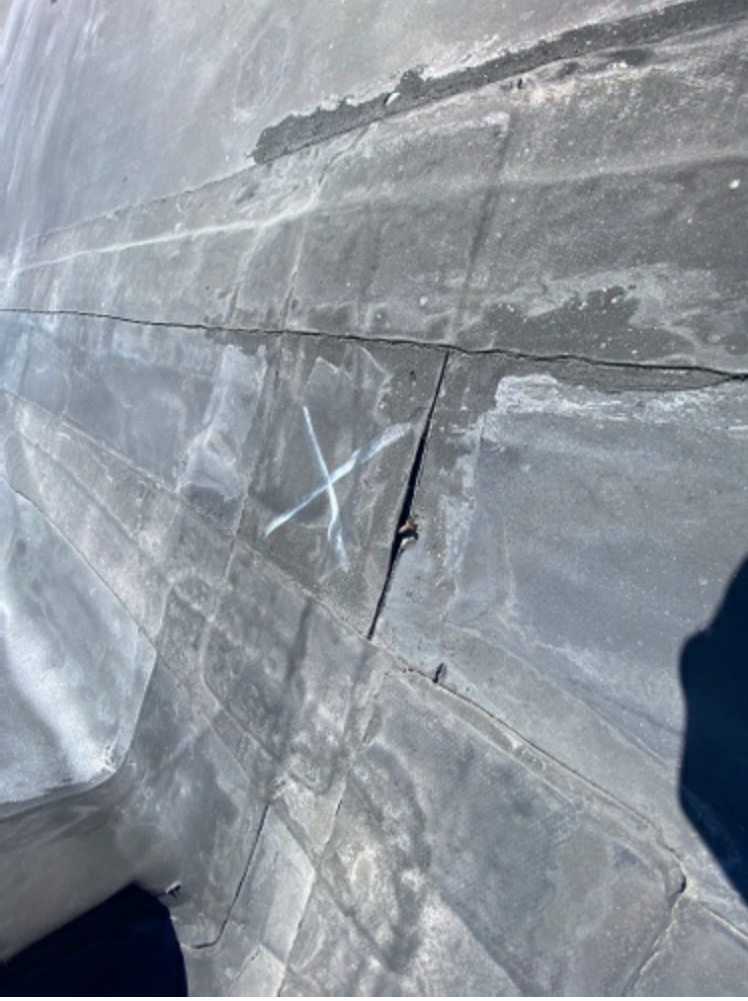
*Photo 29*

**Failed patch.**

The following conditions are associated with water infiltration:

- Interior water damage
- Mold/Mildew
- Saturated insulation resulting in loss of dimensional stability and R Value
- Delamination of the membrane from sub-straight.
- Rust/rot of fasteners and decking

- Troubleshoot & repair **20 failed patches and flashing conditions** on all roof sections.
- Troubleshoot & repair **30 failed patches over edge metal laps** on all roof sections.
- For penetrations and failed coverstrip/flashing:
  - Clean roof surface with high grade cleaner
  - Apply peel and stick Uni-Bond 6" tape to penetration or seam
  - Apply White Knight Plus WC to Uni-Bond tape and extend coating 4" past all seams of tape. Ensure felt backing of tape is fully saturated.
- Apply GreenLock Structural Adh at termination bars.
- All debris will be cleared up and removed.

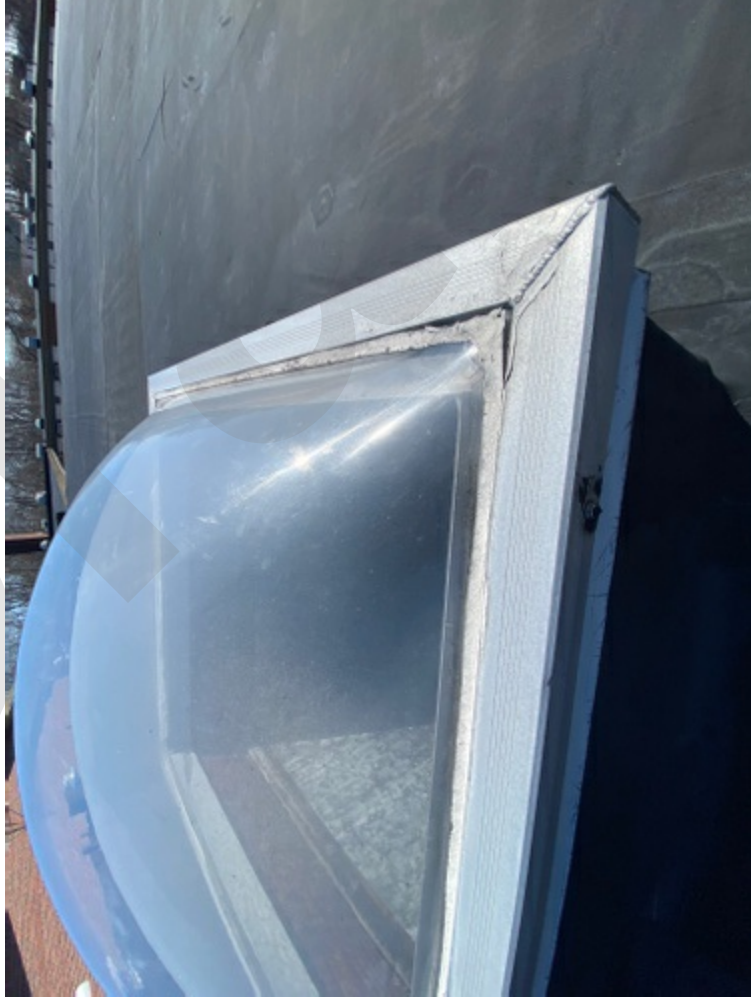
*Photo 30*

**Deteriorated sealant around skylight.**

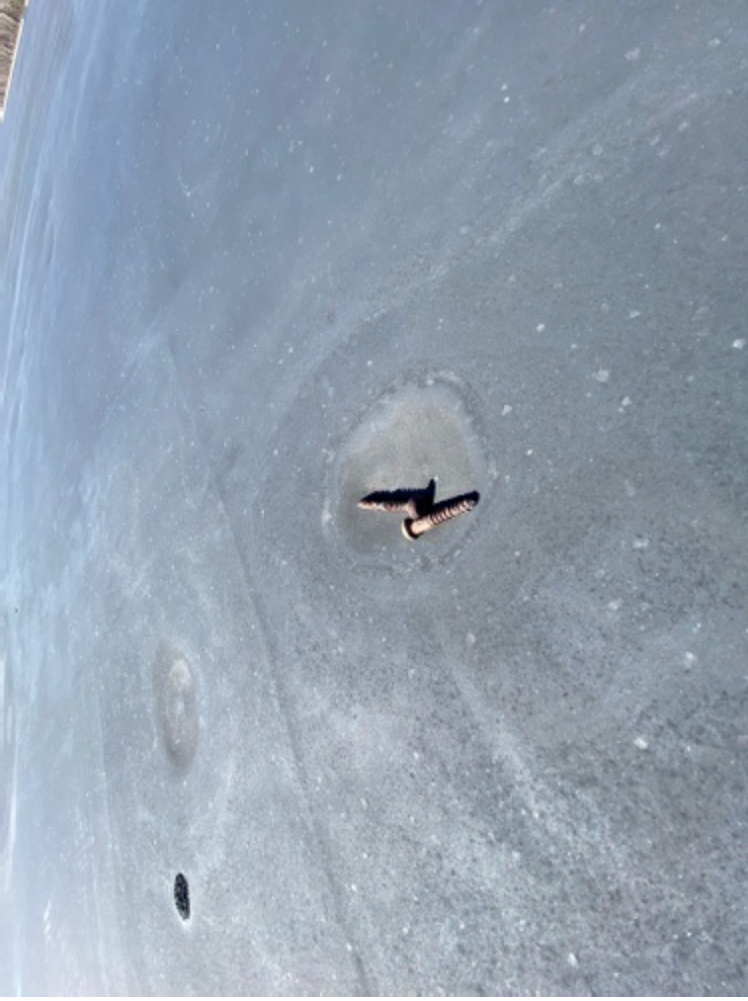
*Photo 31*

**Fasteners were observed around the roof.**  
These are potential puncture points in the membrane.

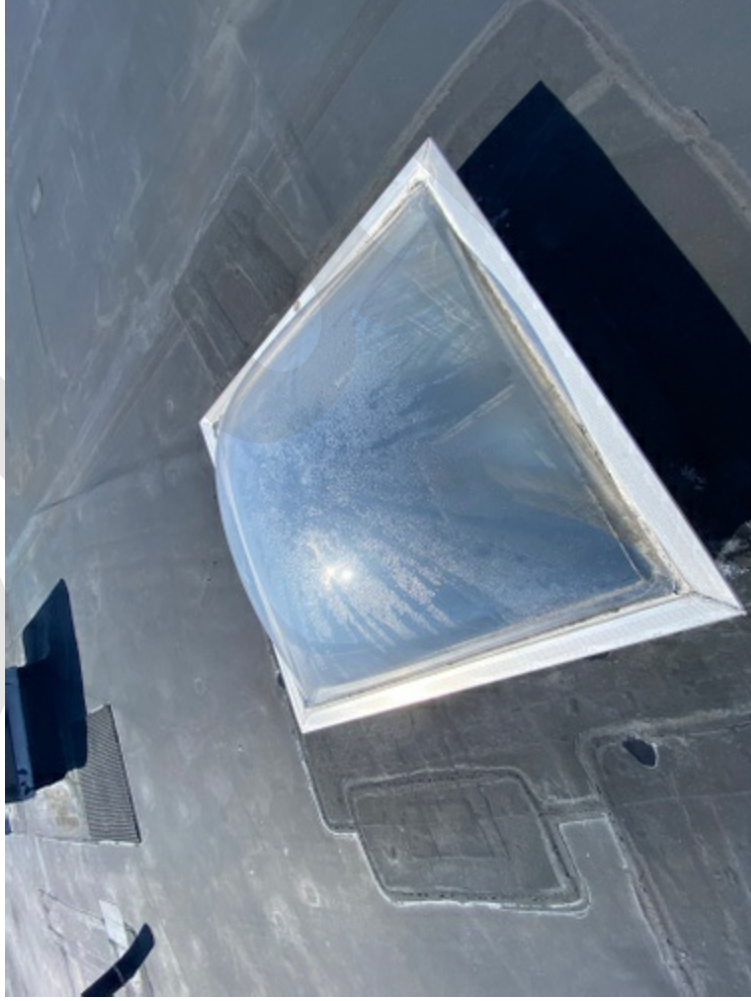
*Photo 32*

**Condensation was observed between the layers of the skylight.**  
This is a sign of end of life cycle.

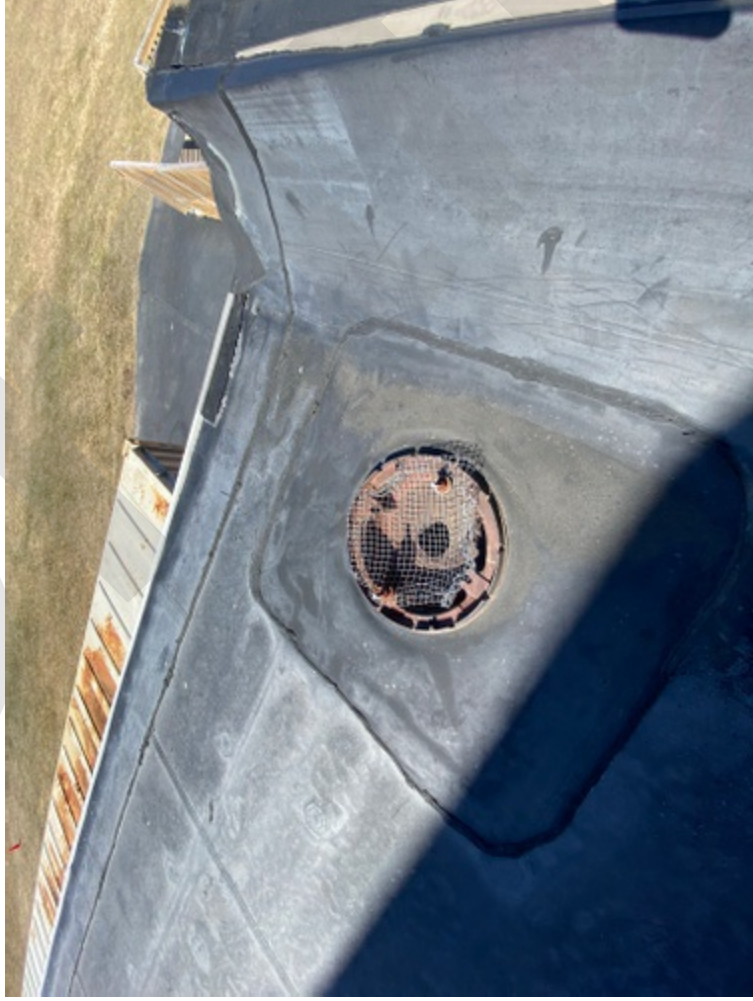
*Photo 34*

**Missing drain basket.**

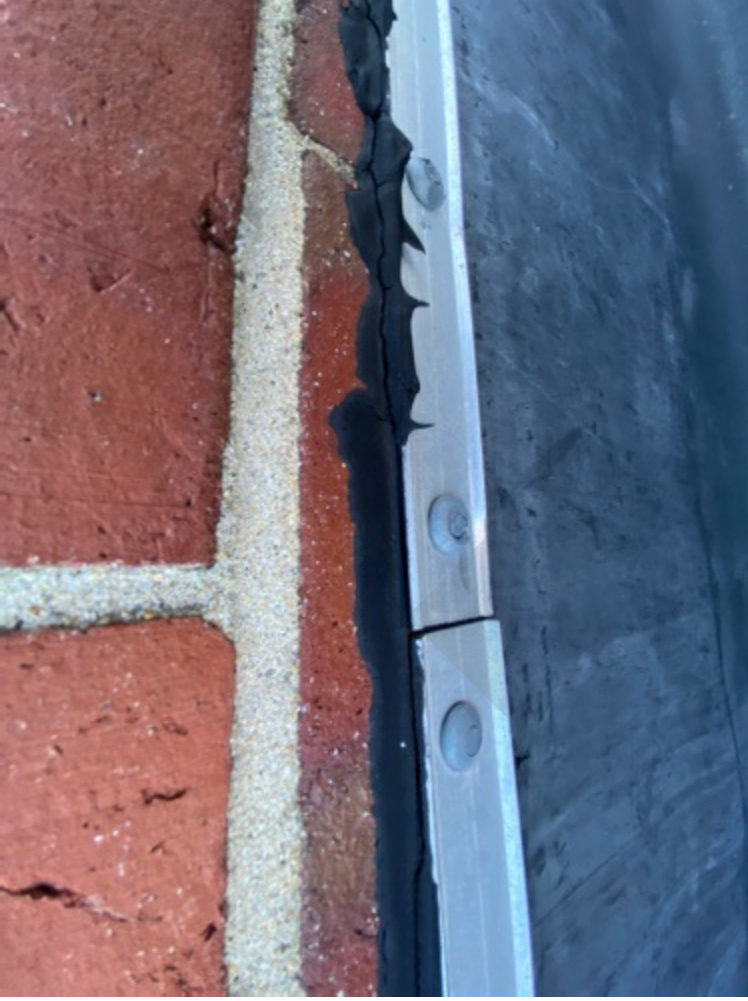
*Photo 35*

**Deteriorated sealant above surface mounted termination bar.**

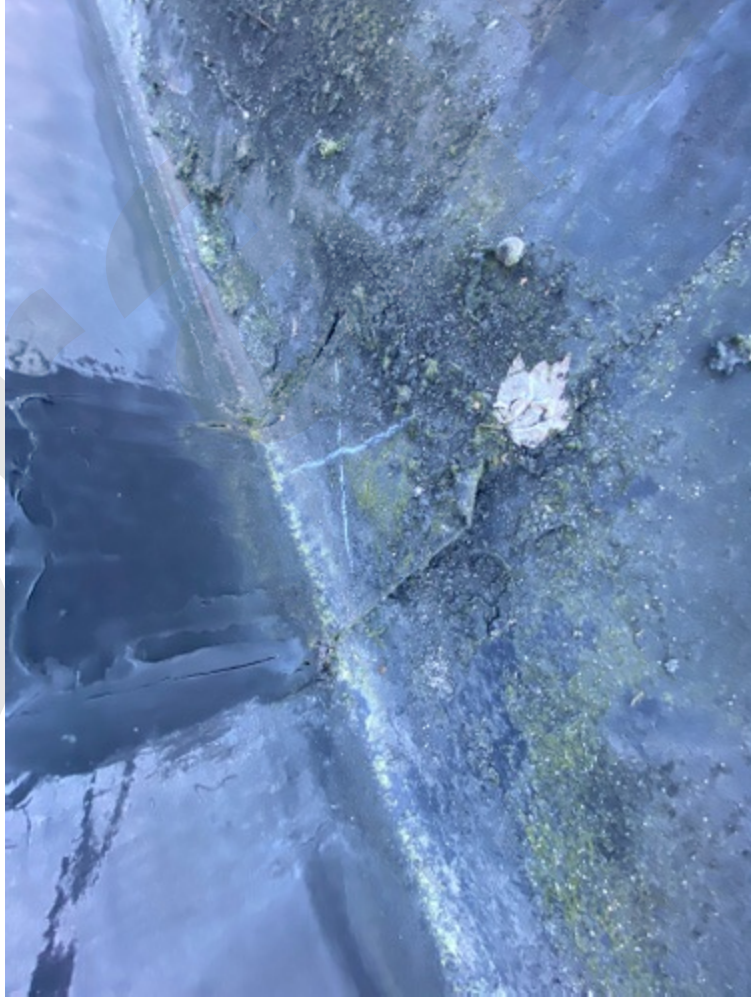
*Photo 36*

**Failed patch.**

The following conditions are associated with water infiltration:

- Interior water damage
- Mold/Mildew
- Saturated insulation resulting in loss of dimensional stability and R Value
- Delamination of the membrane from sub-straight.
- Rust/rot of fasteners and decking

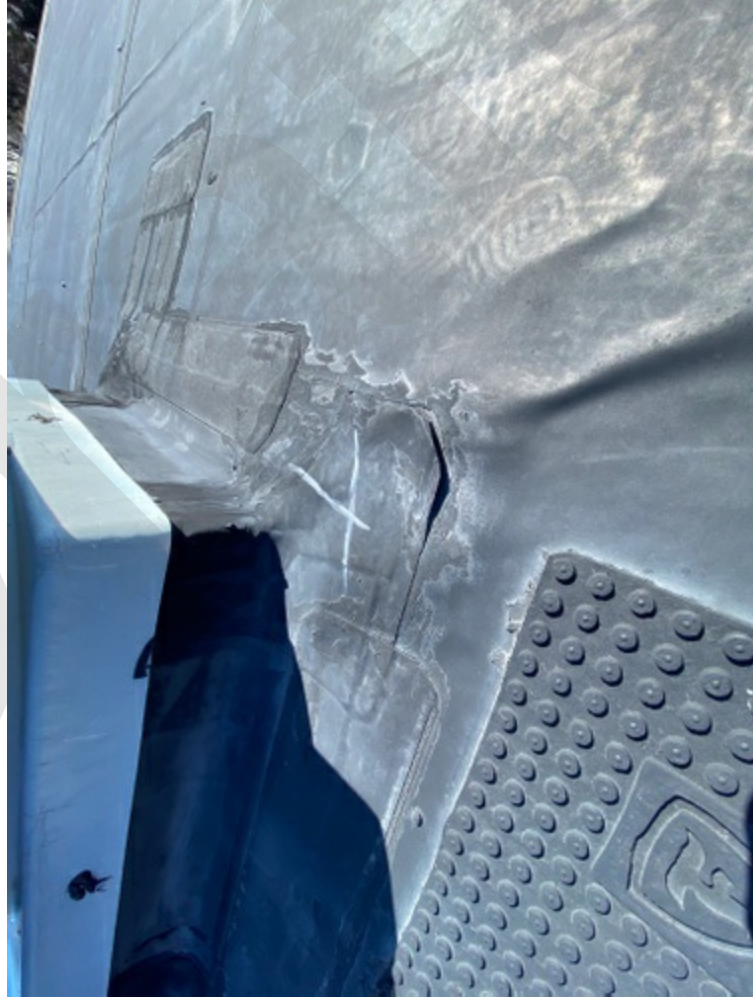
Photo 38

**Failed patch.**
