## FACILITY NEEDS ASSESSMENT

**ESSEX ELEMENTARY SCHOOL  
AND MANCHESTER ESSEX  
MIDDLE-HIGH SCHOOL**

**Manchester Essex  
Regional School District**

**FINAL REPORT: January 27, 2023  
H&A JN 2217.01**

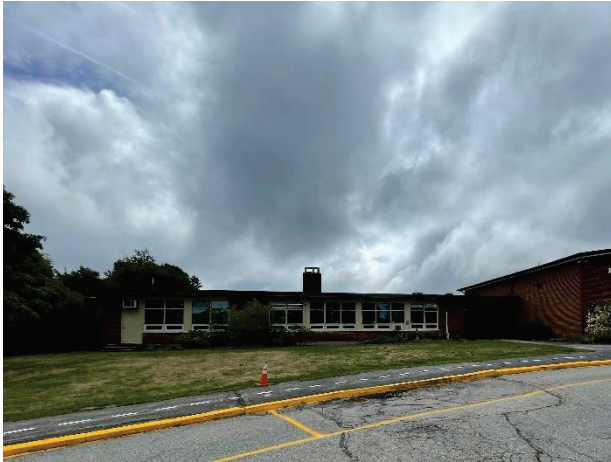
1. Bituminous driveway shows signs of cracking and freeze/thaw damage.

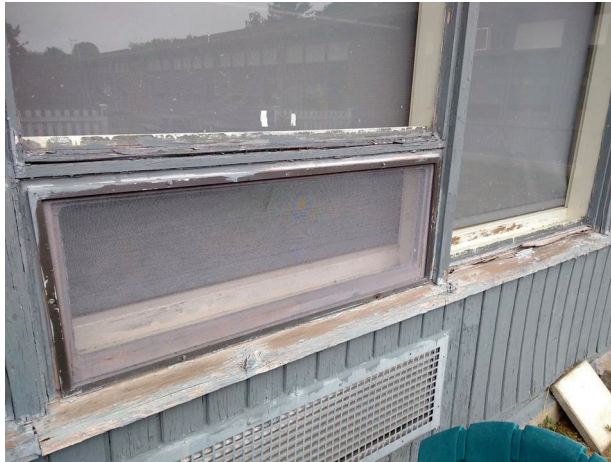
2. Original windows and trim have deteriorated.

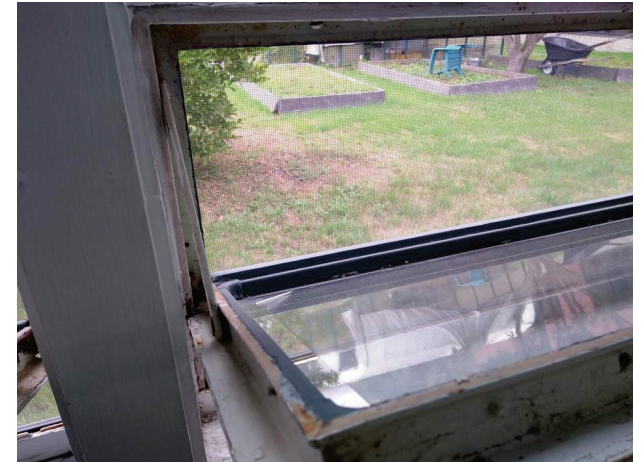
3. Operable steel hopper window has no weather strip.

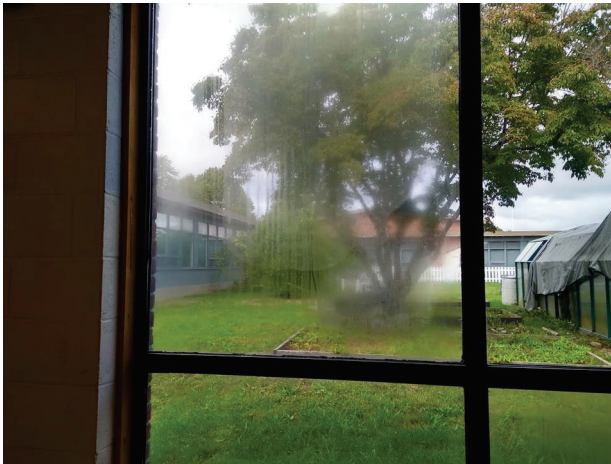
4. Thermal pane window has seal failure.

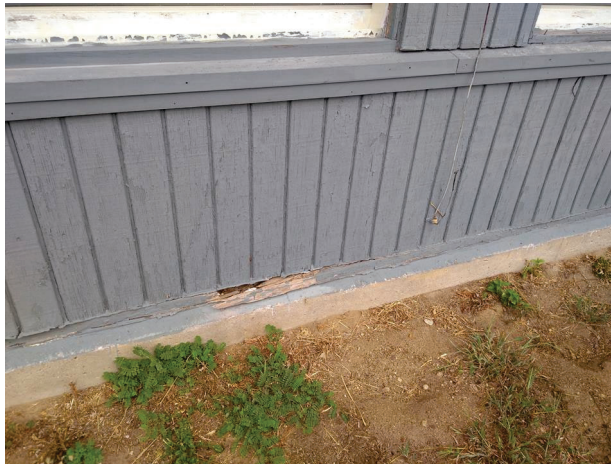
5. The wood siding is rotted and damaged.

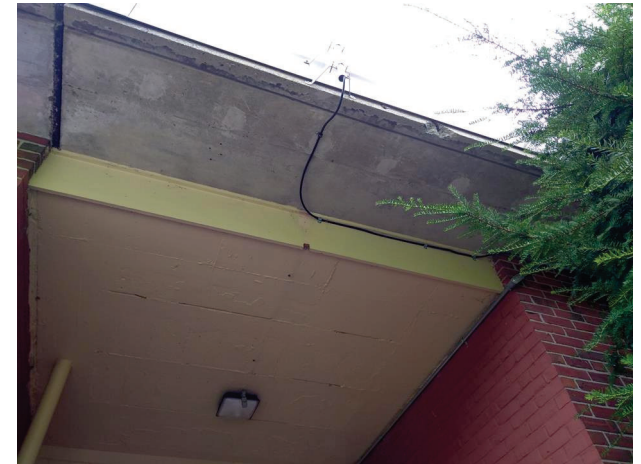
6. The concrete facias and soffits have spalled.

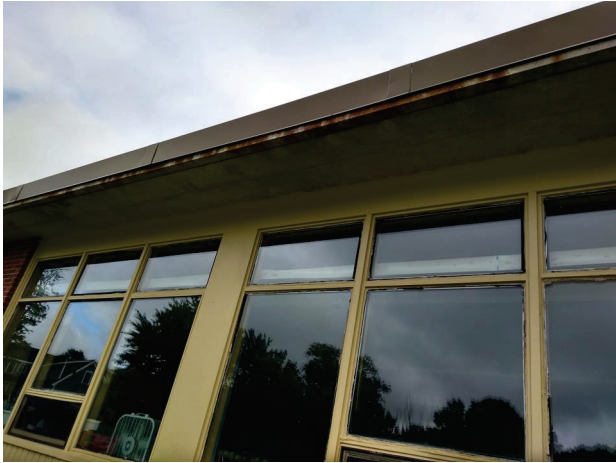
7. Original roof soffits have corroded.

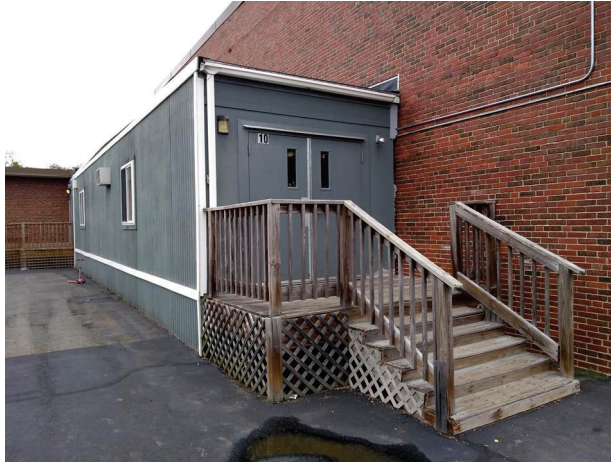
8. Modular addition has deteriorated and leaks at connection to main building.

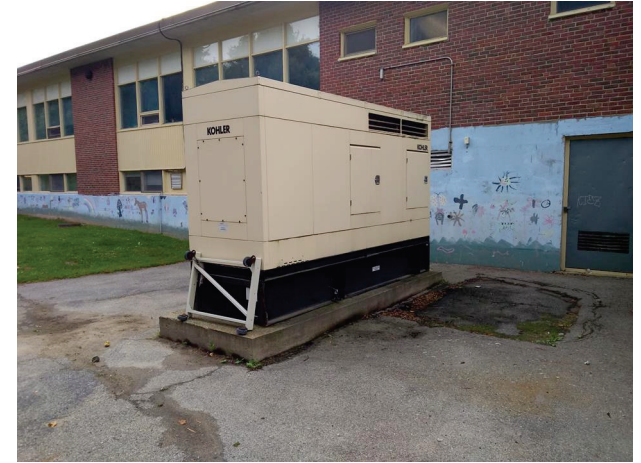
9. Confirm that generator has been maintained per manufacturer's recommendations.

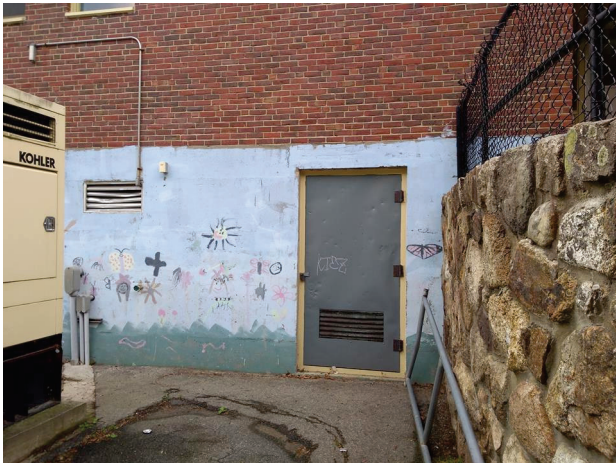
10. Bituminous pavement is damaged, original hollow metal doors require repair/replacement.

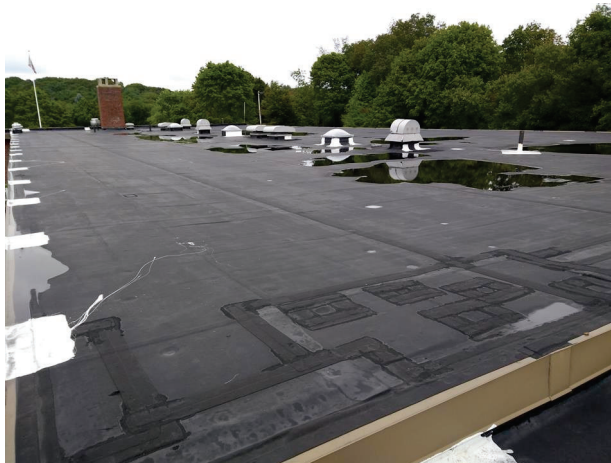
11. Rubber membrane roof has many areas of standing water and is extensively patched.

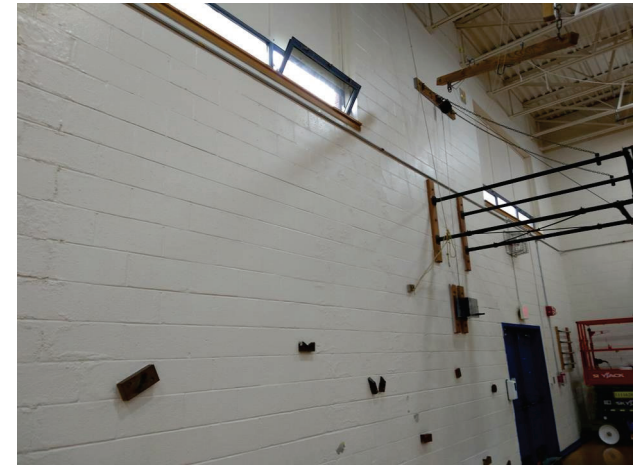
15. The brick/CMU wall of Gym shows signs of extensive water damage and is not insulated.

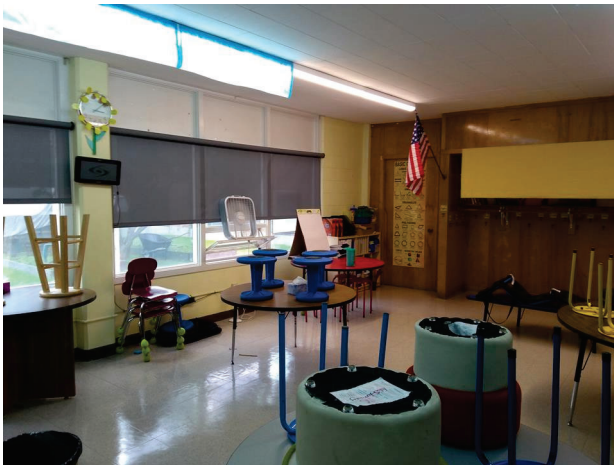
16. Classrooms have outdated spline ceiling and insufficient ventilation.

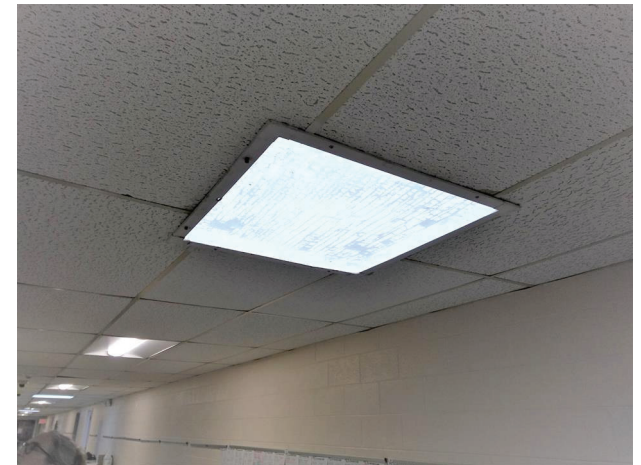
18. The skylights in the corridors are damaged.

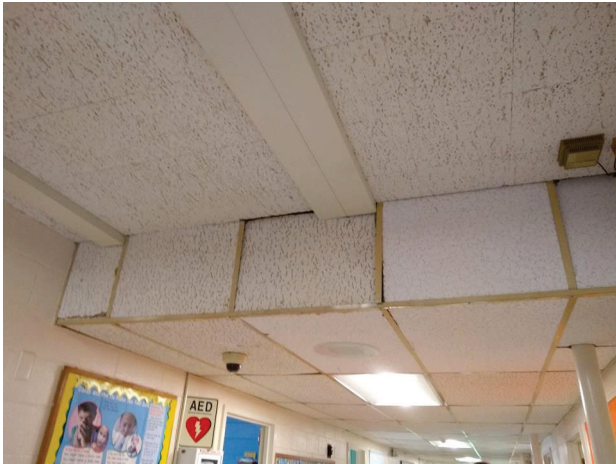
19. Existing 2x4 ceilings are discolored and tiles are mis-matched.

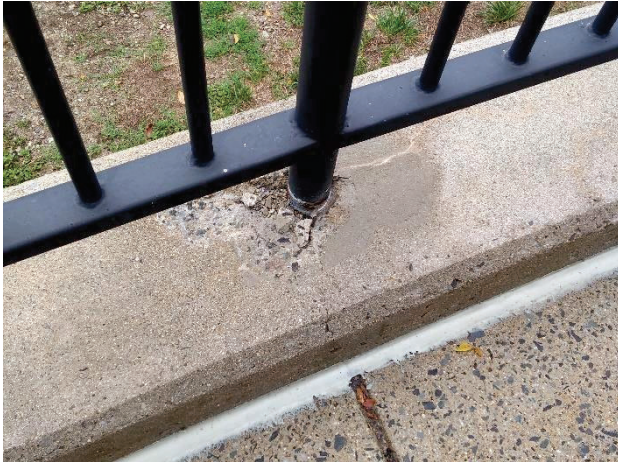
1. Concrete has spalled at some rail posts.

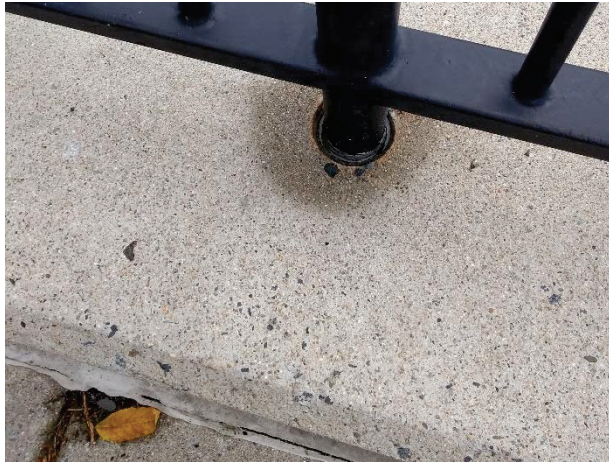
2. Rail posts do not have sealants and some sealants are failing.

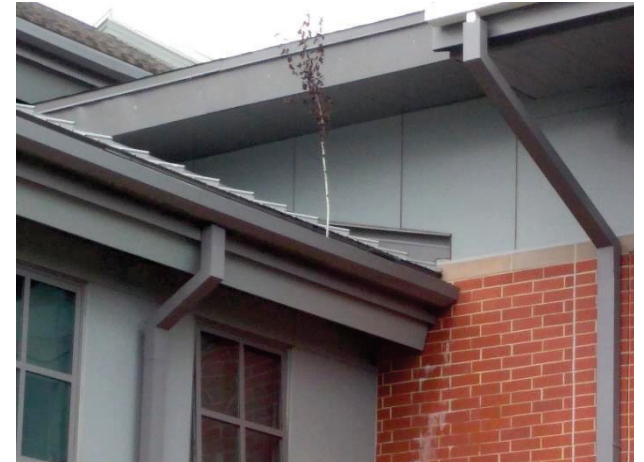
3. Some gutters are clogged with vegetation.

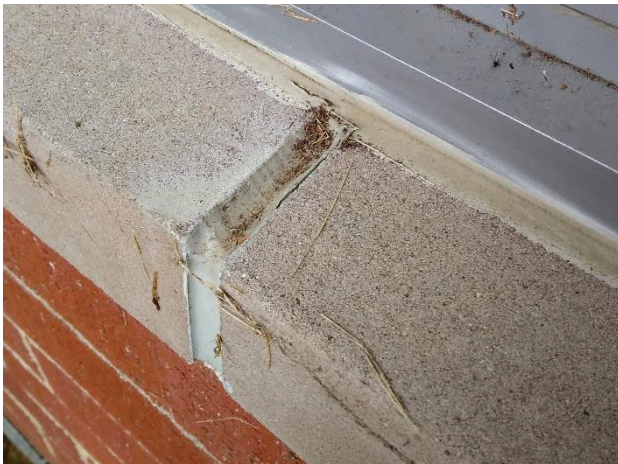
4. Some sealant shows early signs of deterioration.

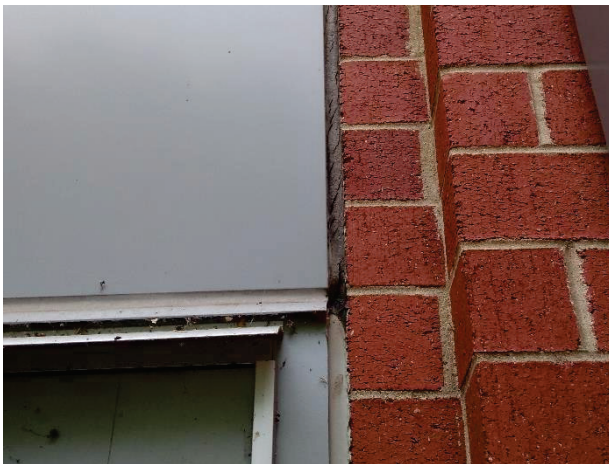
5. Sealant at metal panel is showing signs of deterioration.

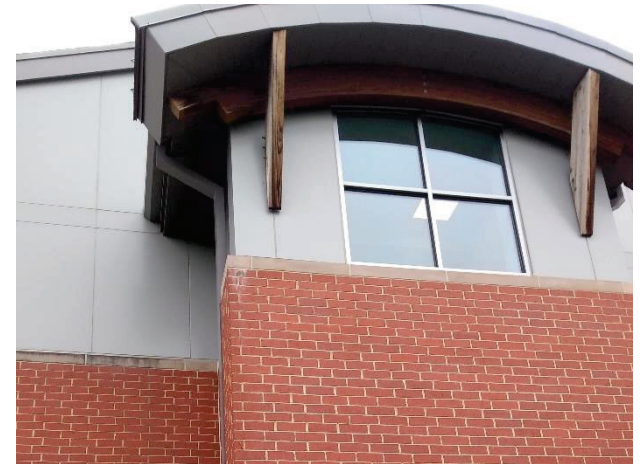
6. Discoloration is evident at wood accents, brick and precast.

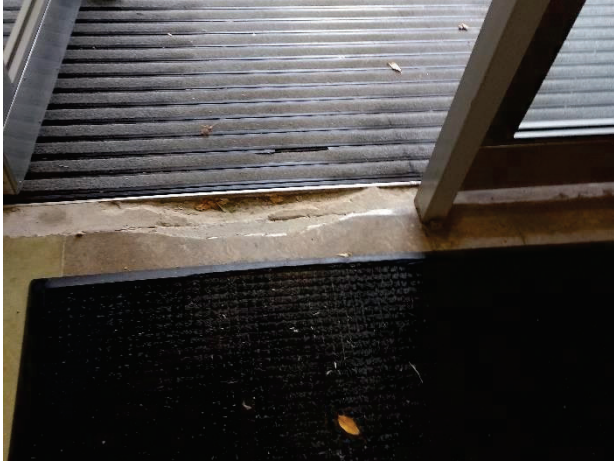
7. Threshold at entry is damaged. Walk off mat is worn.

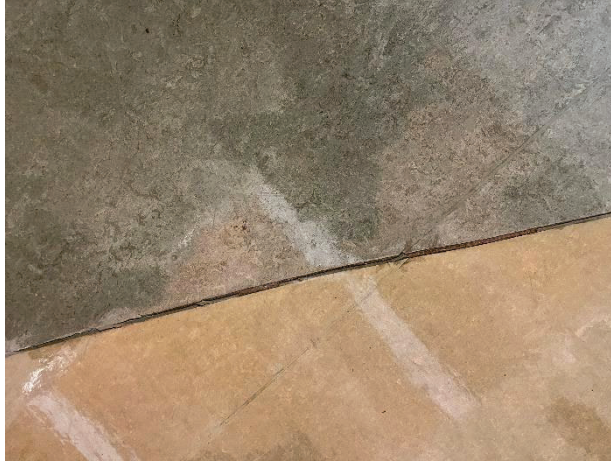
8. Some floor joints at natural linoleum are damaged.

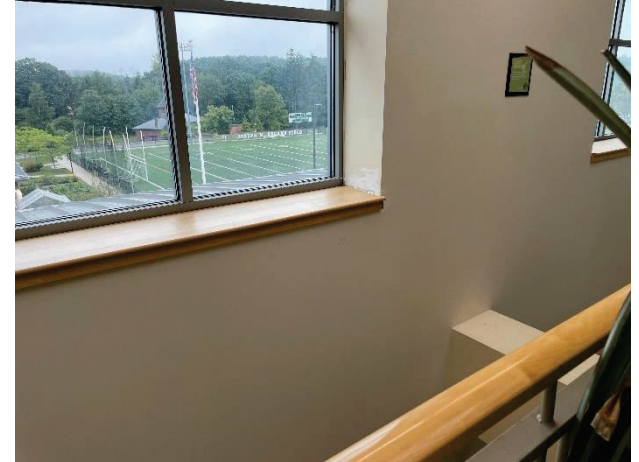
9. Several windows show signs of water damage.

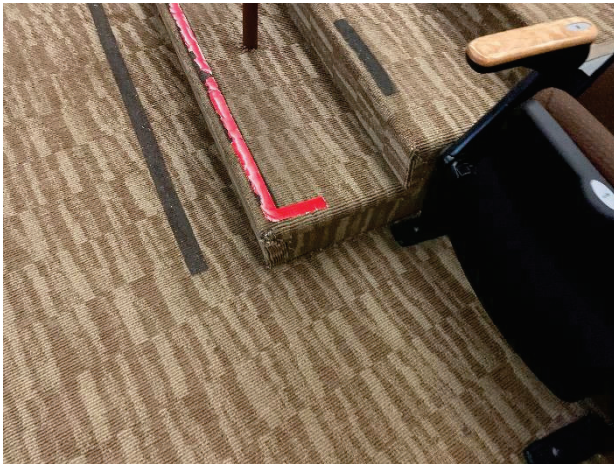
10. Original carpet at Auditorium is showing signs of wear.

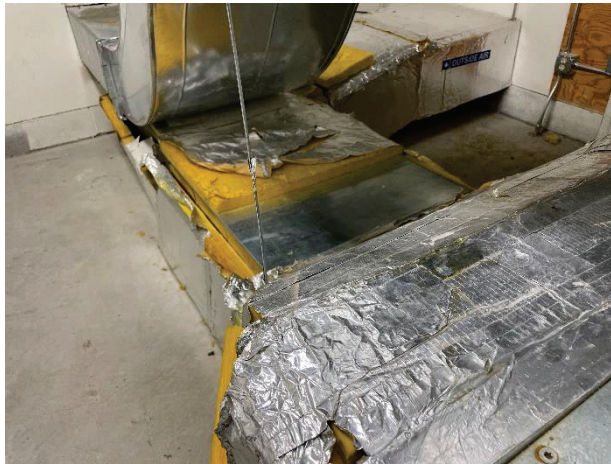
11. Some duct work has damaged or missing insulation.

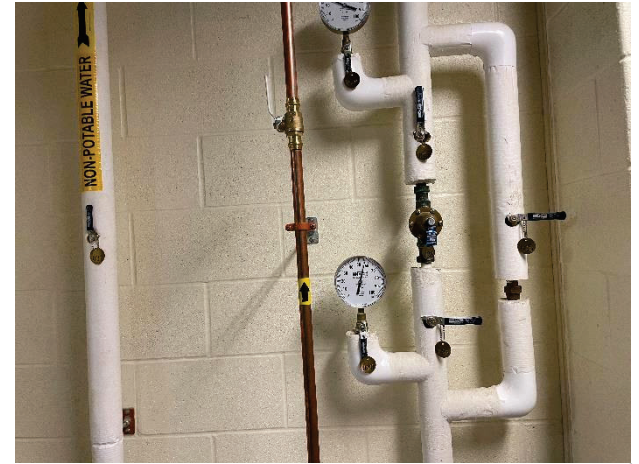
12. Plumbing valves require frequent replacement due to high mineral content in water supply.

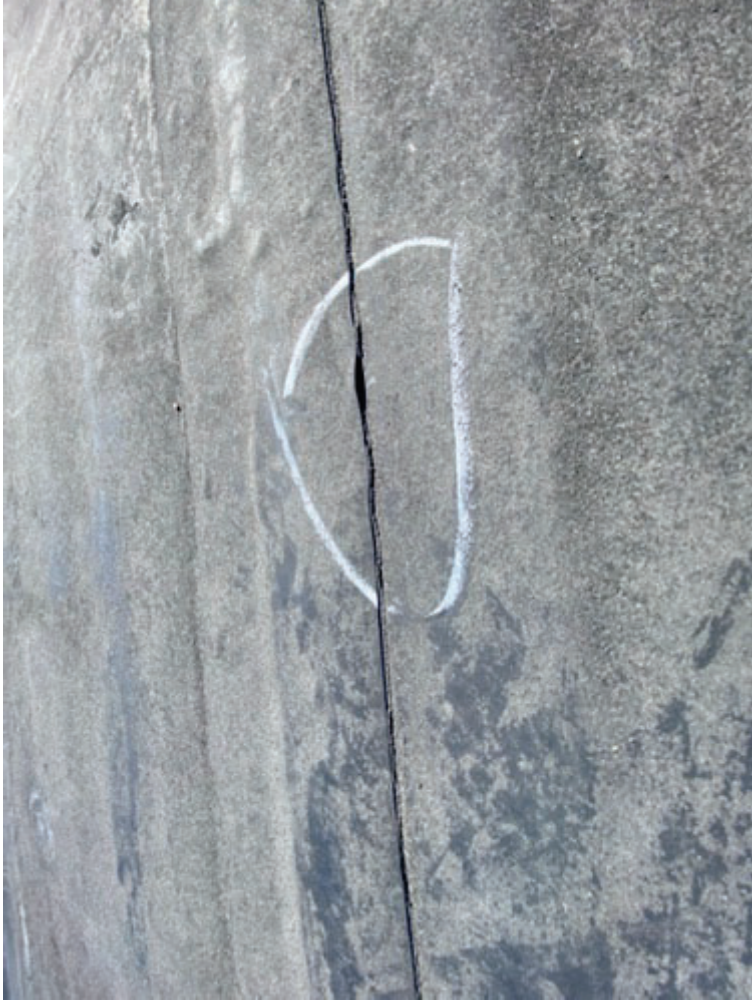
*Photo 3*

Failed seam in ponding area.

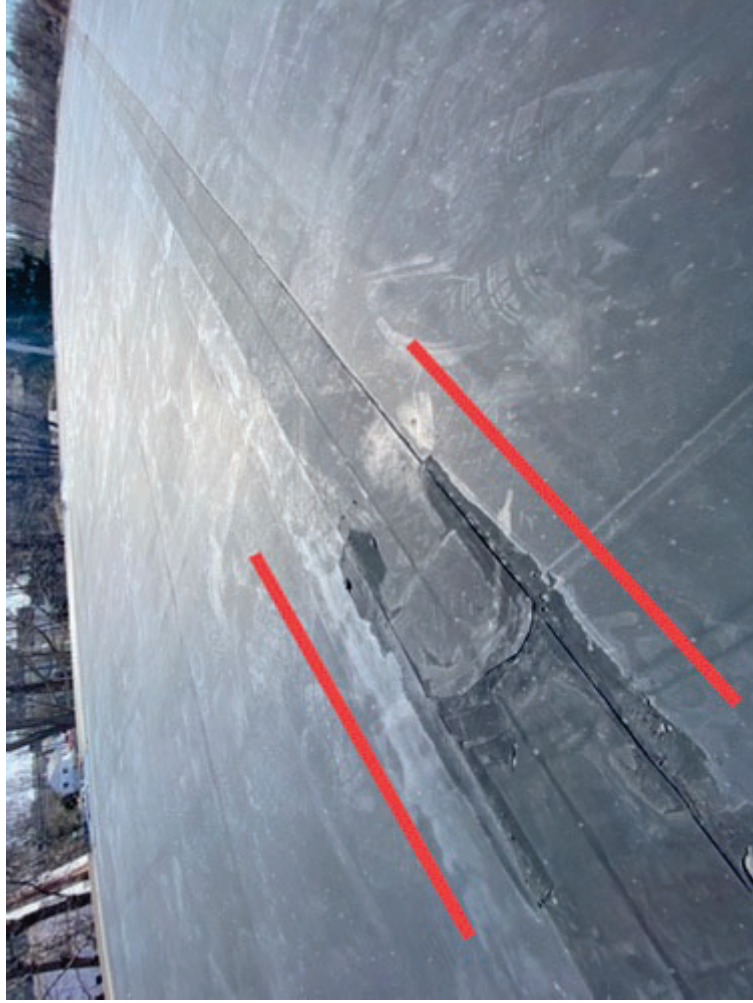
*Photo 4*

Deteriorating coverstrip repair over seam.

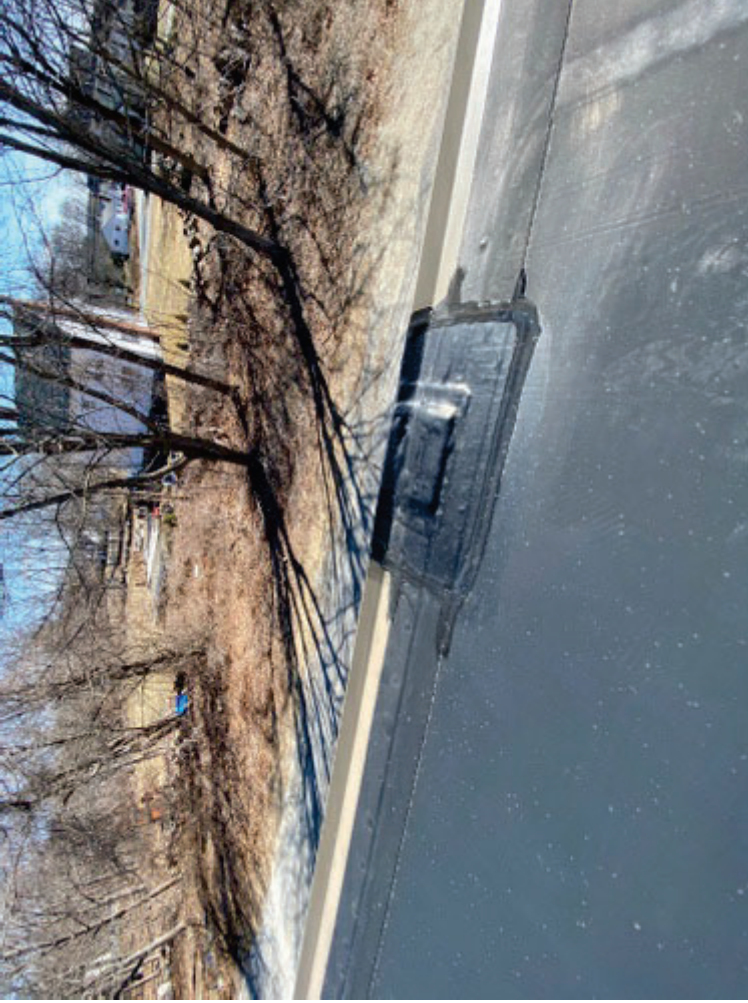
*Photo 5*

Previously repaired open condition at lap in edge metal.

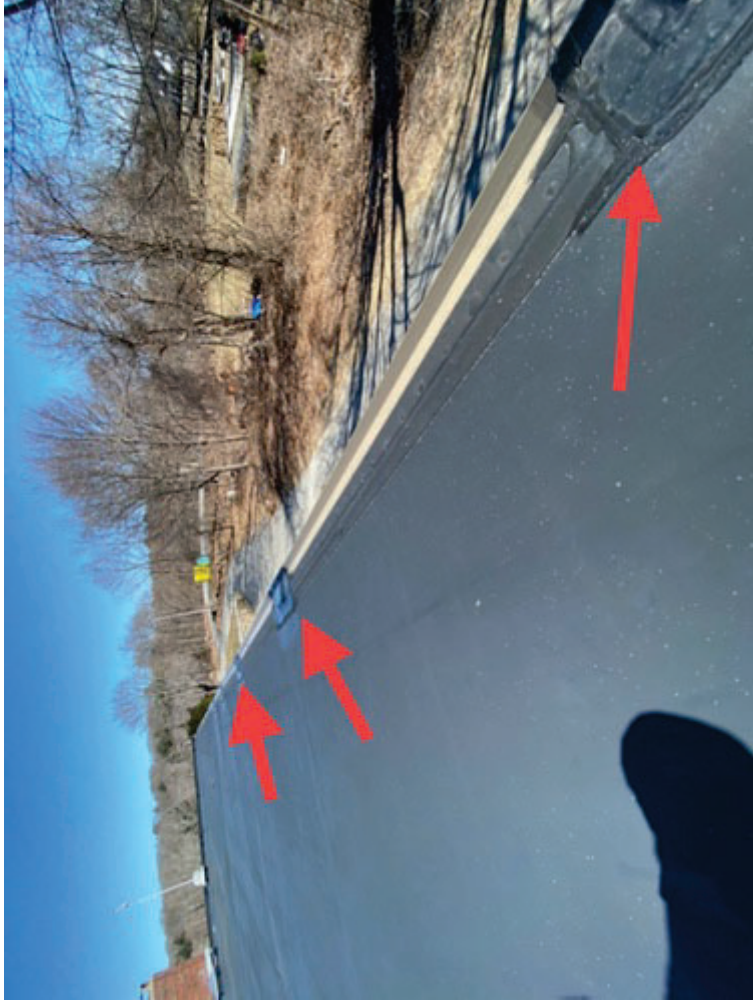
*Photo 6*

Previously repaired laps in edge metal.

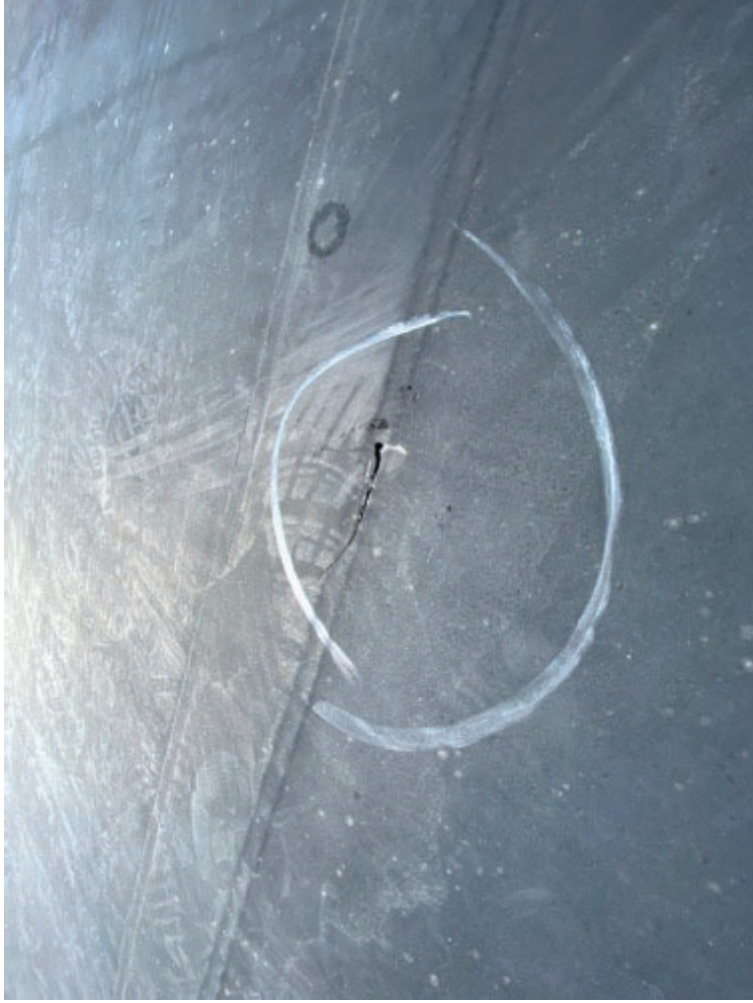
*Photo 8*

**Penetration in membrane.**  
This is a source of water infiltration to the roofing assembly.

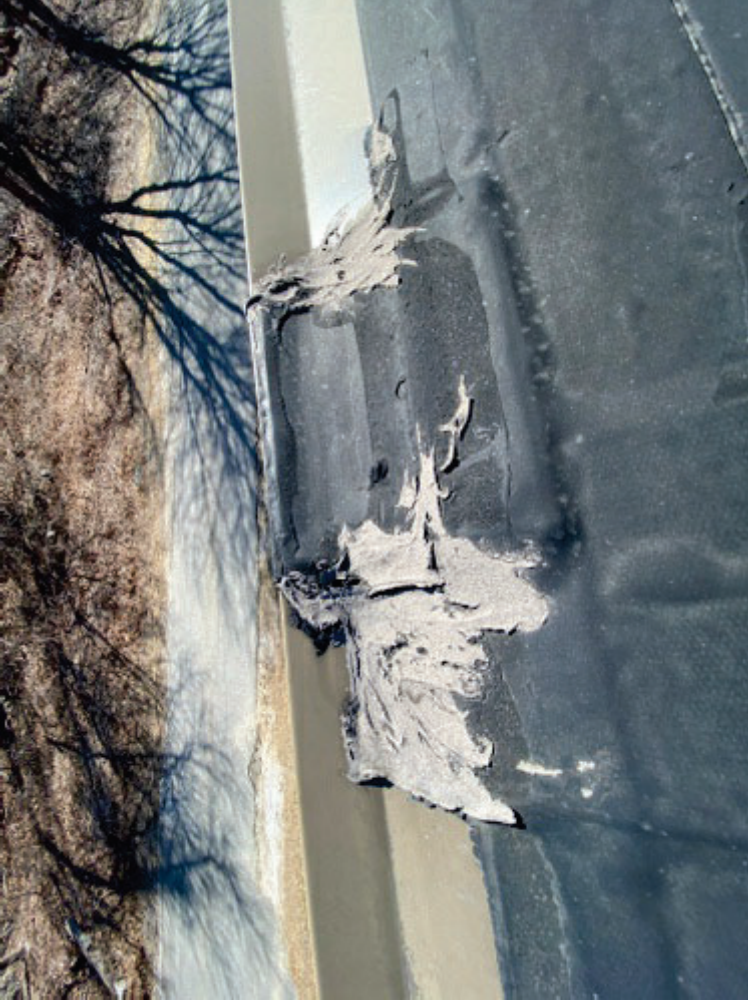
*Photo 9*

**Failed patch over lap in edge metal.**  
This failed condition was observed in approximately 30 locations.

- Troubleshoot & repair **20 failed patches and flashing conditions** on all roof sections.
- Troubleshoot & repair **30 failed patches over edge metal laps** on all roof sections.
- For penetrations and failed coverstrip/flashing:
  - Clean roof surface with high grade cleaner
  - Apply peel and stick Uni-Bond 6" tape to penetration or seam
  - Apply White Knight Plus WC to Uni-Bond tape and extend coating 4" past all seams of tape. Ensure felt backing of tape is fully saturated.
- Apply GreenLock Structural Adh at termination bars.
- All debris will be cleared up and removed.

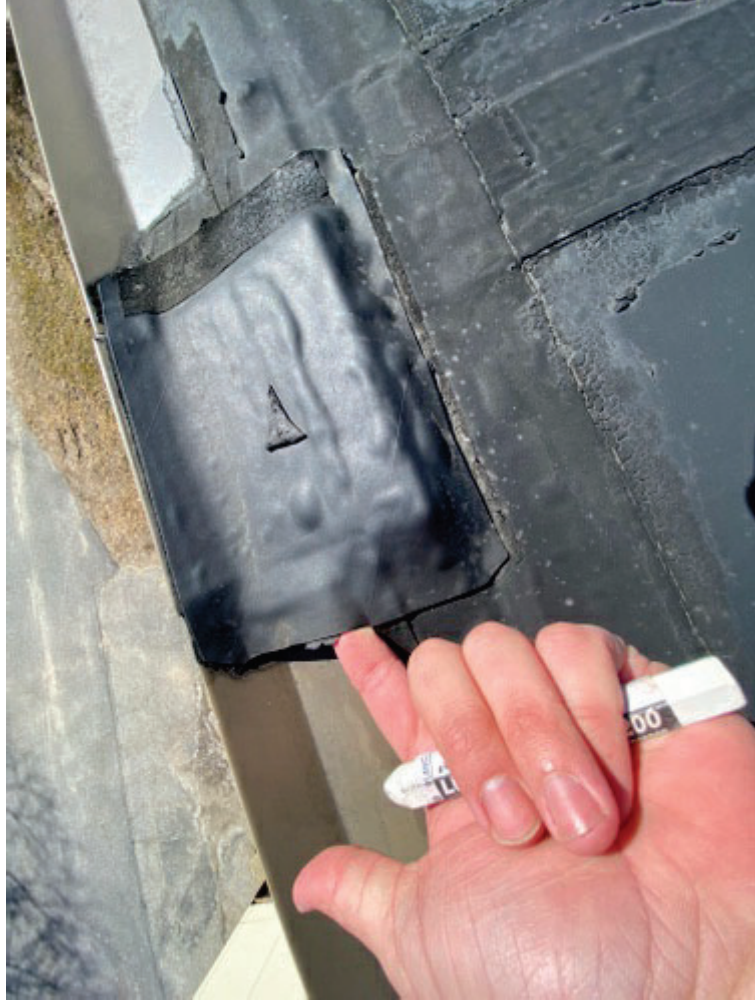
*Photo 10*

**Failed patch over lap in edge metal.**  
This failed condition was observed in approximately 30 locations.

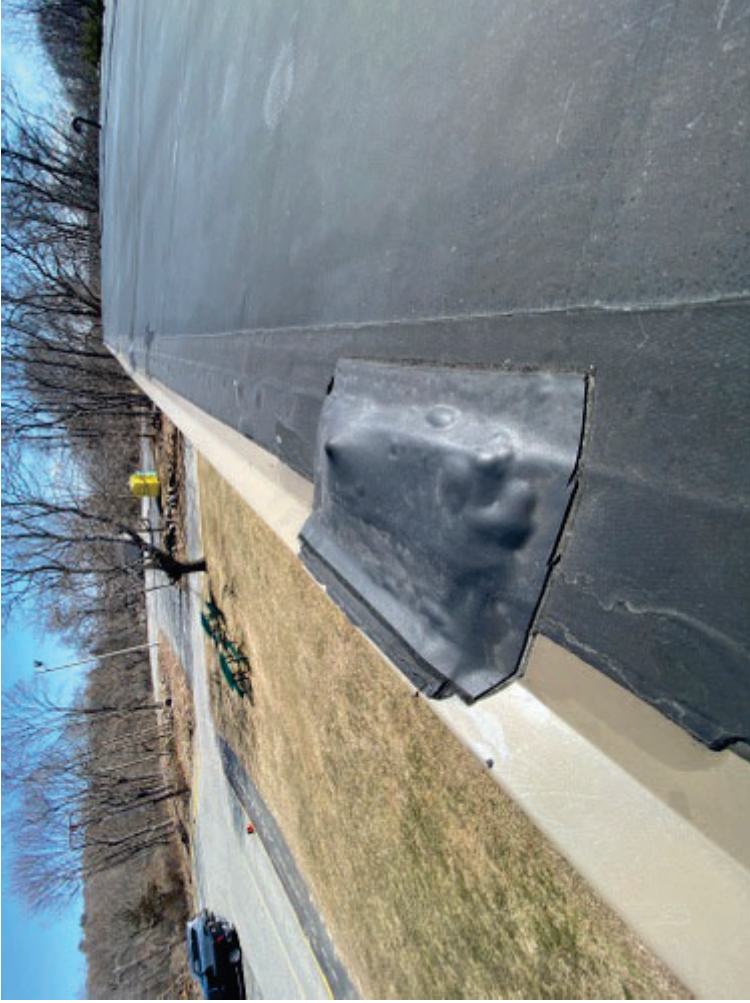
*Photo 11*

**Failed patch over lap in edge metal.**  
This failed condition was observed in approximately 30 locations.

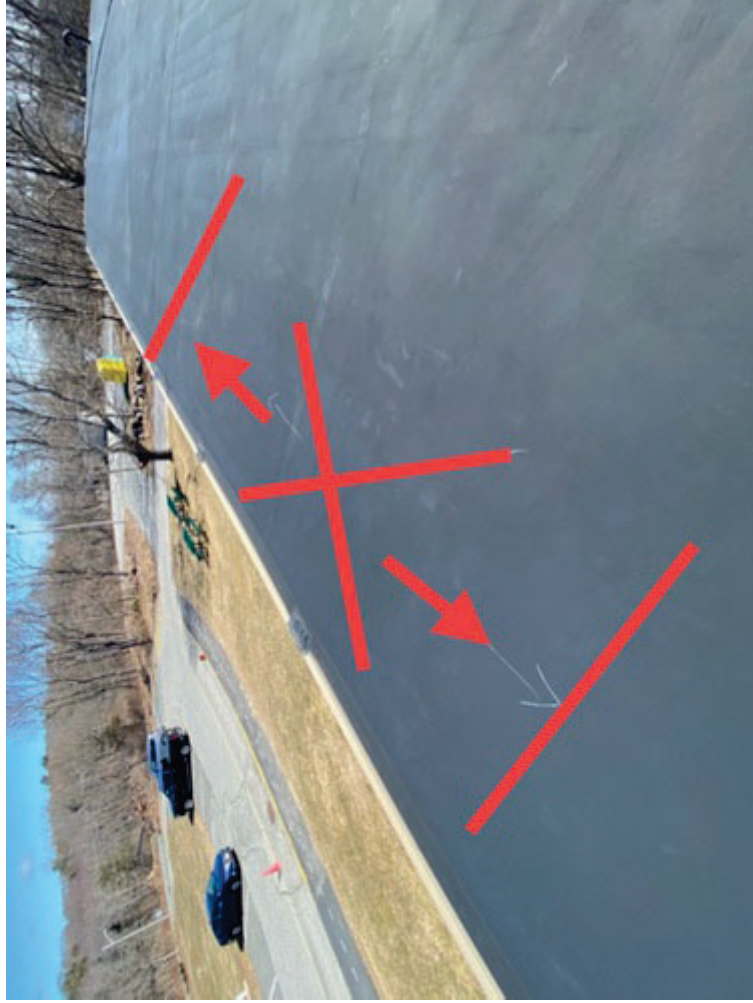
*Photo 12*

**Area of delaminated membrane from insulation.**

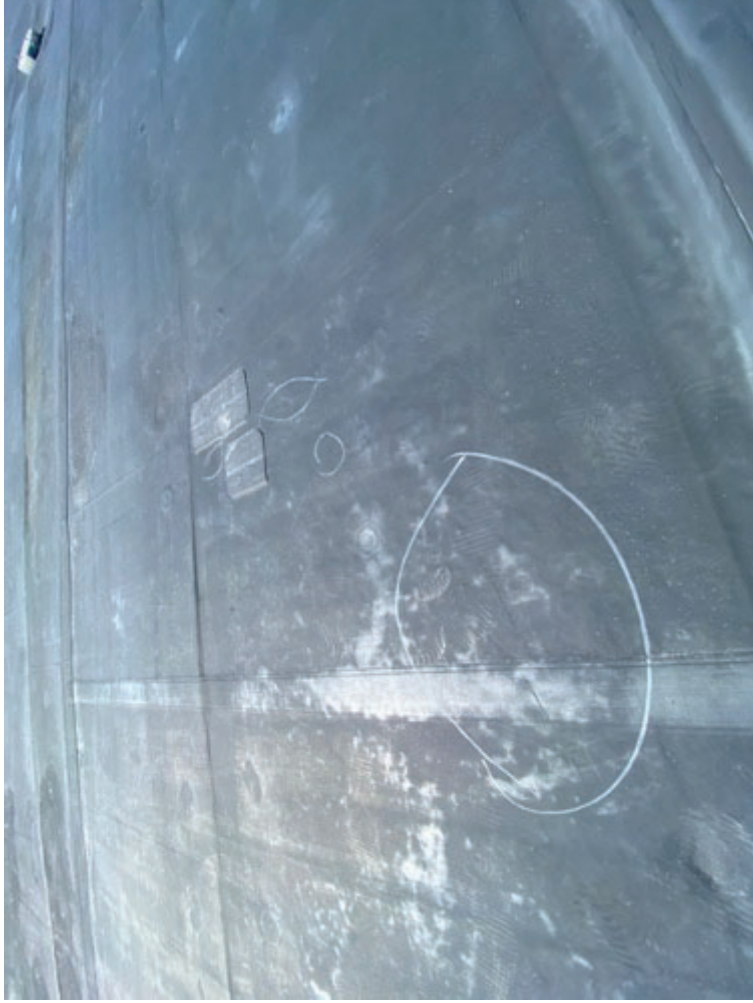
*Photo 14*

**Multiple penetrations observed in membrane.**

- Interior water damage
- Mold/Mildew
- Saturated insulation
- resulting in loss of dimensional stability and R Value
- Delamination of the membrane from sub-straight.
- Rust/rot of fasteners and decking

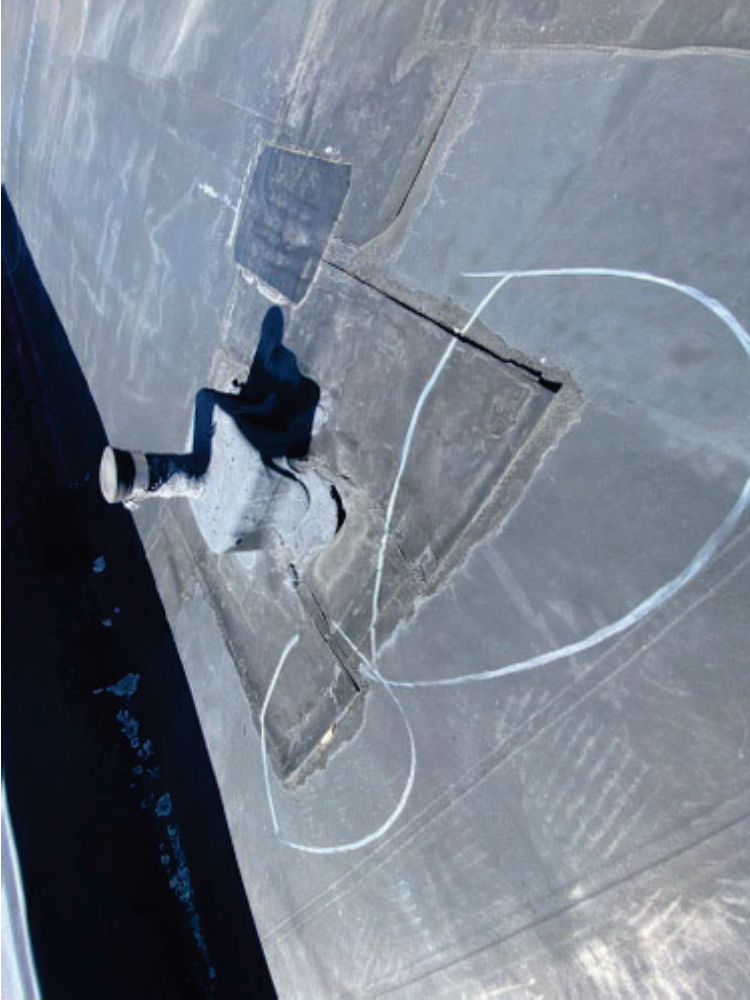
*Photo 15*

**Failed flashing around pitch pocket.**

- Interior water damage
- Mold/Mildew
- Saturated insulation
- resulting in loss of dimensional stability and R Value
- Delamination of the membrane from sub-straight.
- Rust/rot of fasteners and decking

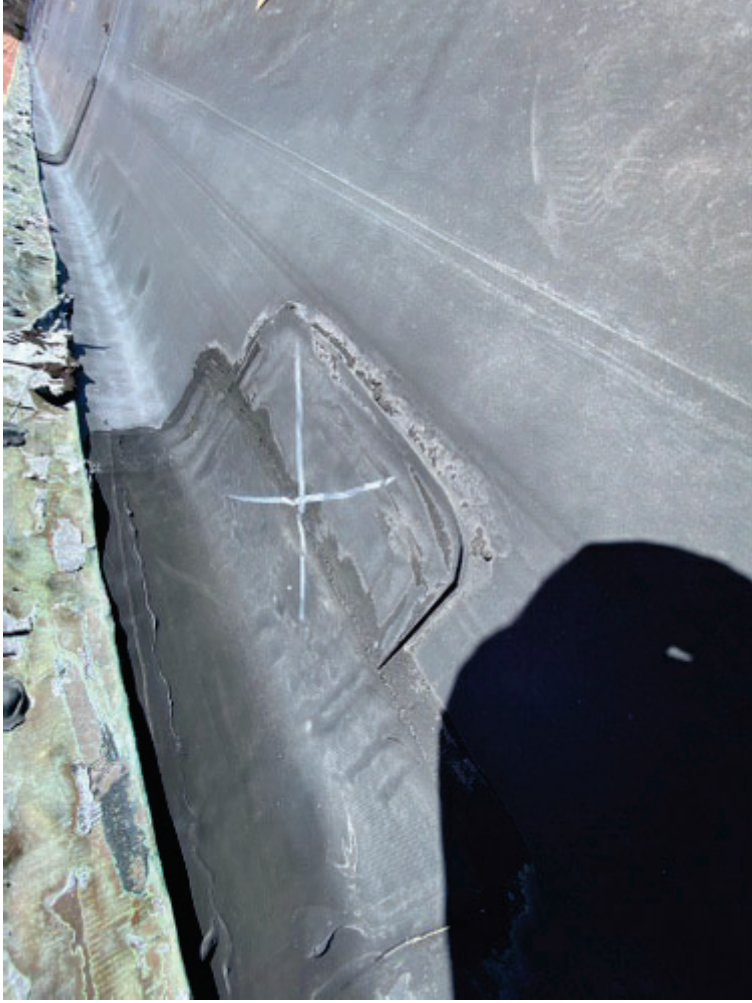
*Photo 19*

**Failed flashing.**

- Interior water damage
- Mold/Mildew
- Saturated insulation resulting in loss of dimensional stability and R Value
- Delamination of the membrane from sub-straight.
- Rust/rot of fasteners and decking

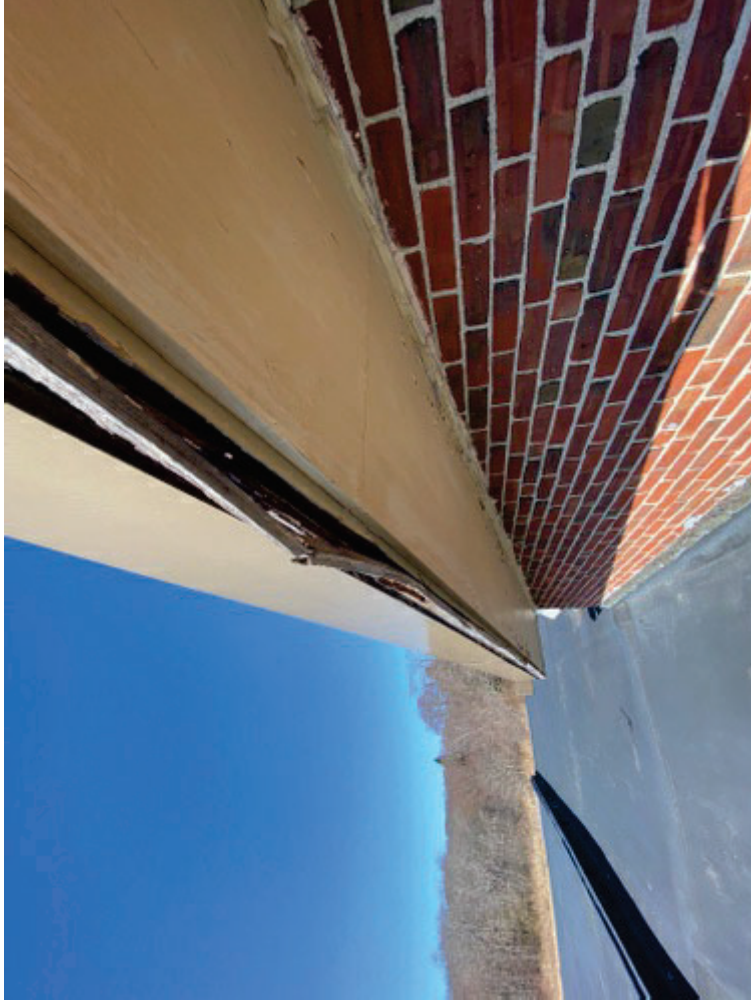
*Photo 20*

**Rotted fascia board under edge metal.**

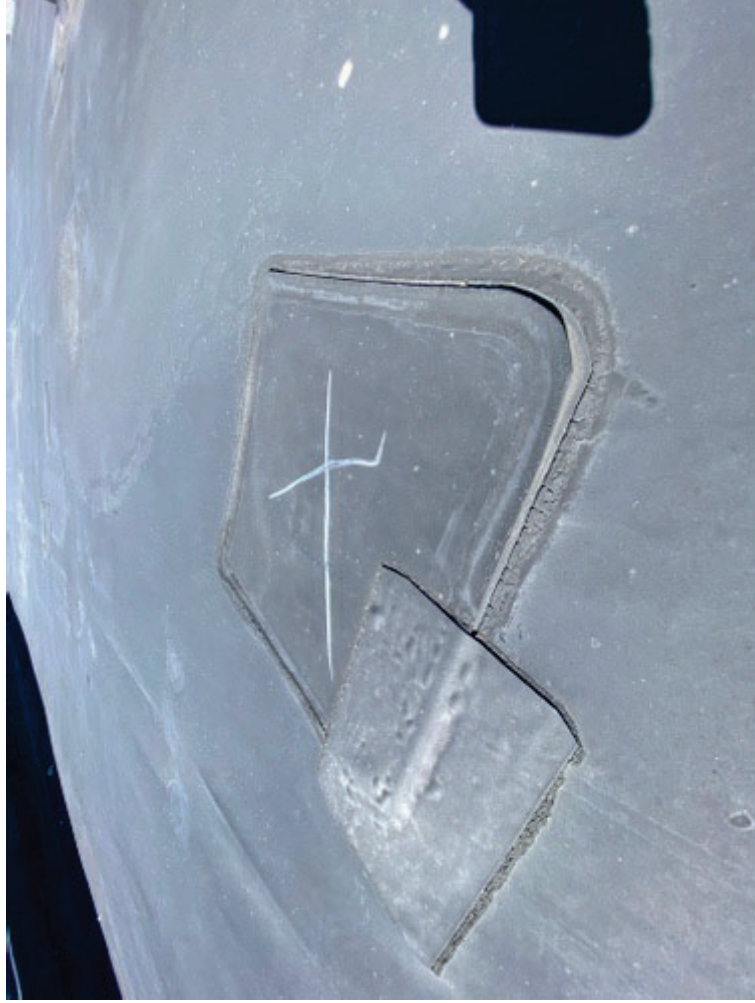
Photo 22

**Failed patch.**

- Interior water damage
- Mold/Mildew
- Saturated insulation resulting in loss of dimensional stability and R Value
- Delamination of the membrane from sub-straight.
- Rust/rot of fasteners and decking

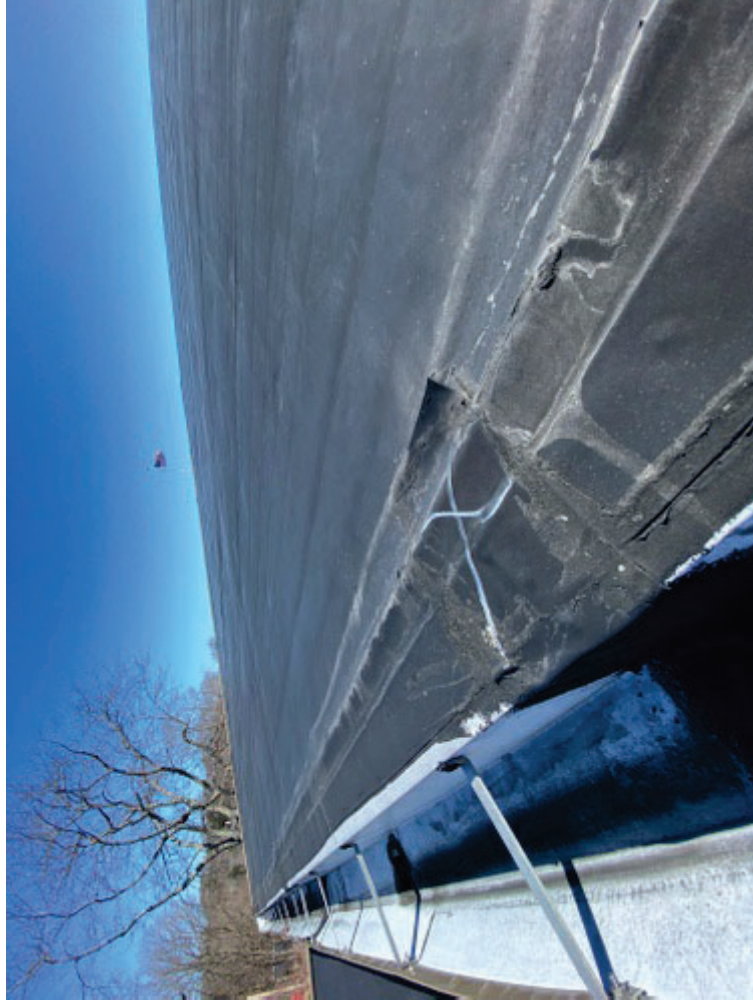
*Photo 24*

**Failed flashing above gutter.**

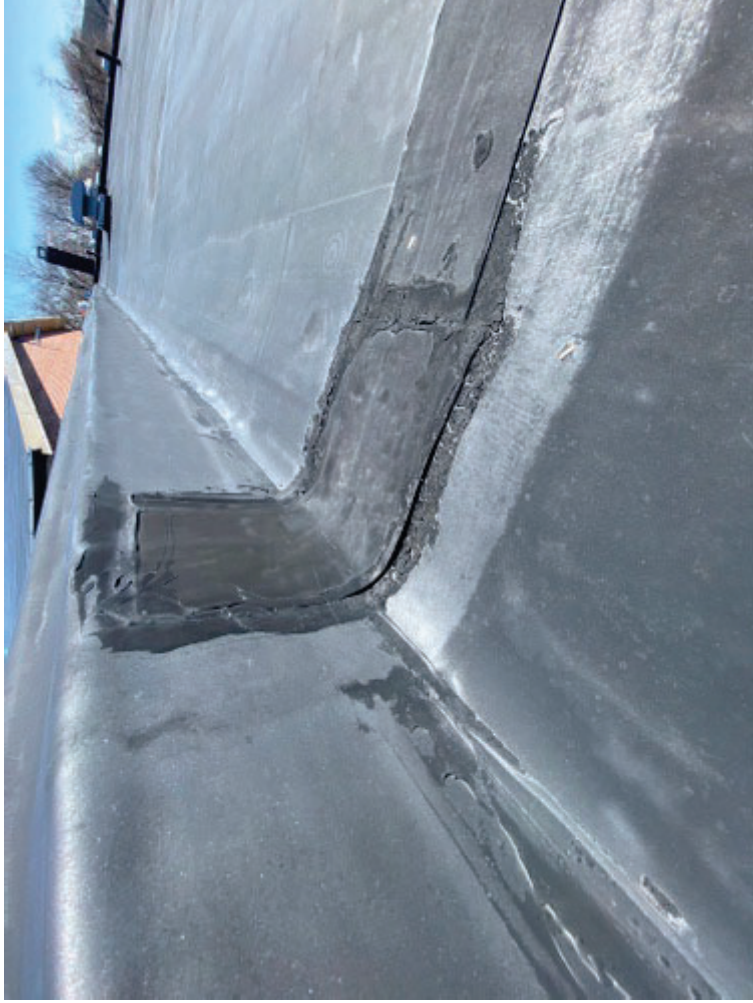
Photo 26

**Failed vertical flashing.**

- Interior water damage
- Mold/Mildew
- Saturated insulation resulting in loss of dimensional stability and R Value
- Delamination of the membrane from sub-straight.
- Rust/rot of fasteners and decking

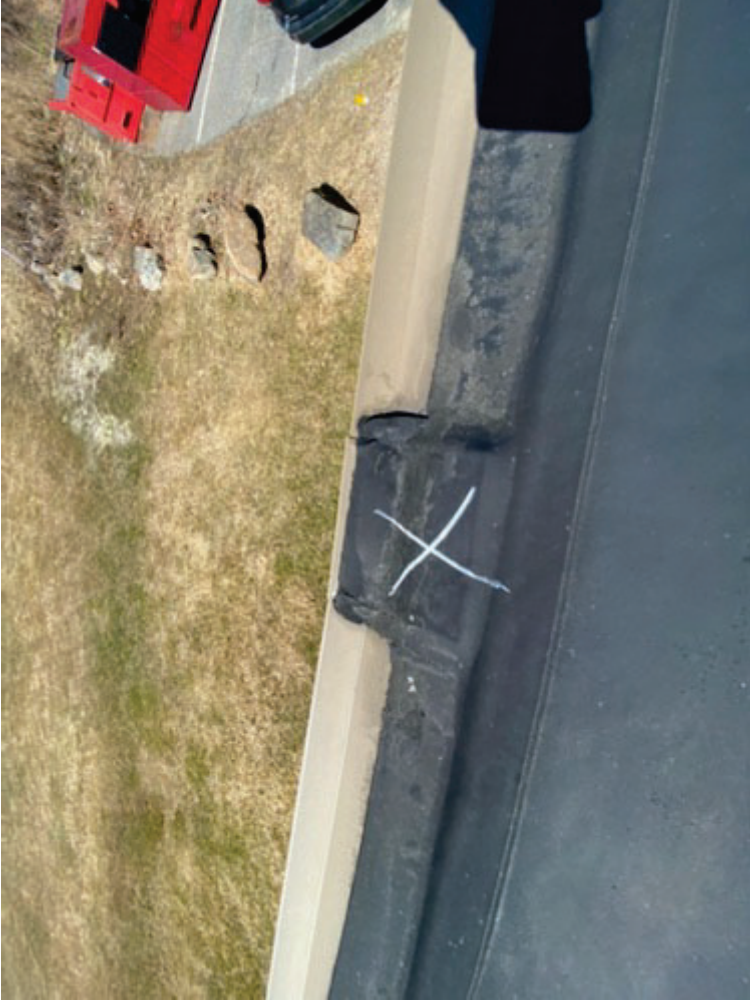
*Photo 27*

**Failed patch over lap in edge metal.**

This failed condition was observed in approximately 30 locations.

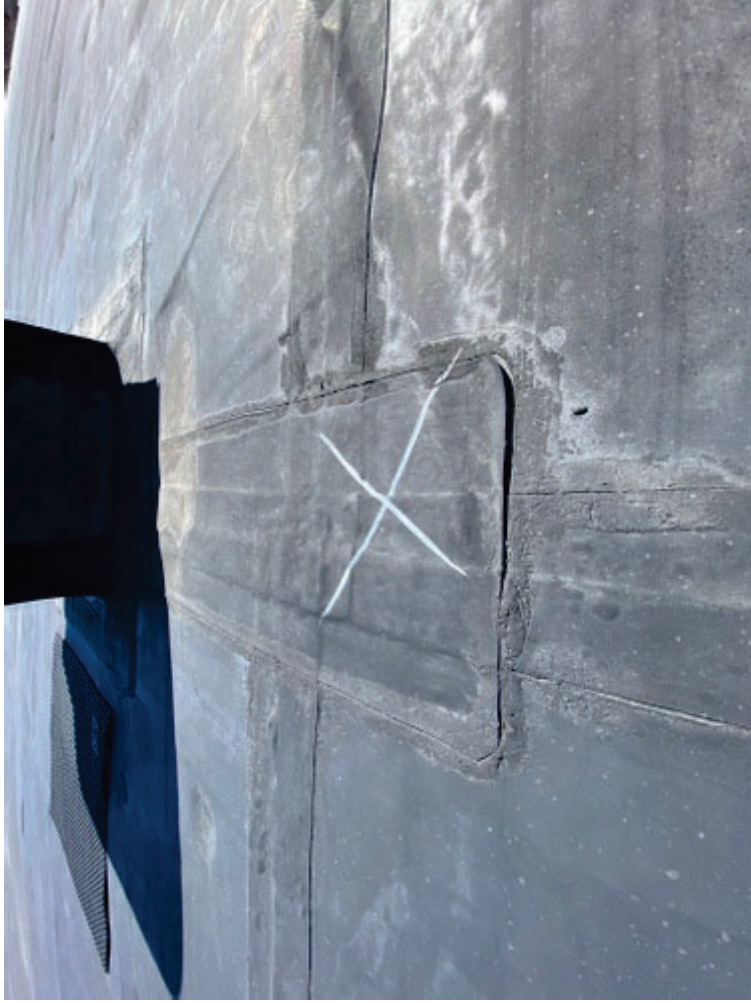
*Photo 28*

**Failed patch.**

- Interior water damage
- Mold/Mildew
- Saturated insulation resulting in loss of dimensional stability and R Value
- Delamination of the membrane from sub-straight.
- Rust/rot of fasteners and decking
