## FACILITY NEEDS ASSESSMENT

**ESSEX ELEMENTARY SCHOOL  
AND MANCHESTER ESSEX  
MIDDLE-HIGH SCHOOL**

**Manchester Essex  
Regional School District**

**FINAL REPORT: January 27, 2023  
H&A JN 2217.01**

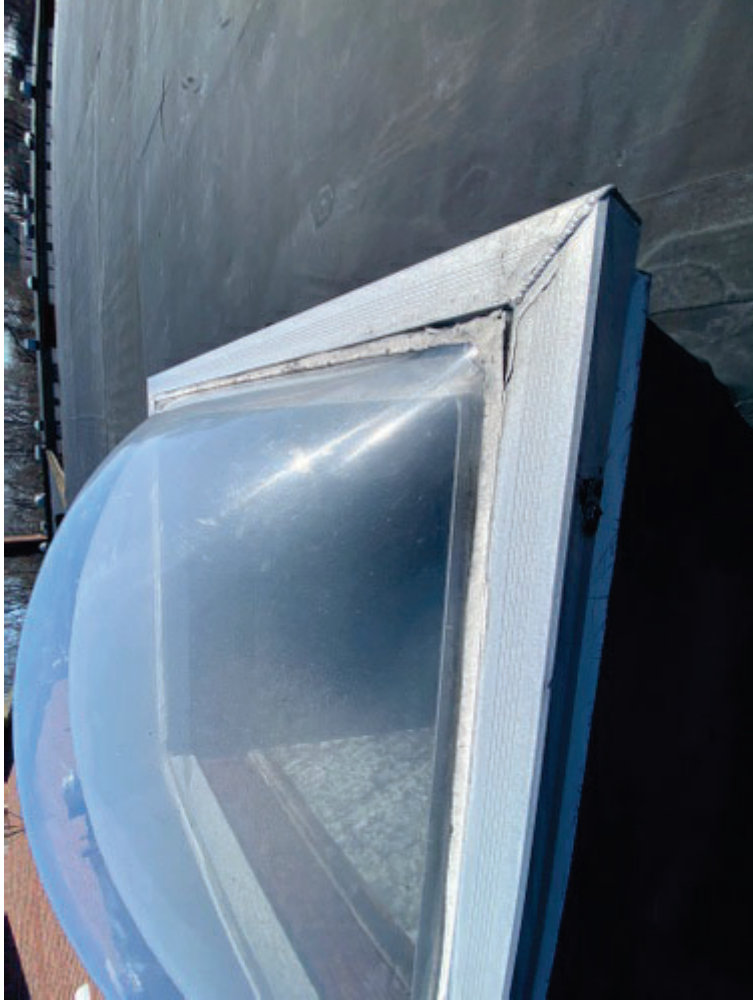
*Photo 30*

**Deteriorated sealant around skylight.**

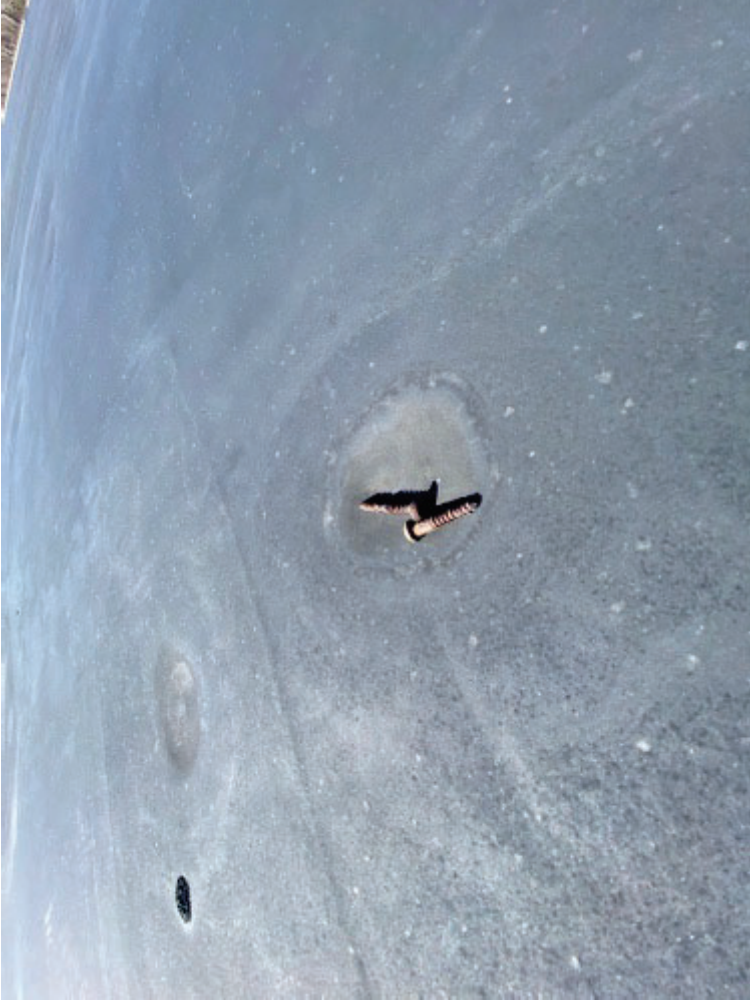
*Photo 31*

**Fasteners were observed around the roof.**  
These are potential puncture points in the membrane.

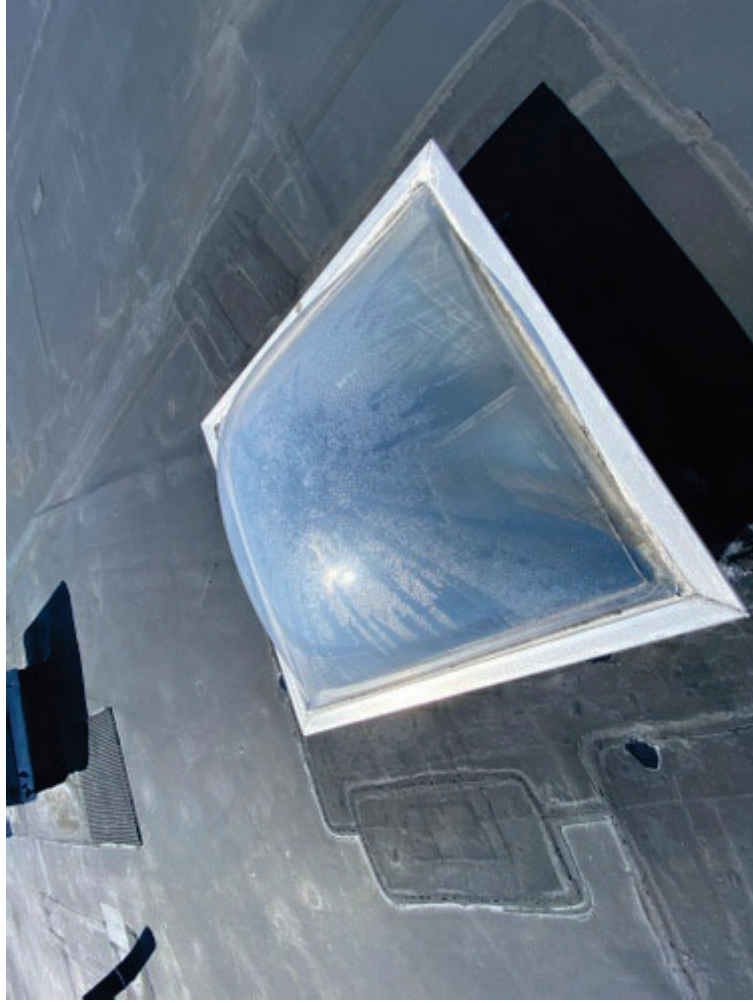
*Photo 32*

**Condensation was observed between the layers of the skylight.**  
This is a sign of end of life cycle.

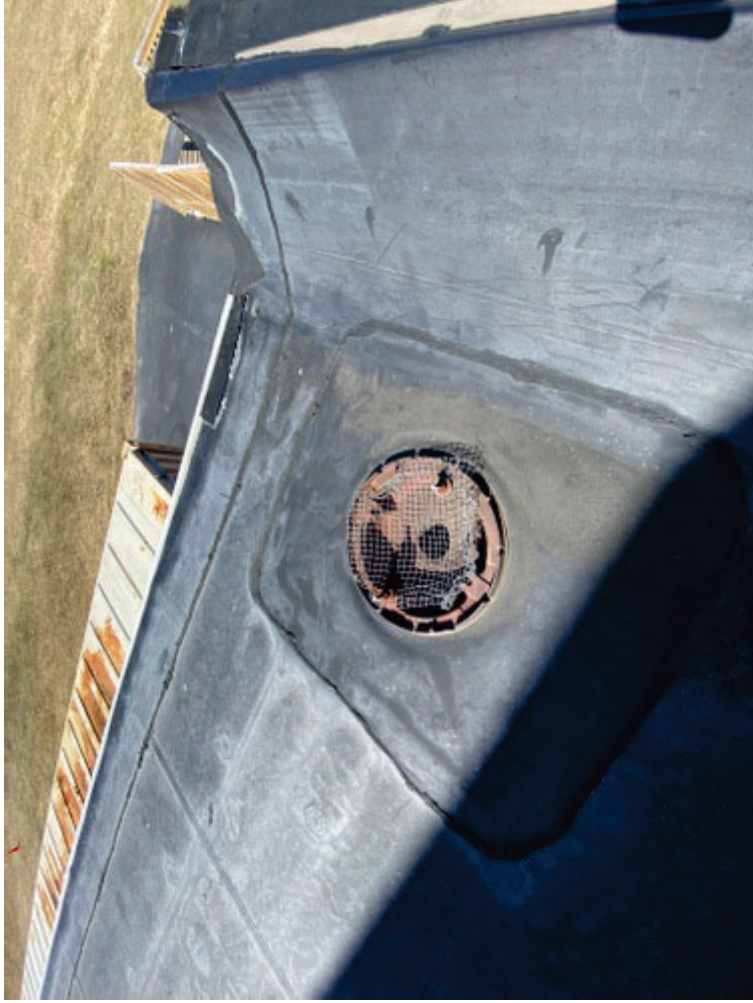
*Photo 34*

**Missing drain basket.**

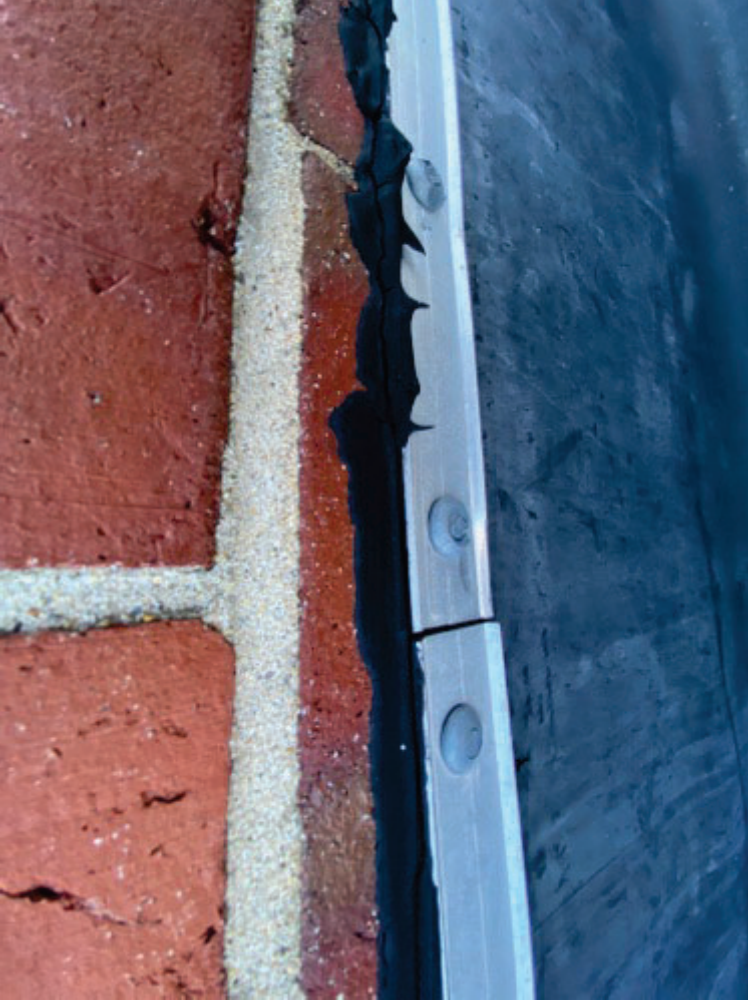
*Photo 35*

**Deteriorated sealant above surface mounted termination bar.**

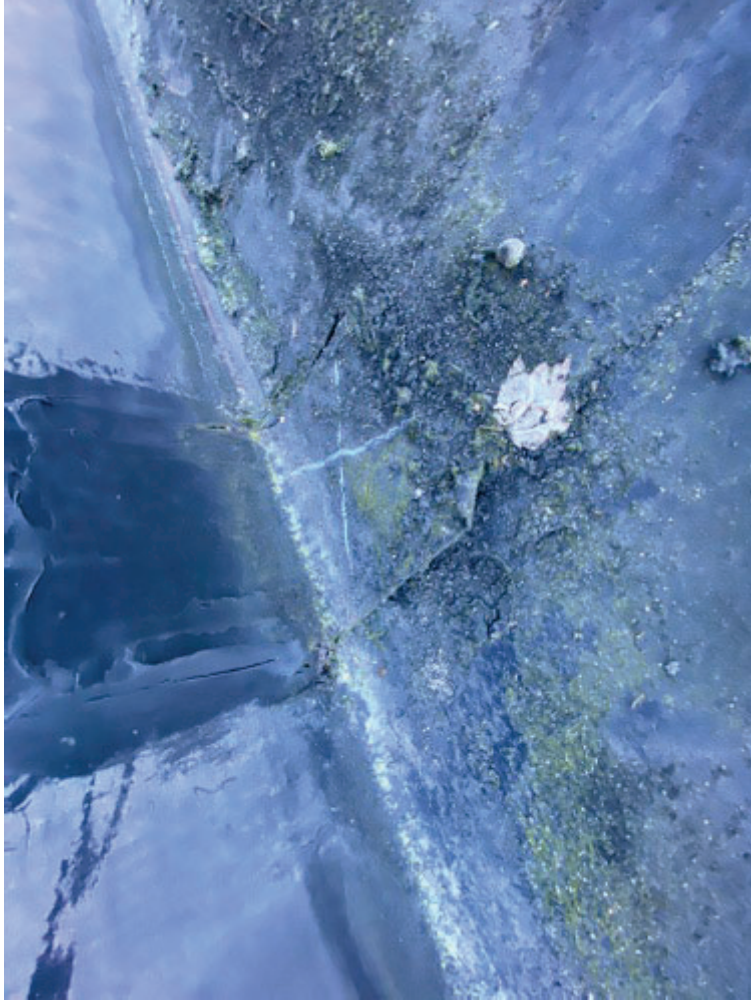
*Photo 36*

**Failed patch.**

- Interior water damage
- Mold/Mildew
- Saturated insulation resulting in loss of dimensional stability and R Value
- Delamination of the membrane from sub-straight.
- Rust/rot of fasteners and decking

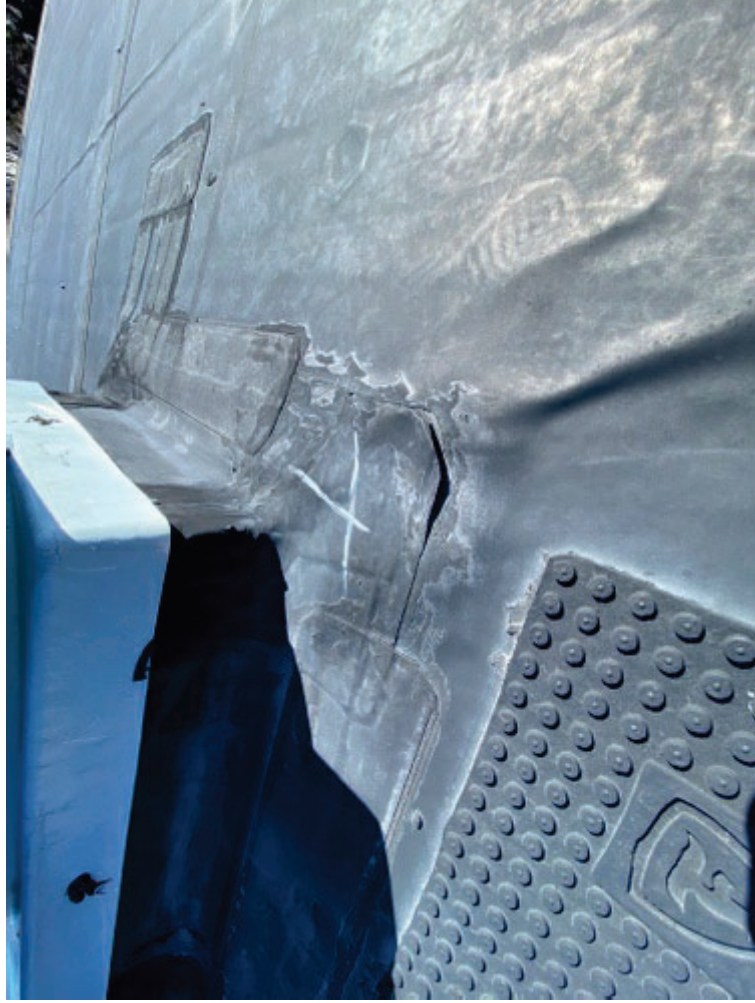
Photo 38

**Failed patch.**
