Re: Evaluation of Impact Attenuation Properties of Playing Surfaces
Manchester-Essex Regional School District
36 Lincoln Street
Manchester-by-the-Sea, MA 01944
Gale JN 718111

ATTACHMENT 1:
GMAX TESTING REPORT
BROOK STREET FIELD

ATTACHMENT 2:
GMAX TESTING REPORT
JOSEPH M. HYLAND FIELD

ATTACHMENT 5:
JOSEPH M. HYLAND FIELD
AREAS OF CONCERN

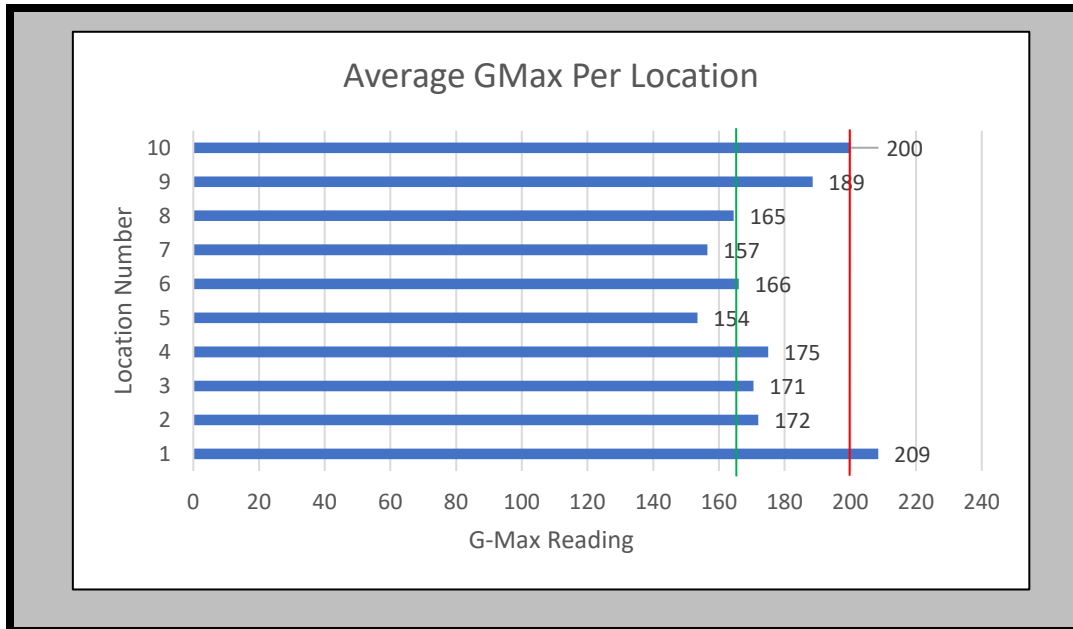
Results Graphs

The synthetic turf field recorded an average GMax of 176, with all but two location testing below the ASTM maximum limits of <200. Although not a requirement, per the Synthetic Turf Council's (STC) "Suggested Guidelines for the Essential Elements of Synthetic Turf Systems," the GMax should be below 165 throughout the life of the field. Three test locations recorded GMax values below the 165 limit as suggested by the STC guidelines. The synthetic turf field recorded an average infill depth of 29 mm (1.15"), which is below the ± 44 mm (± 1.75") recommended infill depth at time of installation, as is typical per turf manufacturer's guidelines for a 2.25" turf system. Having less infill may result in fiber layover, as was observed at the time of evaluation.

*Per ASTM F1936 Specification, the average Gmax shall be less than **200**. If the turf playing system is tested in accordance with this specification, and the reported average Gmax of one or more test points is equal or greater than **200**, the turf playing system should be brought into compliance and field use should be limited or suspended until rectified.

*Although not a requirement, per the Synthetic Turf Council's (STC) Suggested Guidelines for the Essential Elements of Synthetic Turf Systems, Gmax should be below **165** throughout the life of the field.

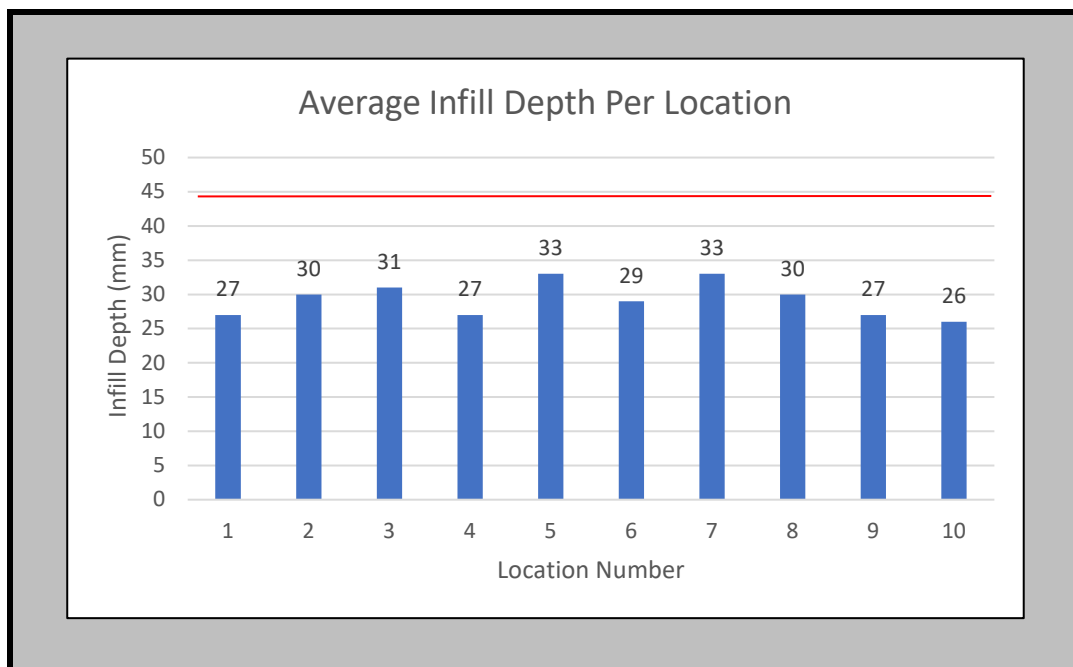
*Per turf manufacturer's typical guidelines for a 2.25" turf system, the recommended infill depth at time of installation is **+44 mm** (1.75").

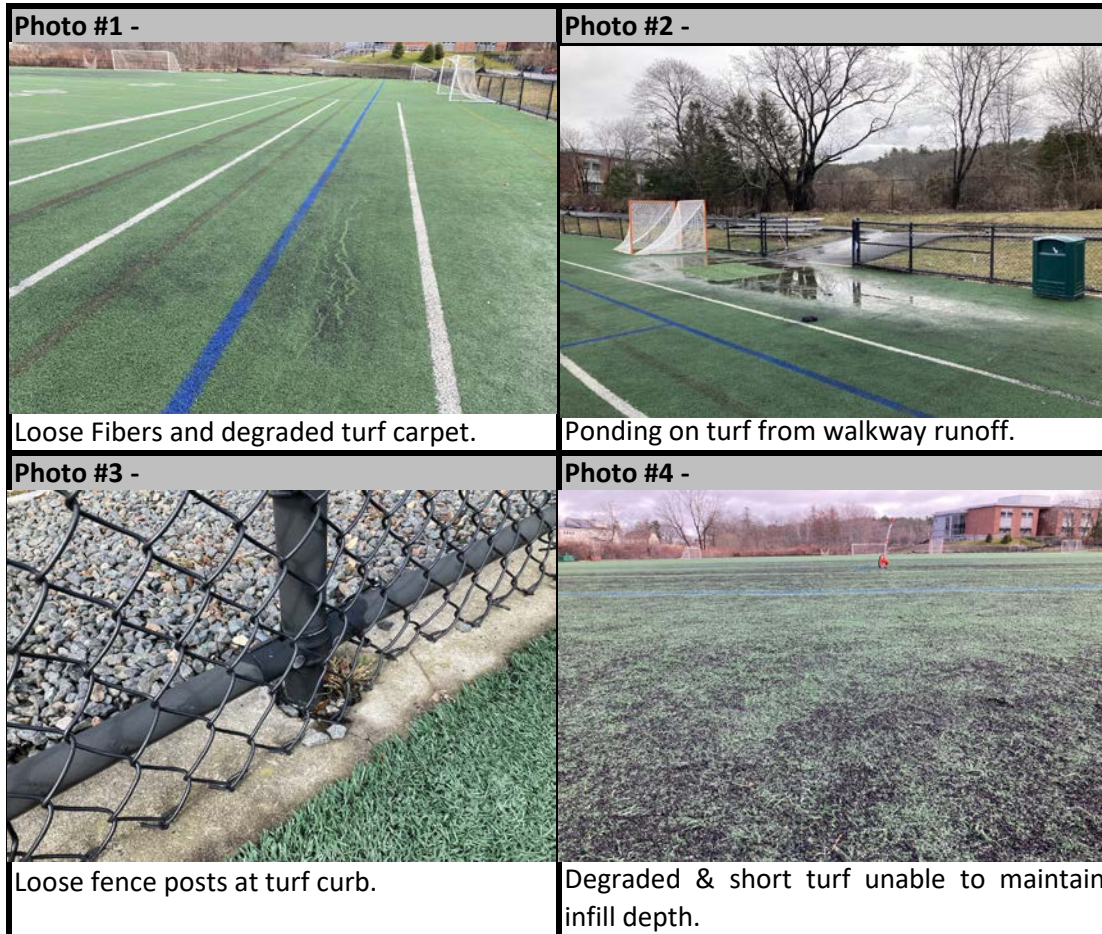
Project Photos - Page 1

2. The turf fibers were noticeably degraded. Fiber layover was observed throughout the field and accumulations of loose fibers were visible.
3. The infill depth appeared low throughout the field.

4. Inlaid striping lines and seams were generally in fair condition throughout the field. The seams along the football sidelines, though partially visible and raised, appear to remain intact.

5. Several "heaves" and "depressions" in the field were observed in the goal areas. These variations have the potential to affect a ball roll or create a trip hazard.

6. Water ponding was observed on the nearby walkway and on the turf at the entrance to the field.
7. The soft soil side slope behind the southwestern goal has eroded onto the turf, resulting in a layer of caked mud on the turf behind the goal.

Replacement of an approximately ten by ten (10 x 10) yard section of synthetic turf at each goal area, extending from the goal line to the front of the end zone.

- Remove and dispose of the existing synthetic turf surface section (carpet and infill).
- Prepare base stone to receive a synthetic turf surface.
- Install new 2.25" monofilament synthetic turf, and crumb rubber (SBR) and sand infill.
- Perform GMax and infill depth testing at installation and annually.

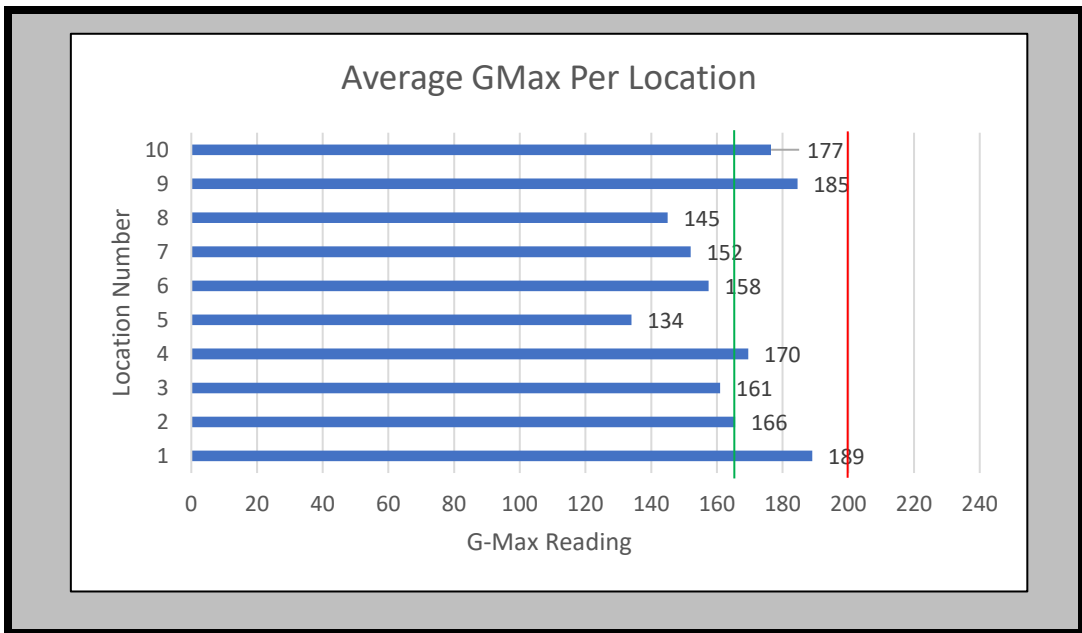
Results Graphs

The synthetic turf field recorded an average GMax of 163, with none of the ten locations testing above the ASTM maximum limits of <200. Although not a requirement, per the Synthetic Turf Council's (STC) "Suggested Guidelines for the Essential Elements of Synthetic Turf Systems," the GMax should be below 165 throughout the life of the field. Five test locations recorded GMax values below the 165 limit as suggested by the STC guidelines. The synthetic turf field recorded an average infill depth of 22 mm (0.87"), which is below the ± 38 mm (± 1.5") recommended infill depth at time of installation, as is typical per turf manufacturer's guidelines for a 2.0" turf system. Having less infill may result in fiber layover, as was observed at the time of evaluation.

*Per ASTM F1936 Specification, the average Gmax shall be less than **200**. If the turf playing system is tested in accordance with this specification, and the reported average Gmax of one or more test points is equal or greater than **200**, the turf playing system should be brought into compliance and field use should be limited or suspended until rectified.

*Although not a requirement, per the Synthetic Turf Council's (STC) Suggested Guidelines for the Essential Elements of Synthetic Turf Systems, Gmax should be below **165** throughout the life of the field.

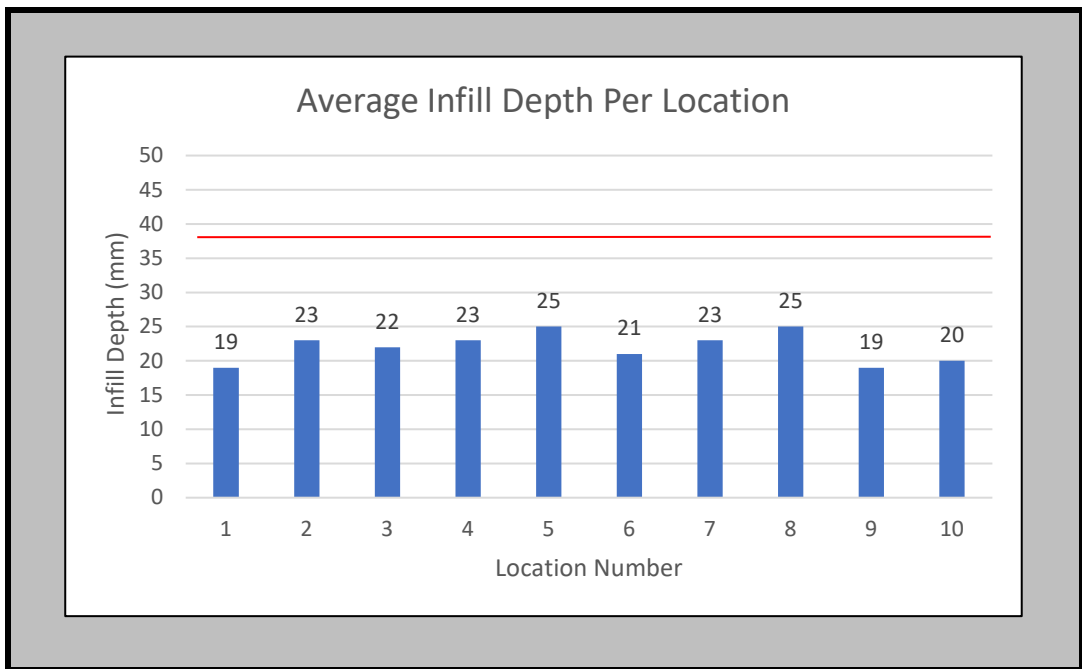
*Per turf manufacturer's typical guidelines for a 2.0" turf system, the recommended infill depth at time of installation is **±38 mm** (1.5").

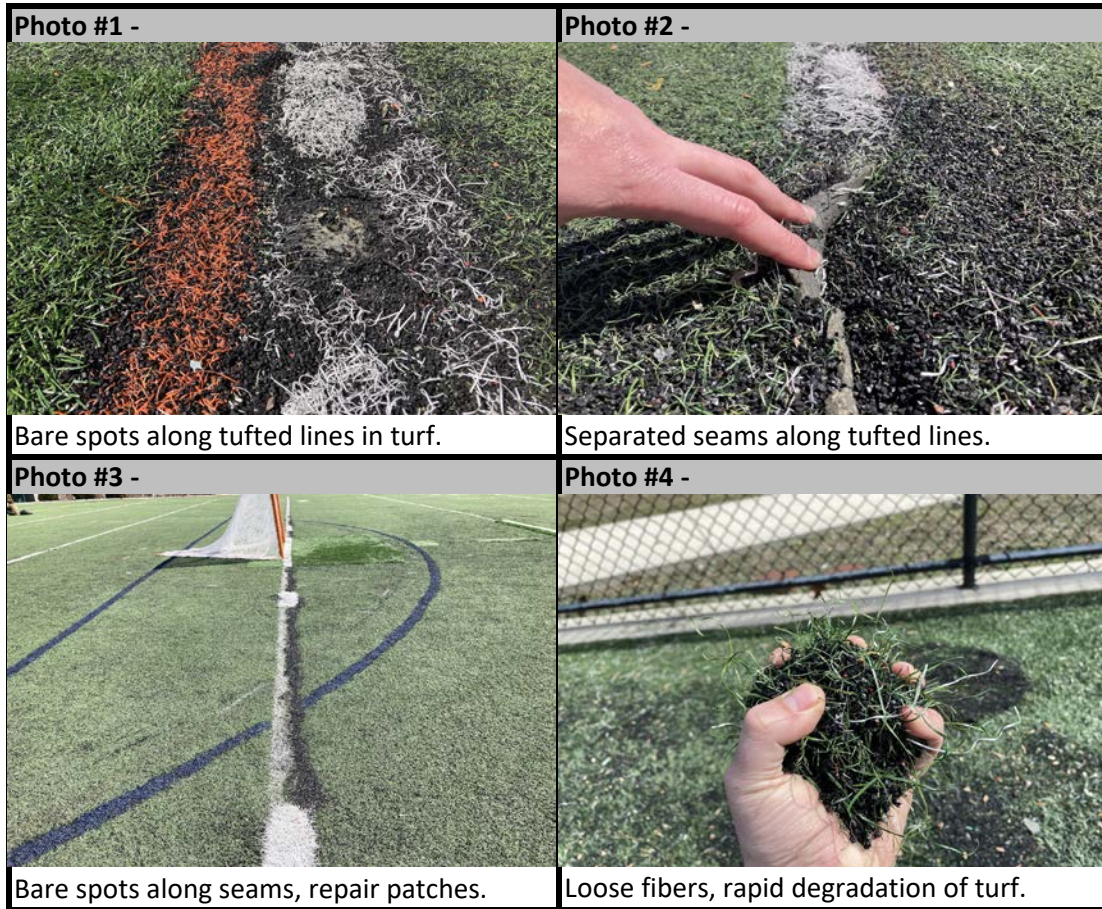
Project Photos

2. Turf fibers were noticeably degraded. Fiber length was found to be inconsistent with the field age, but large accumulations of loose fibers were found throughout the turf field, indicating that the carpet binder is failing and no longer holding turf fibers. This has resulted in bare spots and insufficient cover.

3. Several turf seams, particularly along the football ten-yard lines, were either bare or appeared to be coming apart. The bare spots were found throughout the field have the potential to be trip and fall or slip hazards.

4. The infill depth appeared low throughout the field.

5. Several synthetic turf repair patches were observed across the field.

Selective synthetic turf patch repair by a qualified turf installer along separated seams and areas of full fiber loss. Refer to Attachment 5 of this report for a graphic representation of prospective areas of repair.

- Cut, remove, and dispose of the existing synthetic turf surface to be patched (carpet and infill).
- Compact and prepare base stone to receive a synthetic turf surface.
- Install new 2.0" monofilament fiber synthetic turf, and SBR rubber and sand infill.

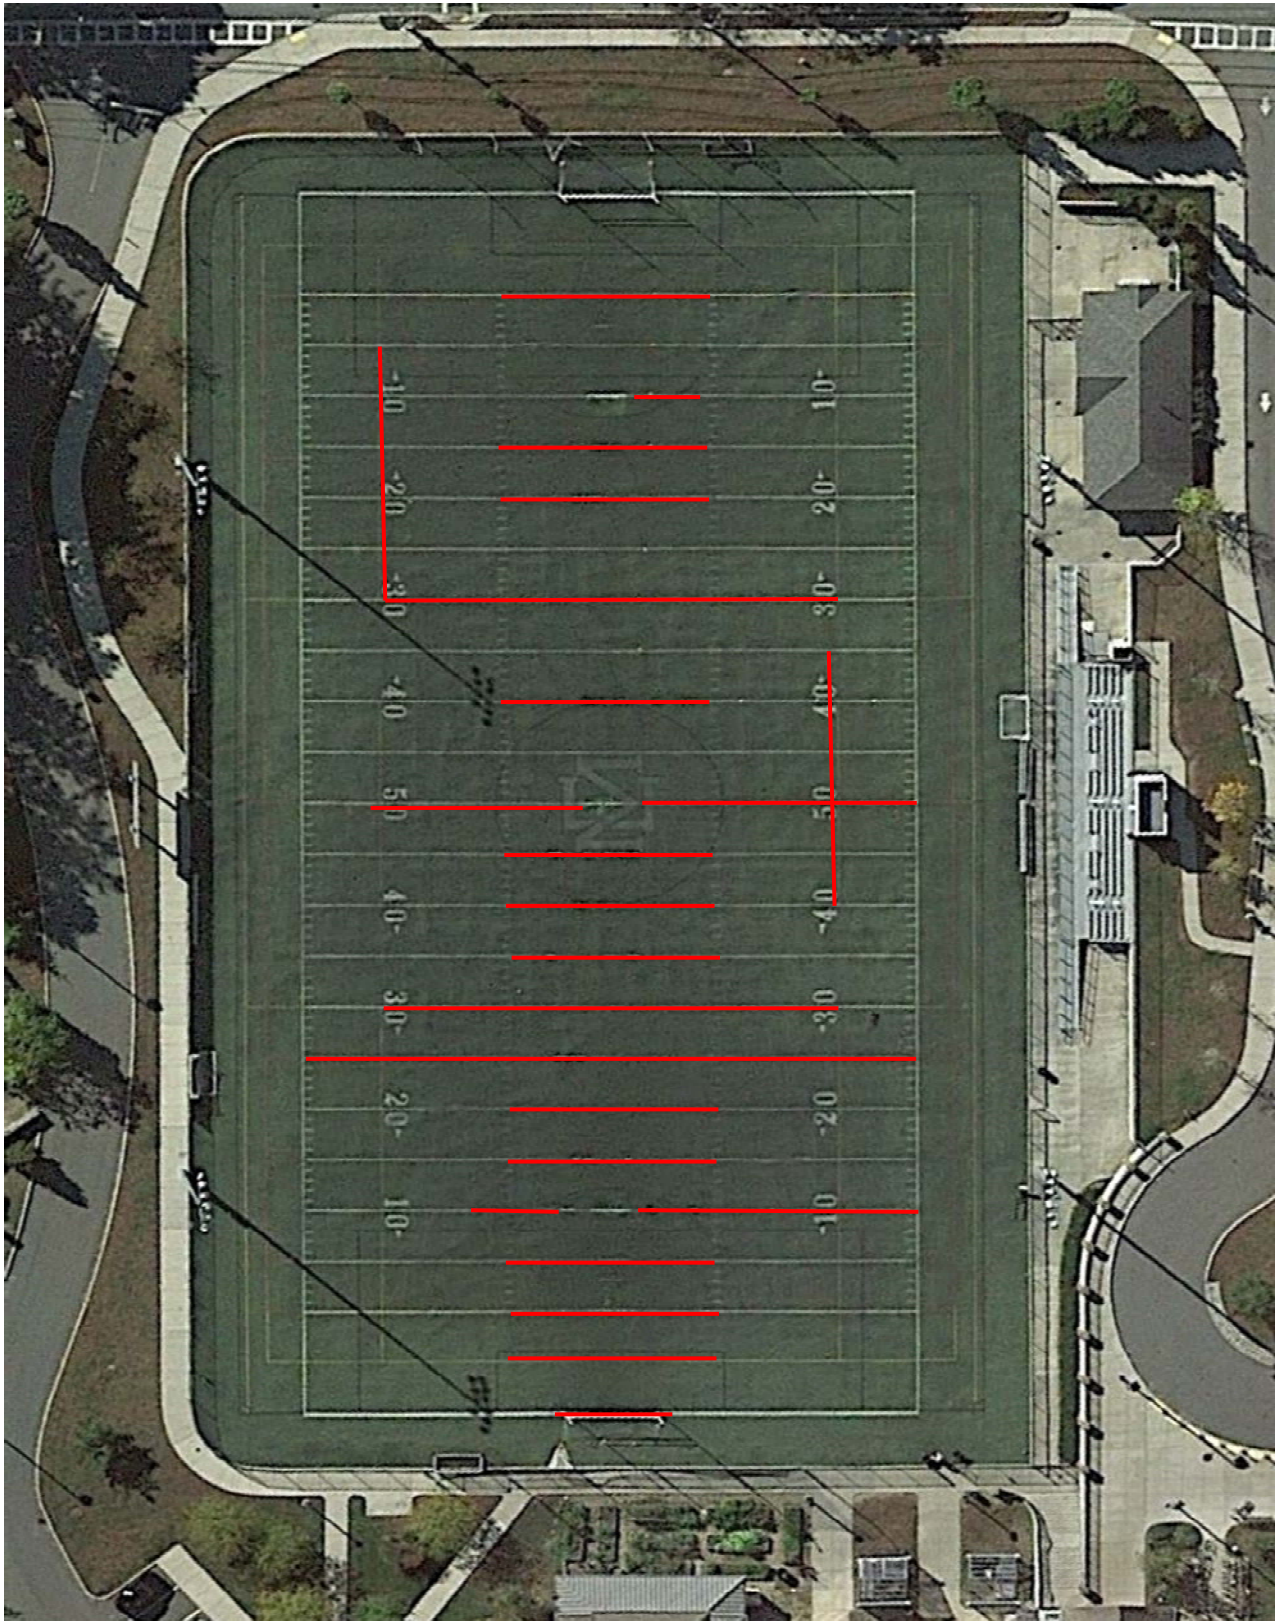
Joseph M. Hyland Field - Areas of Concern

Based on the extent of fiber loss and advanced degradation, the existing turf carpet may no longer be able to retain the amount of infill necessary to achieve GMax values less than 200. Additionally, numerous areas of seam separation present additional concerns. As a result of the identified observations, Gale recommends the following repair/renovation options:

This repair option is an attempt to selectively patch and repair locations of seam separation and fiber loss. It is Gale's opinion that this option be considered a short-term repair, providing MERSD a limited window of additional field use prior to full replacement, as described in the "Replacement Options/Considerations" section below. Based on the areas depicted in Attachment 5, Gale has estimated the quantity of required patch repairs to be 1,250 linear feet.
