## FACILITY NEEDS ASSESSMENT

### ESSEX ELEMENTARY SCHOOL AND MANCHESTER ESSEX MIDDLE-HIGH SCHOOL

#### Manchester Essex Regional School District

DRAFT REPORT: January 27, 2023  
H&A JN 2217.01

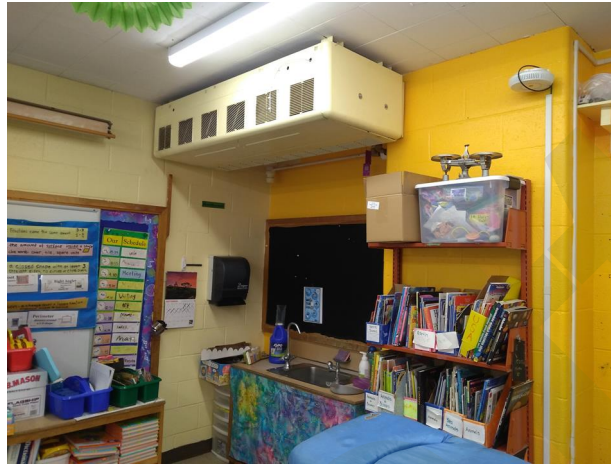
19. Existing 2x4 ceilings are discolored and tiles are mis-matched.
