## FACILITY NEEDS ASSESSMENT

**ESSEX ELEMENTARY SCHOOL  
AND MANCHESTER ESSEX  
MIDDLE-HIGH SCHOOL**

**Manchester Essex  
Regional School District**

**FINAL REPORT: January 27, 2023  
H&A JN 2217.01**

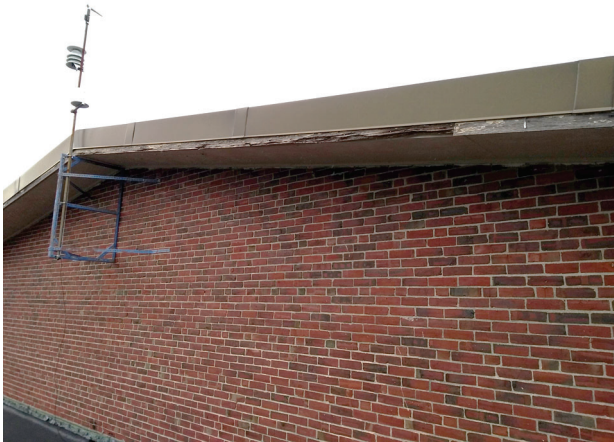
13. The fascia is rotted at the Cafetorium.

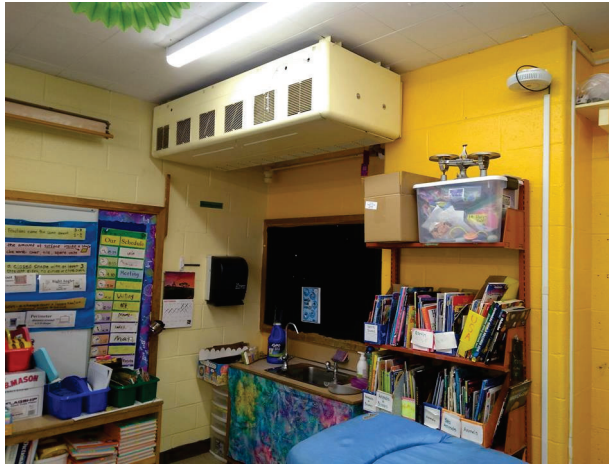
20. Classrooms have outdated and inefficient unit ventilators.

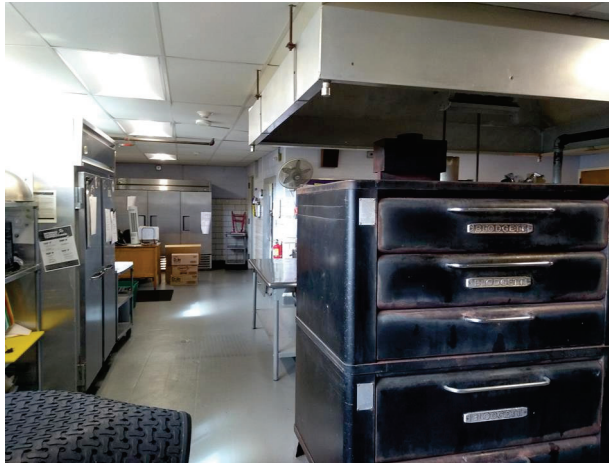
26. Kitchen equipment is very old and inefficient.
