Re: Evaluation of Impact Attenuation Properties of Playing Surfaces
Manchester-Essex Regional School District
36 Lincoln Street
Manchester-by-the-Sea, MA 01944
Gale JN 718111

ATTACHMENT 1:
GMAX TESTING REPORT
BROOK STREET FIELD

ATTACHMENT 2:
GMAX TESTING REPORT
JOSEPH M. HYLAND FIELD

ATTACHMENT 5:
JOSEPH M. HYLAND FIELD
AREAS OF CONCERN

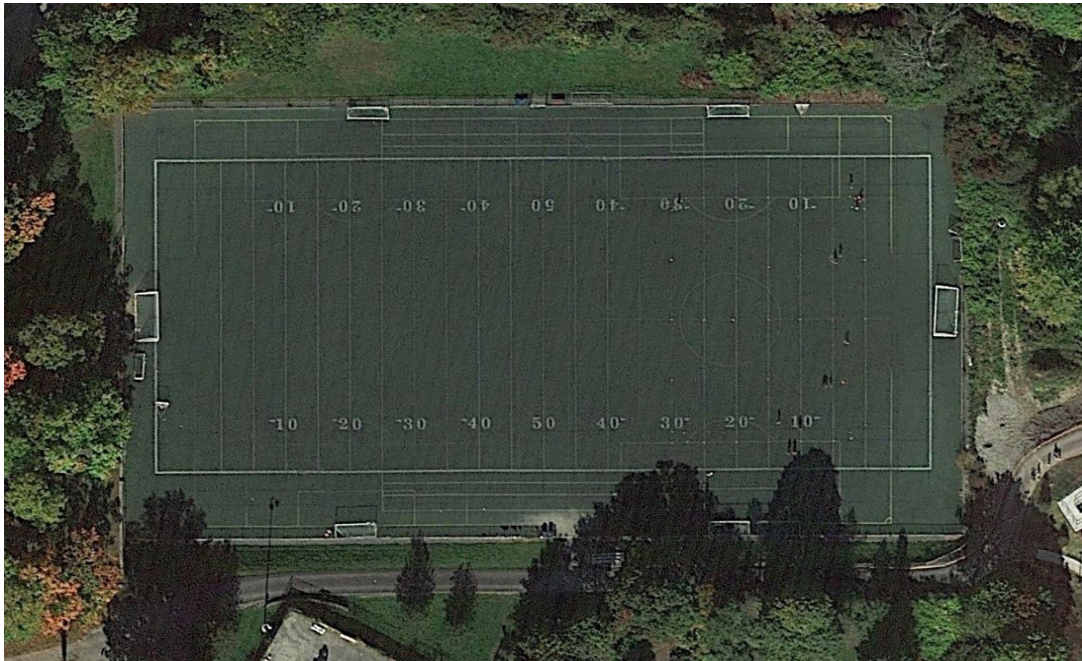
Testing Location Map (Aerial google photo)

The synthetic turf field recorded an average GMax of 176, with all but two location testing below the ASTM maximum limits of <200. Although not a requirement, per the Synthetic Turf Council's (STC) "Suggested Guidelines for the Essential Elements of Synthetic Turf Systems," the GMax should be below 165 throughout the life of the field. Three test locations recorded GMax values below the 165 limit as suggested by the STC guidelines. The synthetic turf field recorded an average infill depth of 29 mm (1.15"), which is below the ± 44 mm (± 1.75") recommended infill depth at time of installation, as is typical per turf manufacturer's guidelines for a 2.25" turf system. Having less infill may result in fiber layover, as was observed at the time of evaluation.

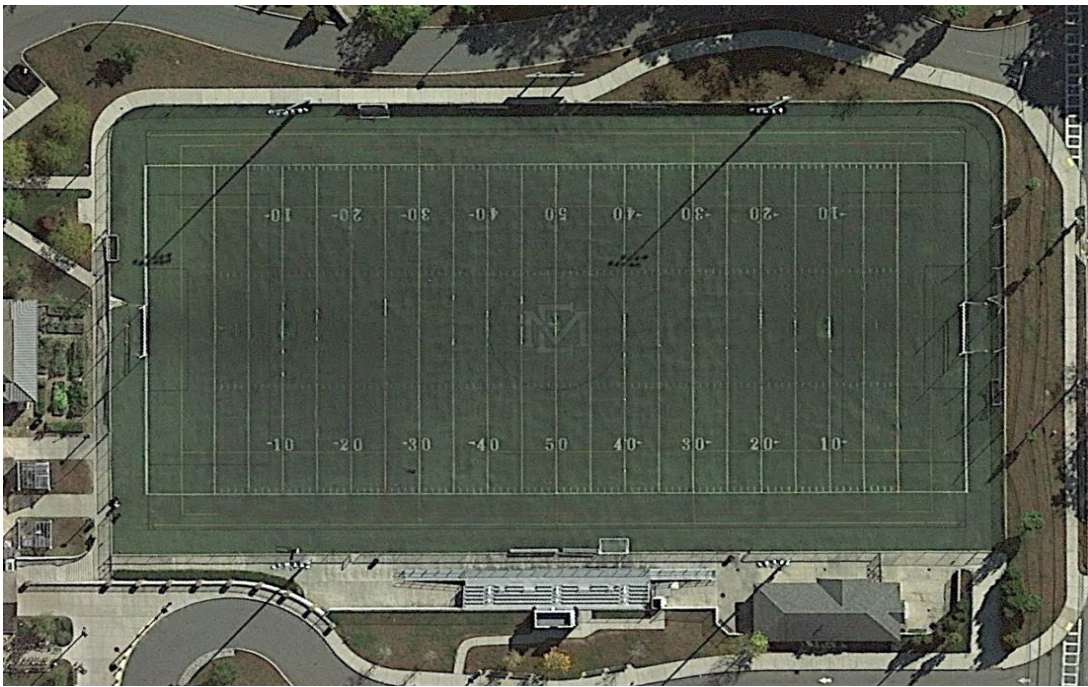
Testing Location Map (Aerial Google Photo)

The synthetic turf field recorded an average GMax of 163, with none of the ten locations testing above the ASTM maximum limits of <200. Although not a requirement, per the Synthetic Turf Council's (STC) "Suggested Guidelines for the Essential Elements of Synthetic Turf Systems," the GMax should be below 165 throughout the life of the field. Five test locations recorded GMax values below the 165 limit as suggested by the STC guidelines. The synthetic turf field recorded an average infill depth of 22 mm (0.87"), which is below the ± 38 mm (± 1.5") recommended infill depth at time of installation, as is typical per turf manufacturer's guidelines for a 2.0" turf system. Having less infill may result in fiber layover, as was observed at the time of evaluation.
