MANCHESTER ESSEX
REGIONAL SCHOOL DISTRICT

ESSEX ELEMENTARY
AND
MEMORIAL ELEMENTARY
SCHOOLS FACILITIES
NEEDS ASSESSMENT

DECEMBER 1, 2013

SCHOOL FACILITIES NEEDS ASSESSMENT: MEMORIAL AND ESSEX ELEMENTARY SCHOOLS

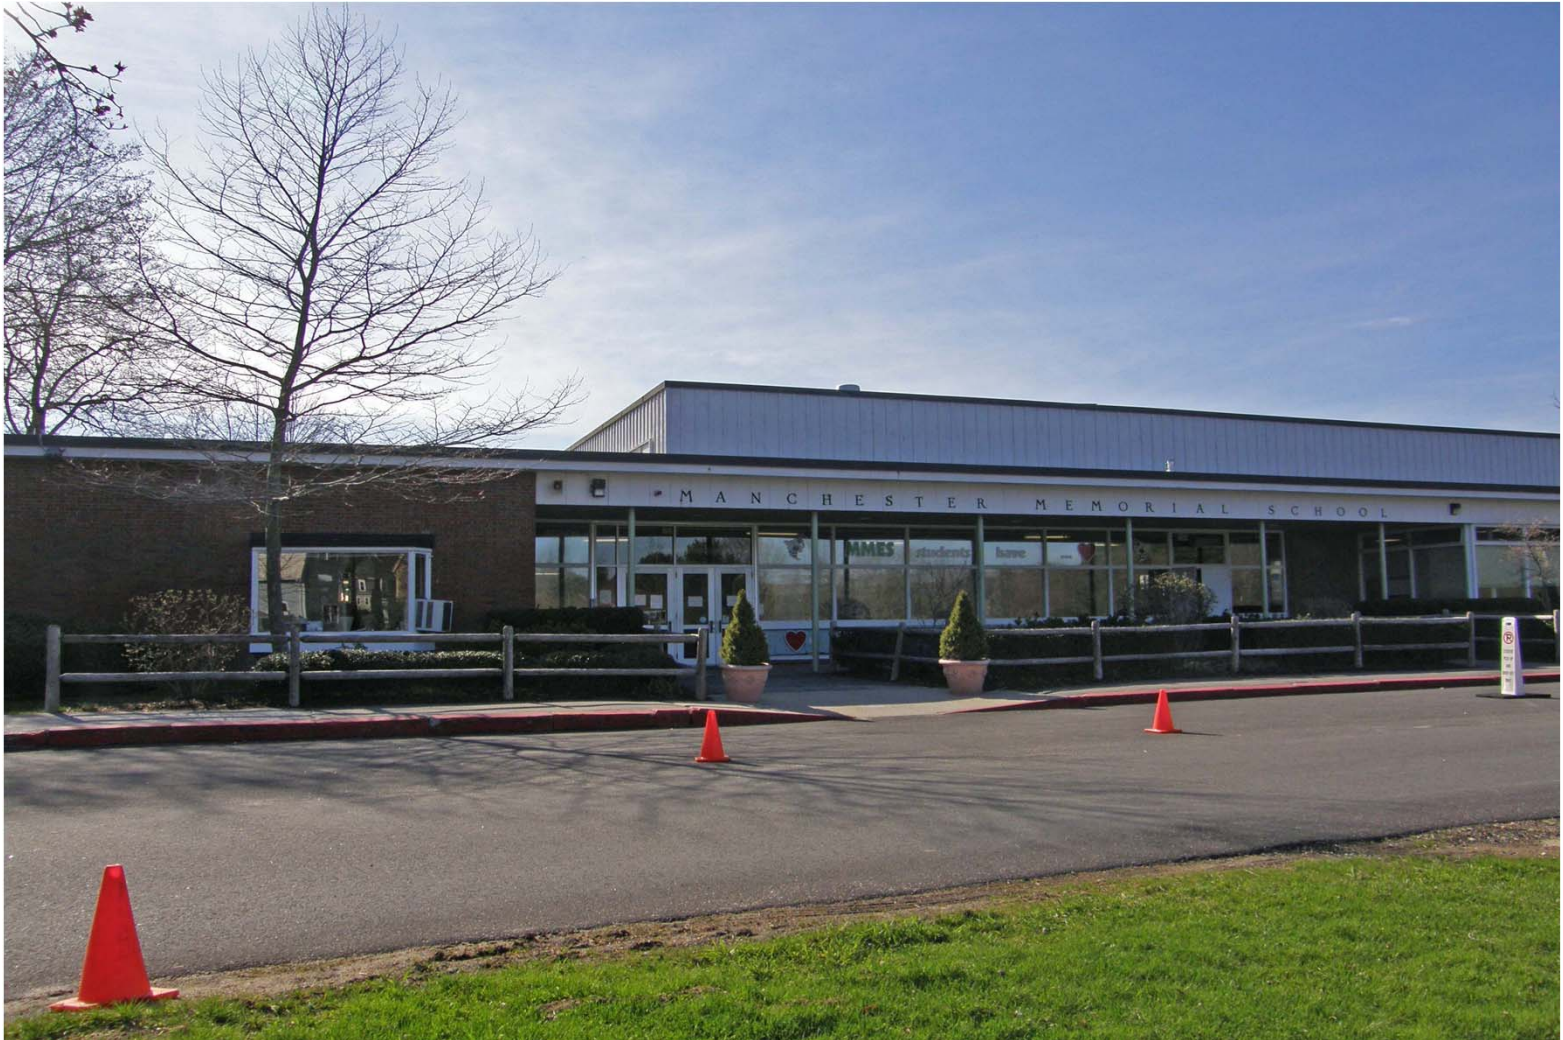
MEMORIAL ELEMENTARY SCHOOL

PHYSICAL CONDITIONS ASSESSMENT: MEMORIAL

43 Lincoln Street
Manchester, MA 01944

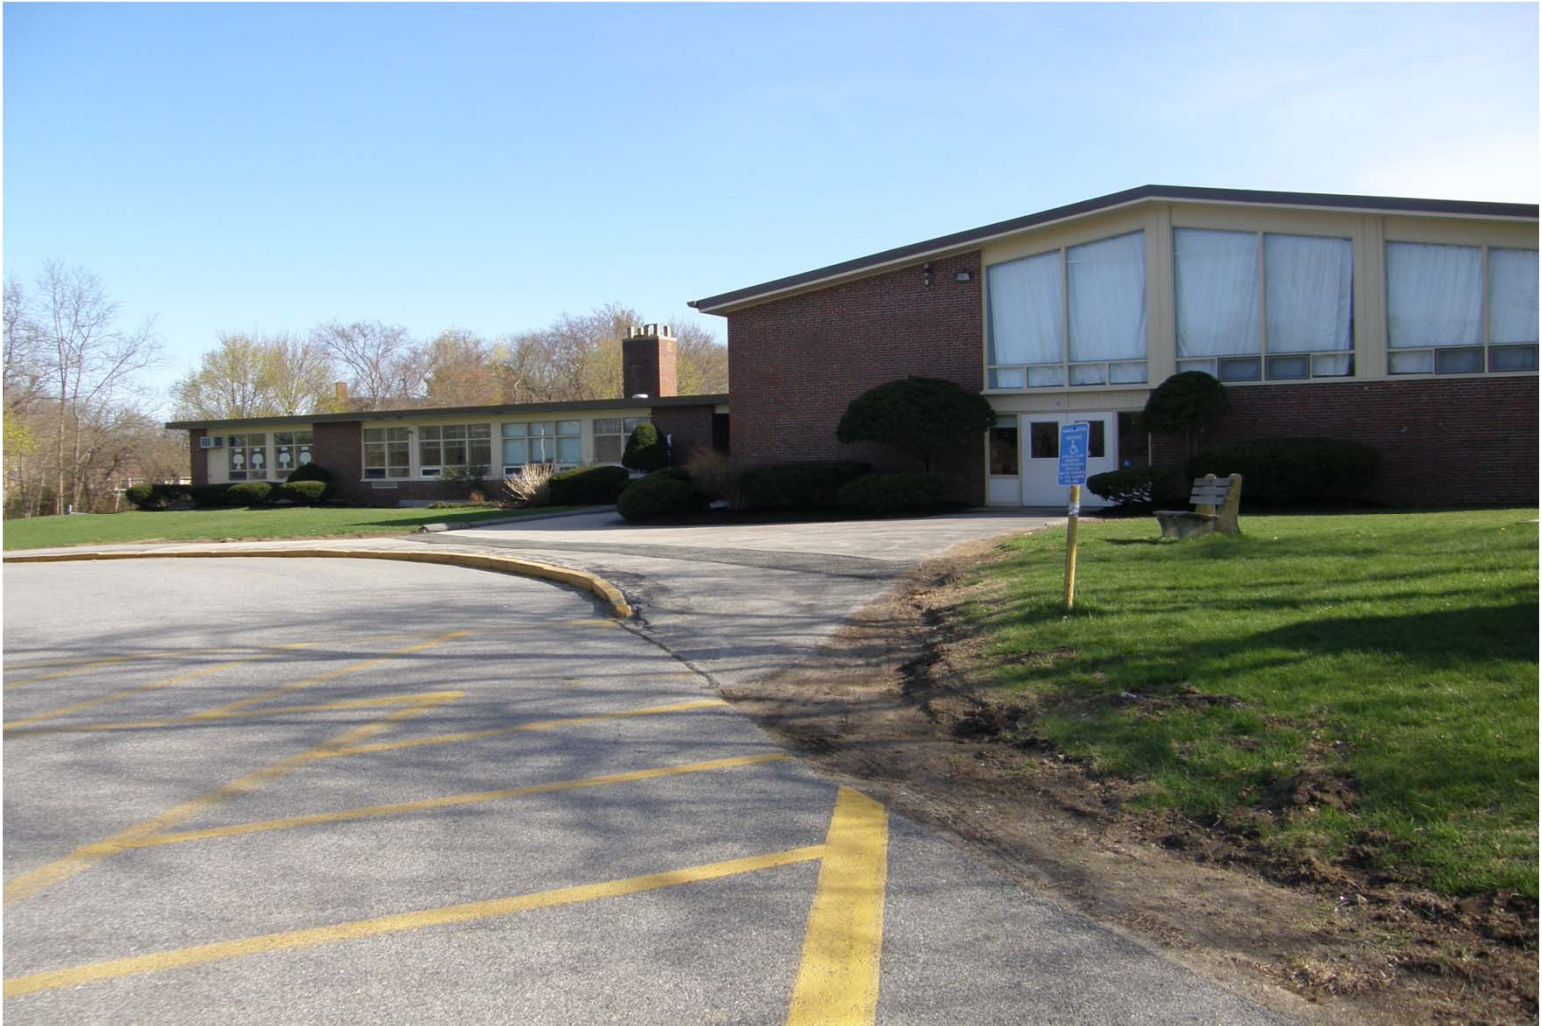
12 Story Street

Essex, MA 01929
