## FACILITY NEEDS ASSESSMENT

### ESSEX ELEMENTARY SCHOOL AND MANCHESTER ESSEX MIDDLE-HIGH SCHOOL

#### Manchester Essex Regional School District

DRAFT REPORT: January 27, 2023  
H&A JN 2217.01

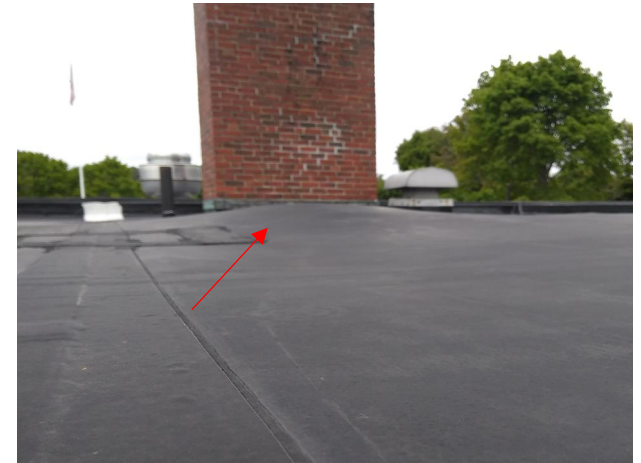
11. Rubber membrane roof has many areas of standing water and is extensively patched.

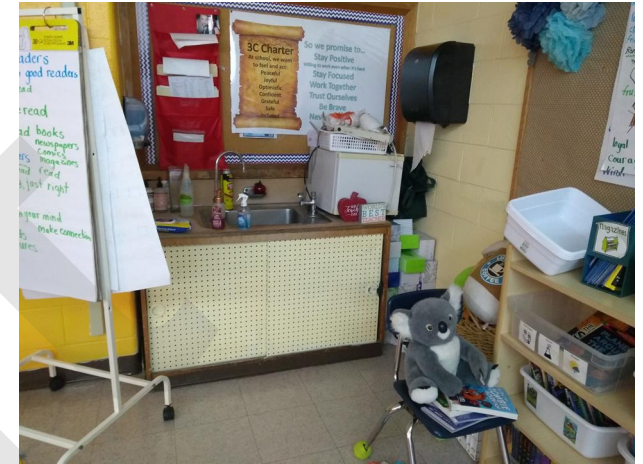
20. Classrooms have outdated and inefficient unit ventilators.

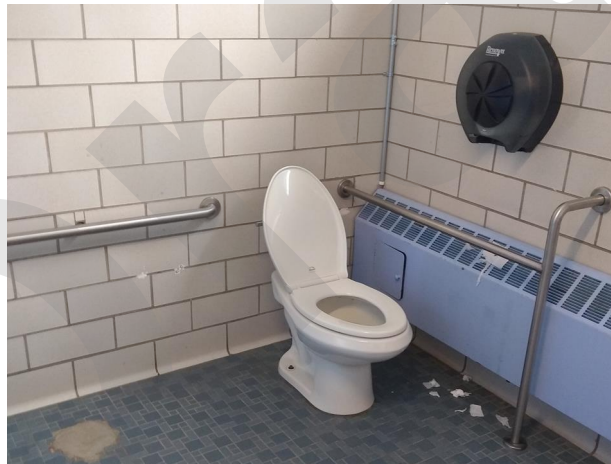
22. Multi-user toilet rooms have original, outdated fixtures and several have no AAB updates.

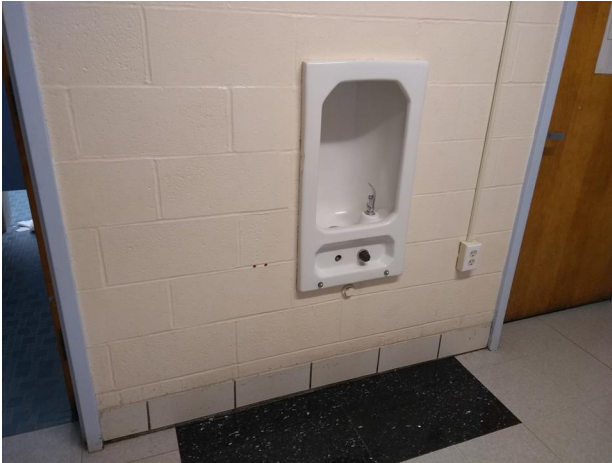
24. Single-user toilet rooms do not meet AAB requirements.

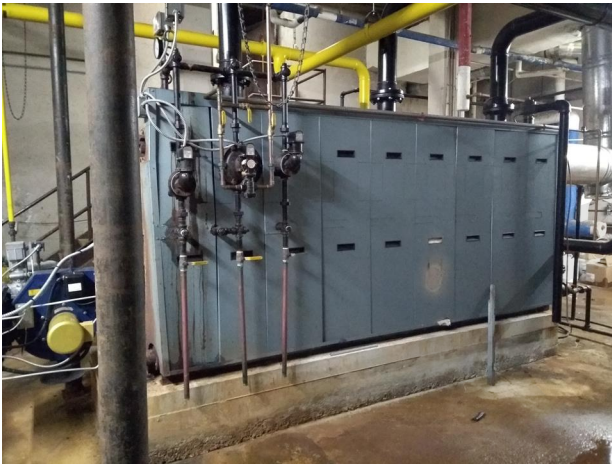
27. This 1975 era boiler is no longer being used.

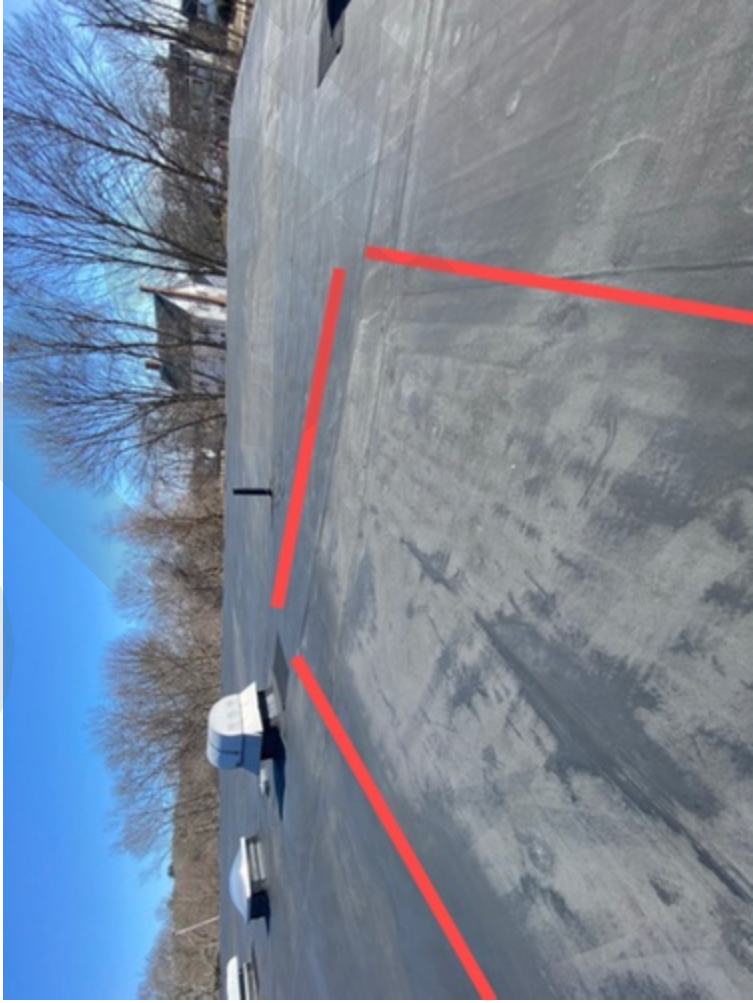
*Photo 2*

**Overview of roof section.  
"Dirty" area indicates  
ponding water.**

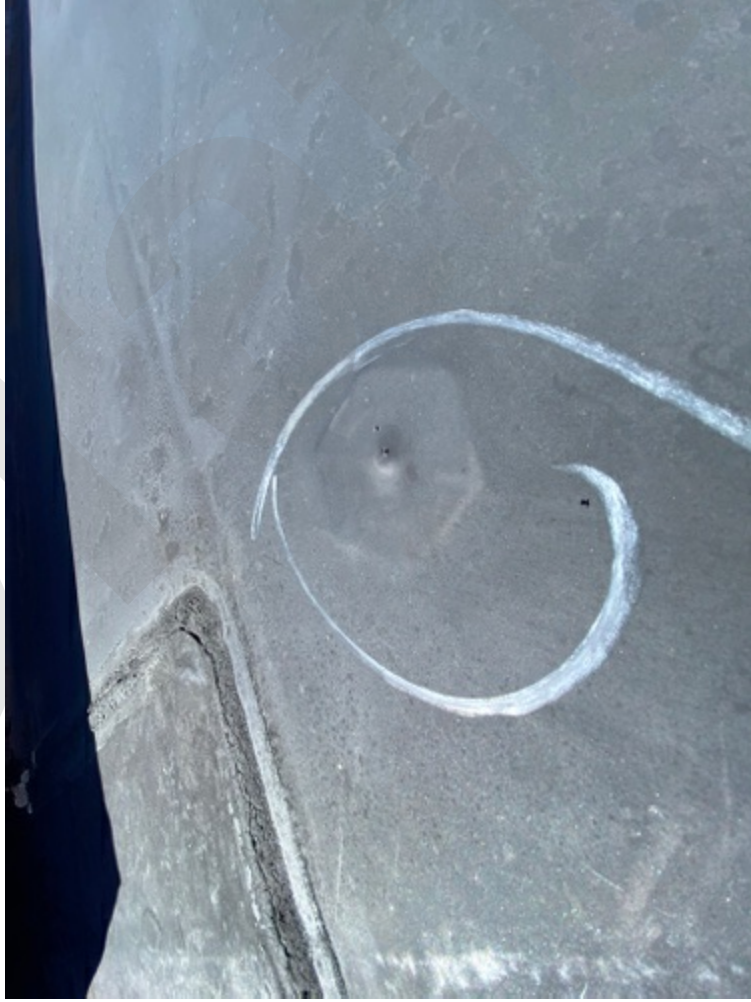
*Photo 18*

**Penetration in membrane  
above fastener location.**

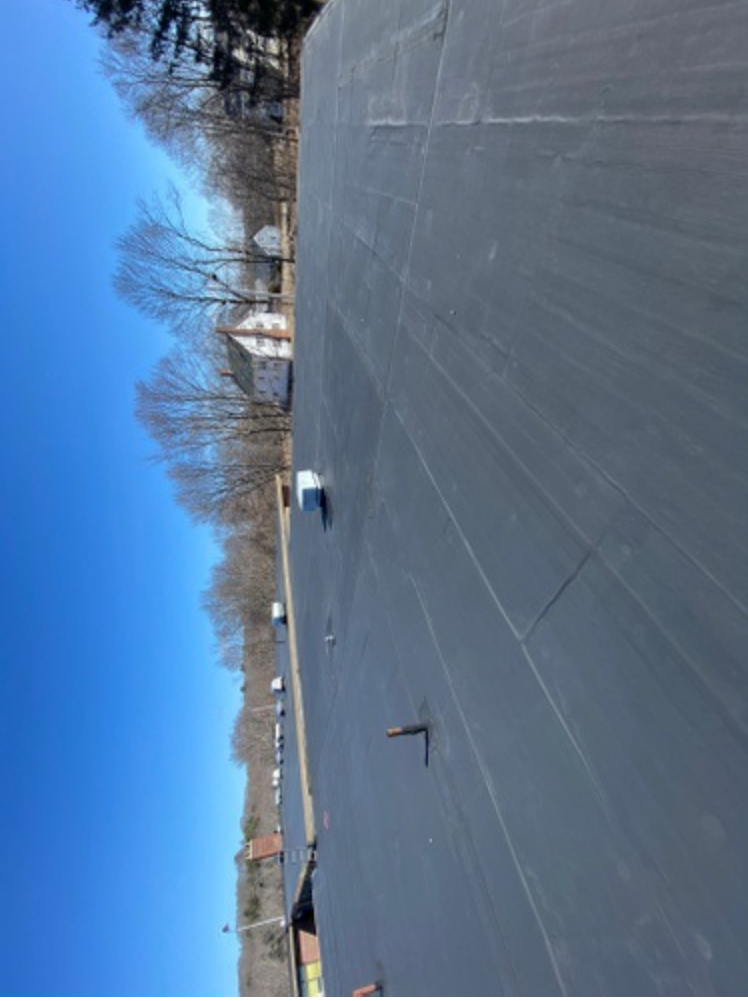
Photo 37

Overview of roof section.
