## FACILITY NEEDS ASSESSMENT

**ESSEX ELEMENTARY SCHOOL  
AND MANCHESTER ESSEX  
MIDDLE-HIGH SCHOOL**

**Manchester Essex  
Regional School District**

**FINAL REPORT: January 27, 2023  
H&A JN 2217.01**

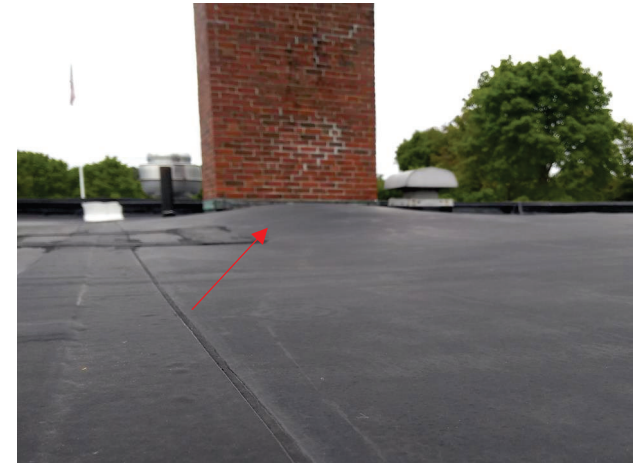
12. There are areas where the roof has bubbled and the membrane is no longer adhered.

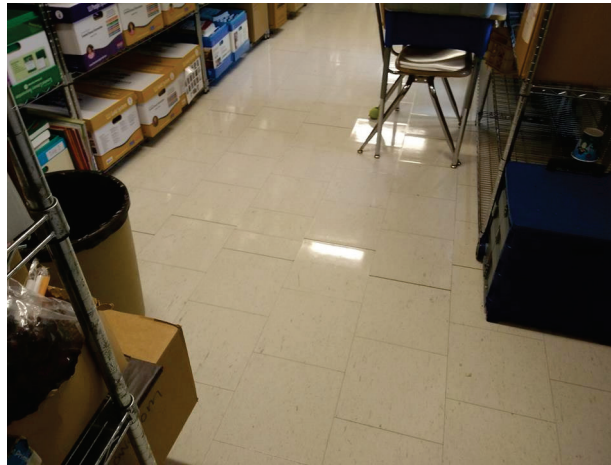
14. Vinyl floor tiles in Modular addition show signs which may indicate issues with subfloor.

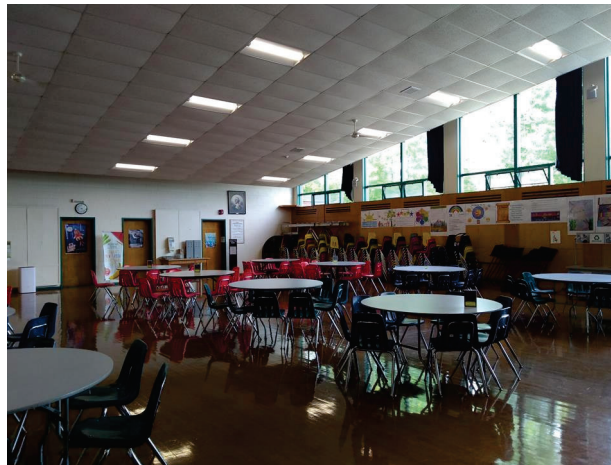
17. Existing 2x4 ceiling tiles have sagged and are cupped.

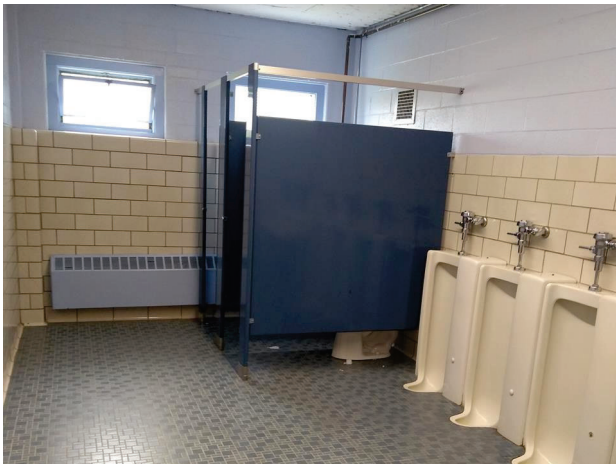
22. Multi-user toilet rooms have original, outdated fixtures and several have no AAB updates.

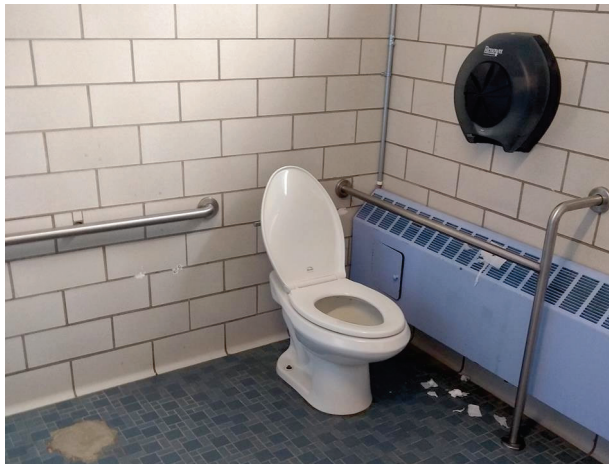
23. Grab bars/accessories are non-compliant and original tile floor is patched.

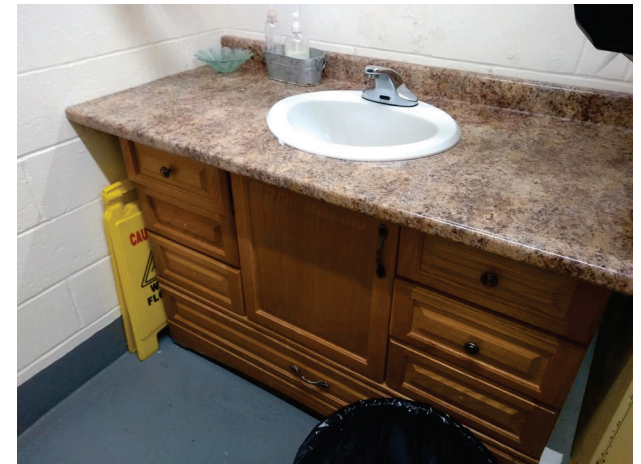
24. Single-user toilet rooms do not meet AAB requirements.

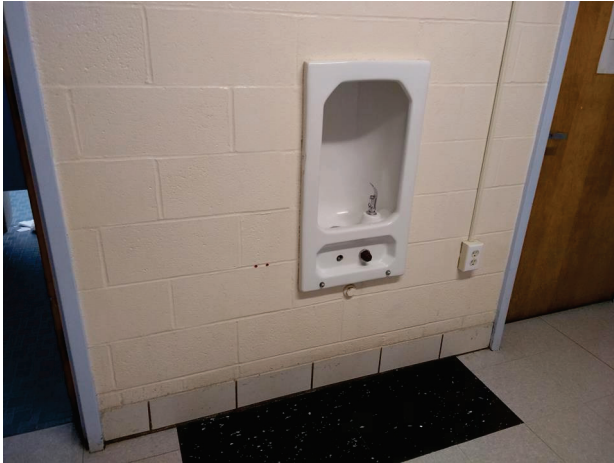
25. All drinking fountains are original and are not AAB compliant.

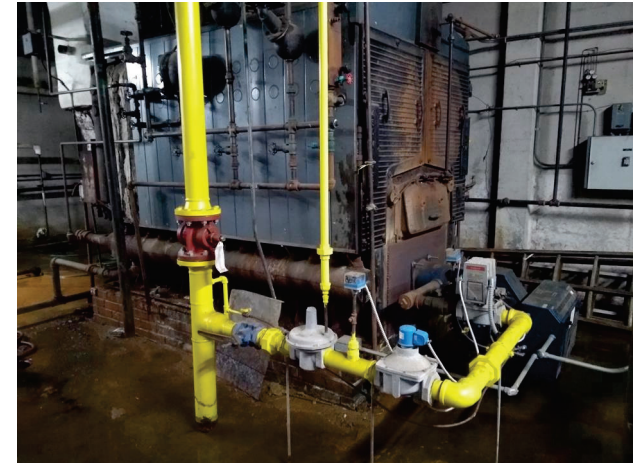
27. This 1975 era boiler is no longer being used.

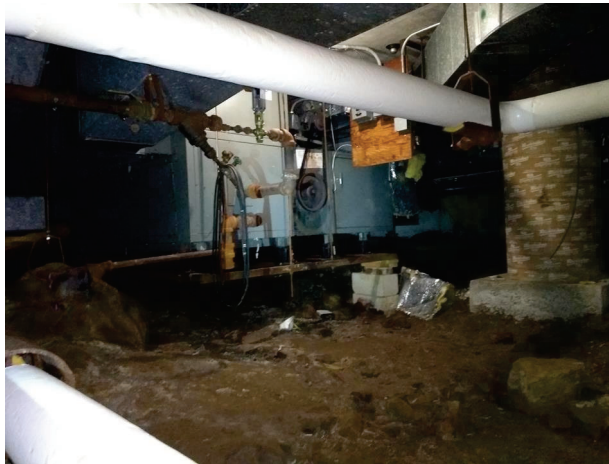
29. This Air Handling Unit in the crawl space is obsolete.

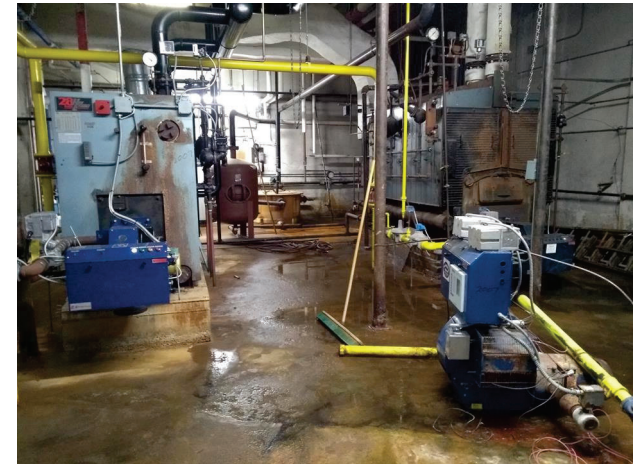
30. Boiler room shows signs of chronic flooding, equipment is obsolete and inefficient.

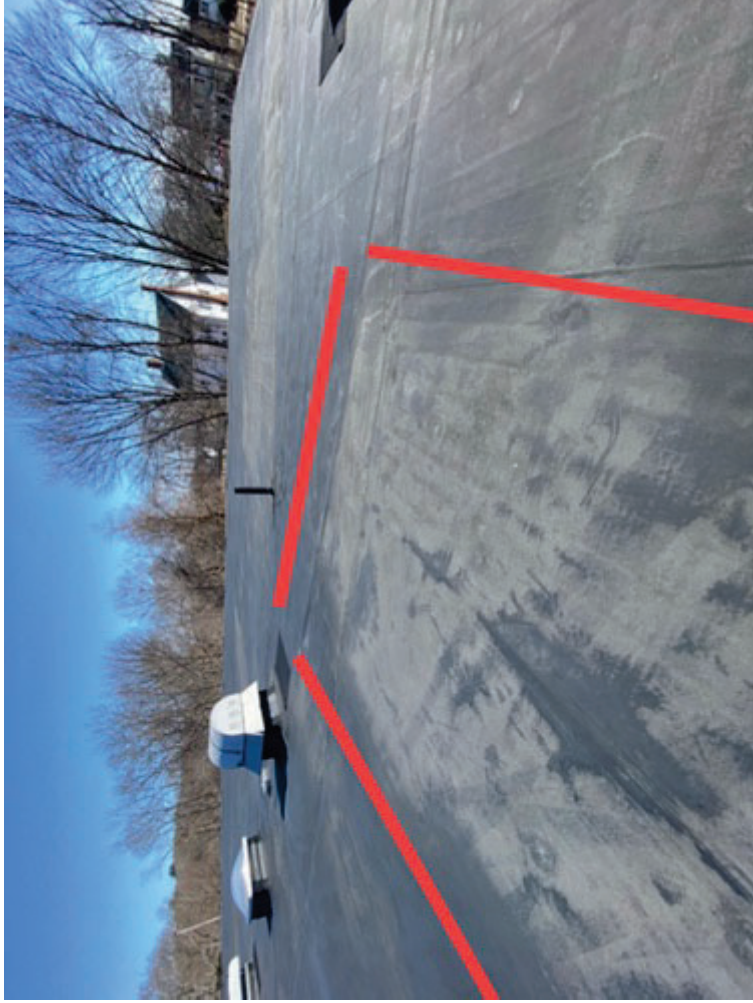
*Photo 2*

**Overview of roof section.**  
"Dirty" area indicates  
ponding water.

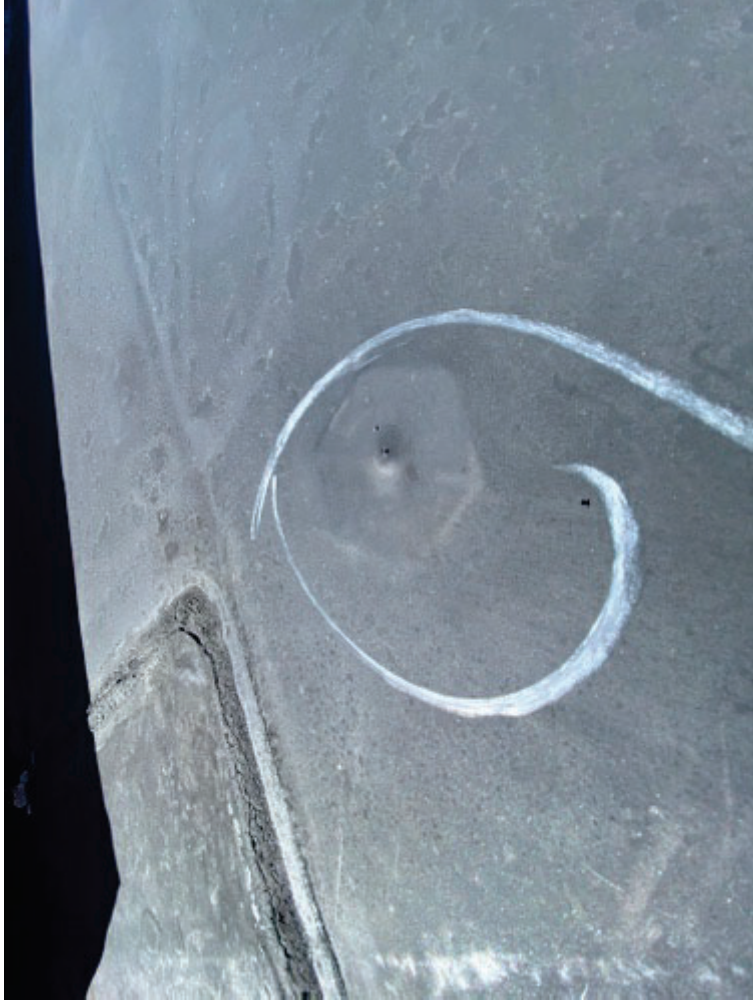
*Photo 18*

**Penetration in membrane  
above fastener location.**

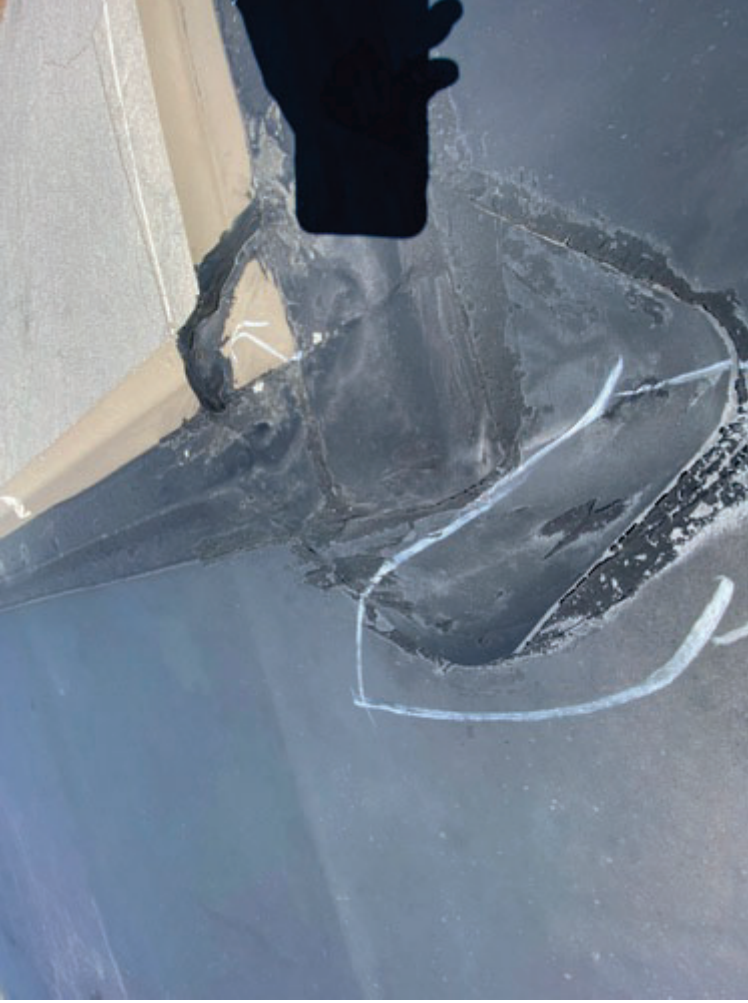
Photo 25

**Failed corner flashing.**

This is a source of water infiltration to the roofing assembly.

The following conditions are associated with water infiltration:

- Interior water damage
- Mold/Mildew
- Saturated insulation resulting in loss of dimensional stability and R Value
- Delamination of the membrane from sub-straight.
- Rust/rot of fasteners and decking

- Troubleshoot & repair **20 failed patches and flashing conditions** on all roof sections.
- Troubleshoot & repair **30 failed patches over edge metal laps** on all roof sections.
- For penetrations and failed coverstrip/flashing:
  - Clean roof surface with high grade cleaner
  - Apply peel and stick Uni-Bond 6" tape to penetration or seam
  - Apply White Knight Plus WC to Uni-Bond tape and extend coating 4" past all seams of tape. Ensure felt backing of tape is fully saturated.
- Apply GreenLock Structural Adh at termination bars.
- All debris will be cleared up and removed.

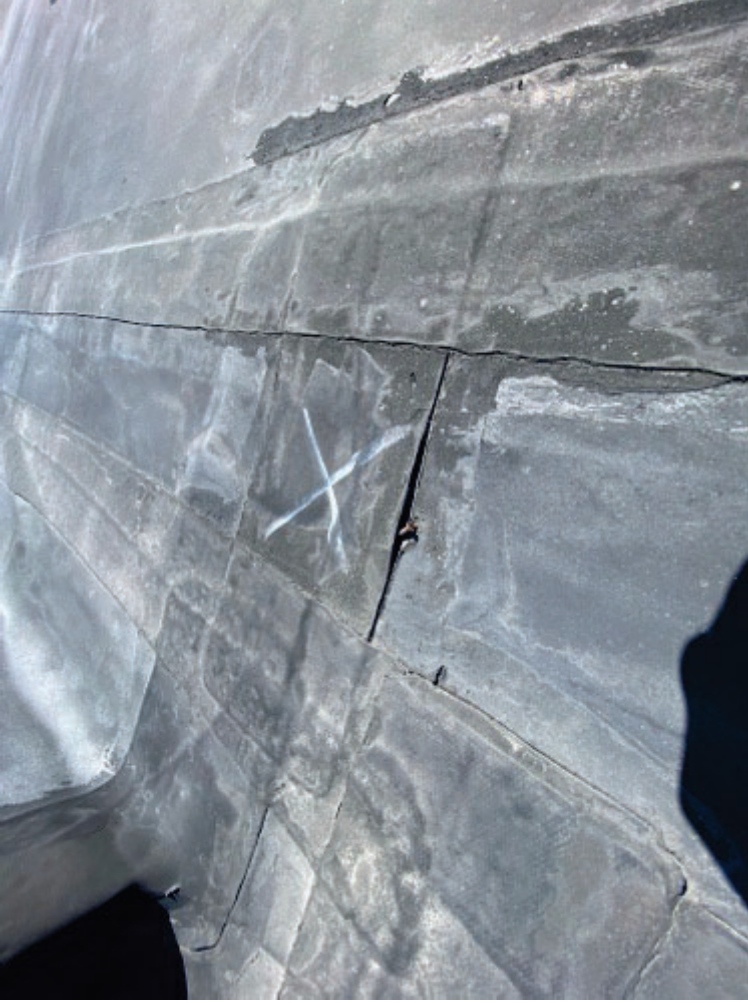
*Photo 29*

**Failed patch.**

This is a source of water infiltration to the roofing assembly.

The following conditions are associated with water infiltration:

- Interior water damage
- Mold/Mildew
- Saturated insulation resulting in loss of dimensional stability and R Value
- Delamination of the membrane from sub-straight.
- Rust/rot of fasteners and decking

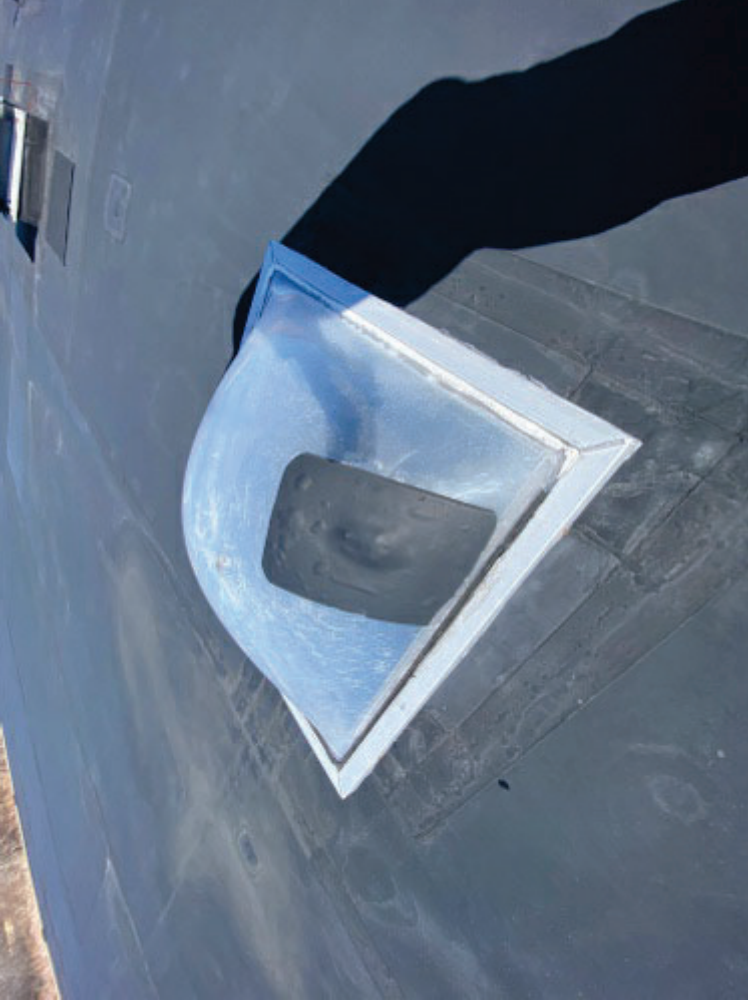
*Photo 33*

**Repaired skylight.**
